Chlorine Dioxide Degradation Issues on Metal and Plastic Water Pipes Tested in Parallel in a Semi-Closed System

Alberto Vertova ¹, Alessandro Miani ^{2,3}, Giordano Lesma ^{1,4}, Sandra Rondinini ¹,
Alessandro Minguzzi ¹, Luigi Falciola ^{1,3} and Marco Aldo Ortenzi ^{1,4,*}

Abstract: Chlorine dioxide (ClO₂) has been widely used as a disinfectant in drinking water in the past but its effects on water pipes have not been investigated deeply, mainly due to the difficult experimental set-up required to simulate real-life water pipe conditions. In the present paper, four different kinds of water pipes, two based on plastics, namely random polypropylene (PPR) and polyethylene of raised temperature (PERT/aluminum multilayer), and two made of metals, i.e., copper and galvanized steel, were put in a semi-closed system where ClO₂ was dosed continuously. The semi-closed system allowed for the simulation of real ClO₂ concentrations in common water distribution systems and to simulate the presence of pipes made with different materials from the source of water to the tap. Results show that ClO₂ has a deep effect on all the materials tested (plastics and metals) and that severe damage occurs

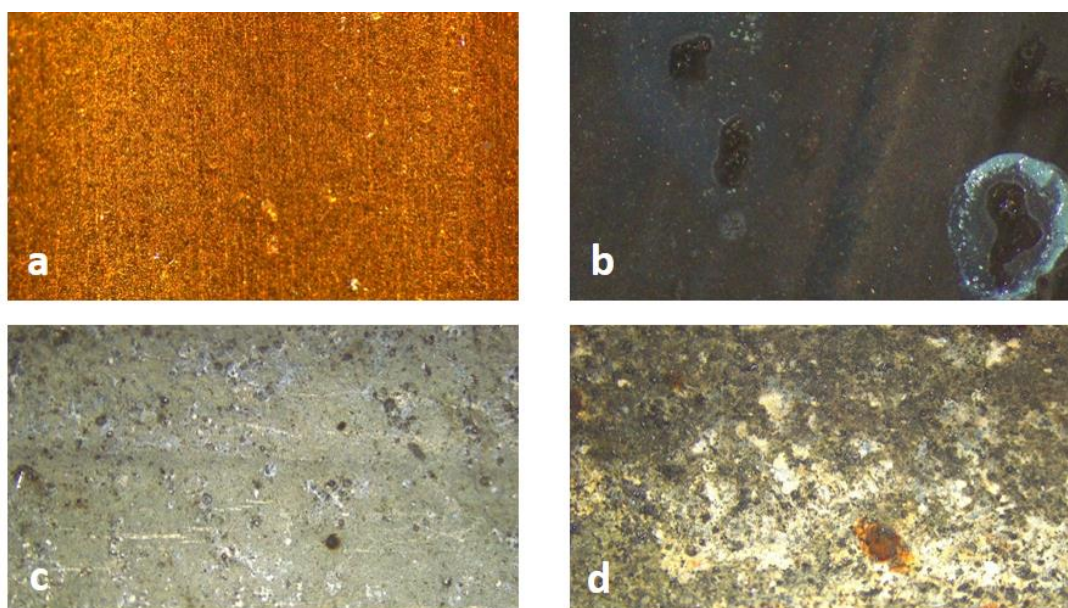
Figure 2. Cu pipe—new (a), Cu pipe—8 weeks (b), galvanized steel—new (c), and galvanized steel—8 weeks (d).

In particular, the black color of Cu pipes indicates the formation of cupric oxide, whereas the galvanized steel shows marked signs of degradation and oxidation.

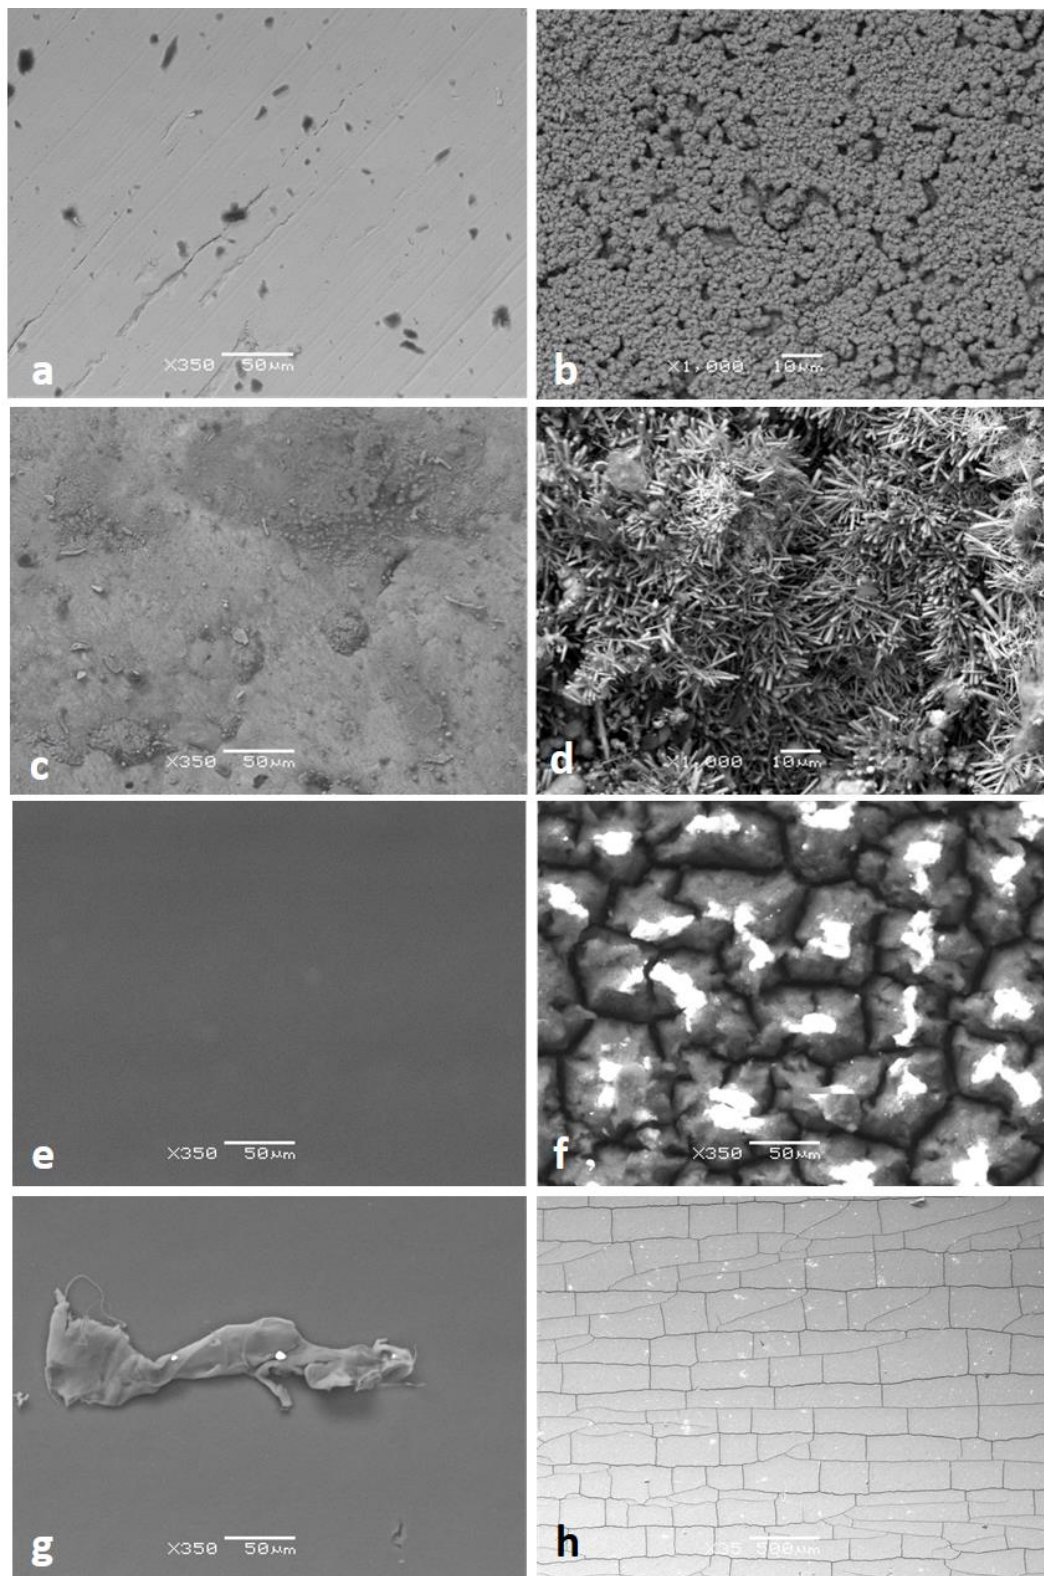
In all cases, SEM images demonstrate severe degradation of the inner surface of the pipes even if, as expected, the behavior changes significantly according to the material, as illustrated after.

Even if the EDS results must be considered as semi-quantitative, they clearly indicate that all pipes have undergone severe degradation: Copper has turned to copper oxide, which, according to Figure 3b, is very porous. Galvanized steel has undergone partial dezincification, with the surface showing the typical appearance of degraded galvanized steel.

Plastic-based pipes have different degradation profiles, with the formation of cracks that, in the case of PE-RT, follow the extrusion direction of the pipe with perpendicular cracks between them, in a brick wall-like pattern. In the case of PPR, cracks are different, i.e., more random. In both cases, materials are highly oxidized on the surface, as confirmed by EDS.

Figure 3. Cu pipe—new (350X) (a), Cu pipe—8 weeks (1000X) (b), galvanized steel—new (350X) (c), galvanized steel—8 weeks (1000X) (d), random polypropylene (PPR)—new (350X) (e), PPR—8 weeks (350X) (f), polyethylene of raised temperature (PERT)—new (350X) (g), and PERT—8 weeks (350X) (h).

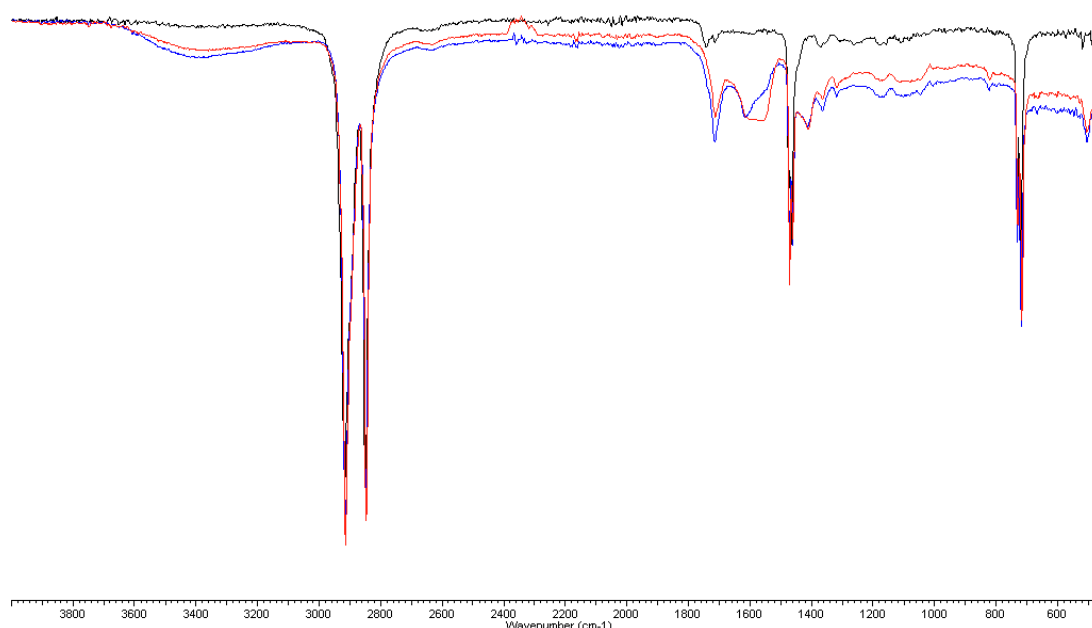
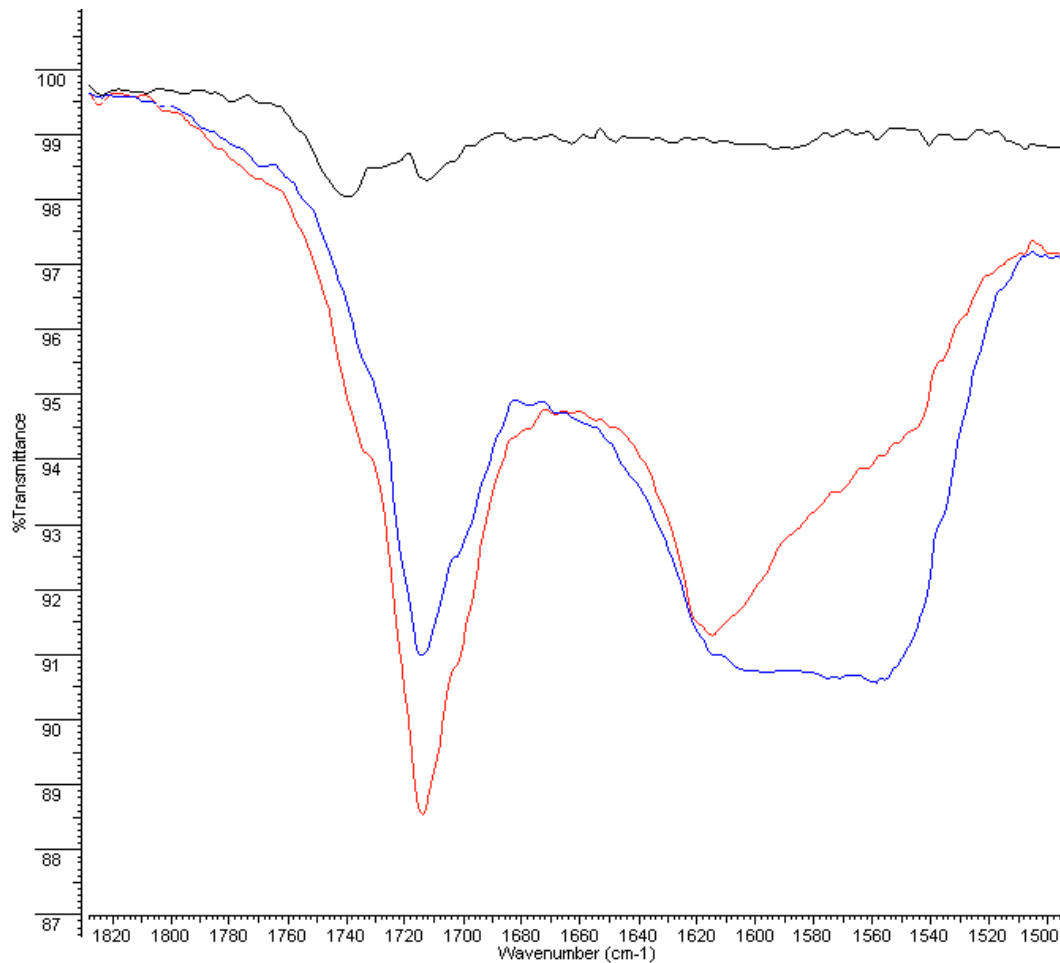
Before aging, FT-IR spectra of PERT and PPR show weak absorption carbonyl signals in the $1750\text{--}1735\text{ cm}^{-1}$ region, attributable to the antioxidants present as additives in the polymer, which shift to lower values ($1710\text{--}1715\text{ cm}^{-1}$) and increase in intensity, suggesting the formation of both carboxylic and carbonyl compounds in the highly oxidized samples (after 4 and 8 weeks of aging). Moreover, a broad hydroxyl band in the $3200\text{--}3500\text{ cm}^{-1}$ region appears, confirming the previous results (Figures 4–7).

Figure 4. FT-IR spectra of PERT inner surface: new (black), 4 weeks (red), and 8 weeks (blue).

Furthermore, these bands are accompanied by the appearance of a broad absorption band between $1550\text{--}1620\text{--}1640\text{ cm}^{-1}$ that becomes dominant after 8 weeks and could be assigned to both H-bonded carboxyl and to carboxylate anion groups, the latter of which is derived from salification. All these data are consistent with the reported literature [15] and indicate a consistent degradation of the pipe inner surface caused by ClO_2 .

Figure 5. FT-IR spectra of PERT inner surface: new (**black**), 4 weeks (**red**), and 8 weeks (**blue**)—magnification of $1830\text{--}1500\text{ cm}^{-1}$ region.

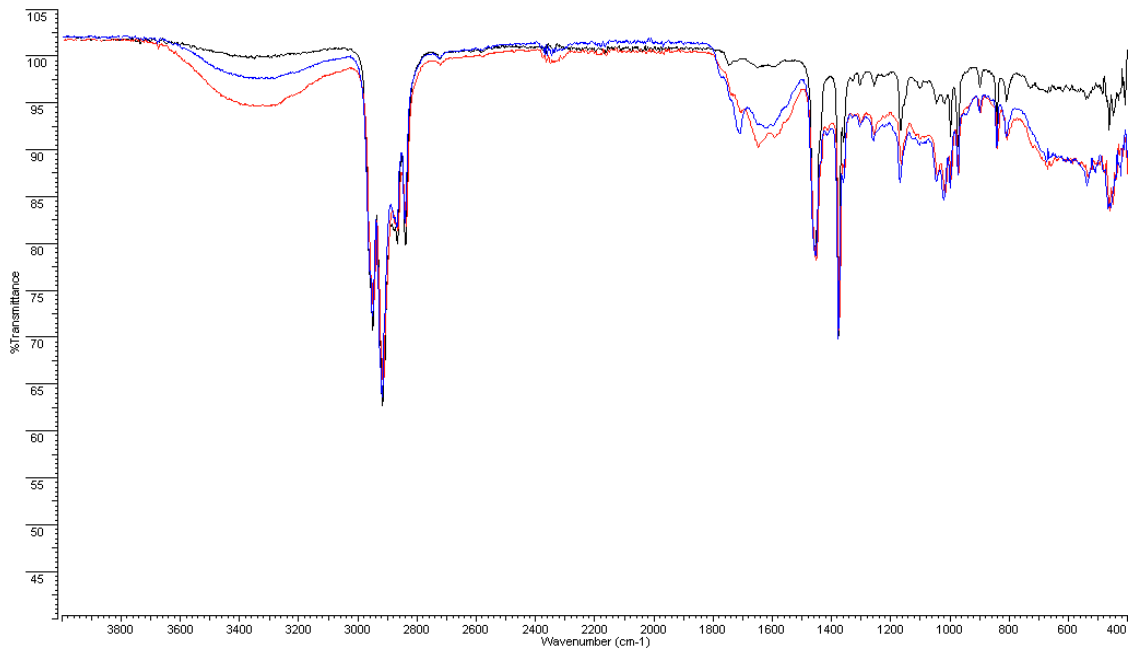
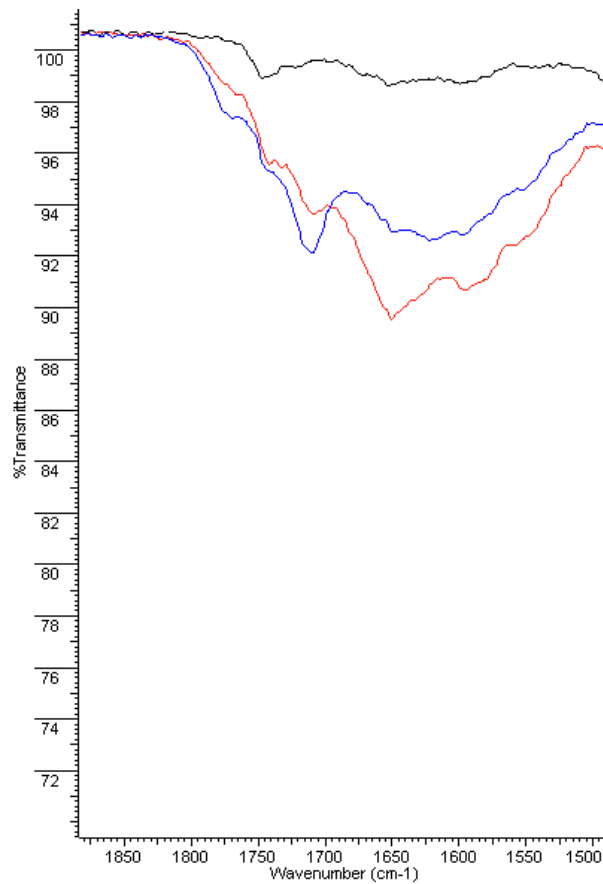
except for a greater persistence of the antioxidants before the appearance of carbonyl and carboxylic functional groups in the IR spectra (Figures S6–S8—Supplementary file).

Figure 6. FT-IR spectra of PPR inner surface: new (black), 4 weeks (red), and 8 weeks (blue).

Figure 7. FT-IR spectra of PPR inner surface: new (black), 4 weeks (red), and 8 weeks (blue)—magnification of 1900–1500 cm^{-1} region.

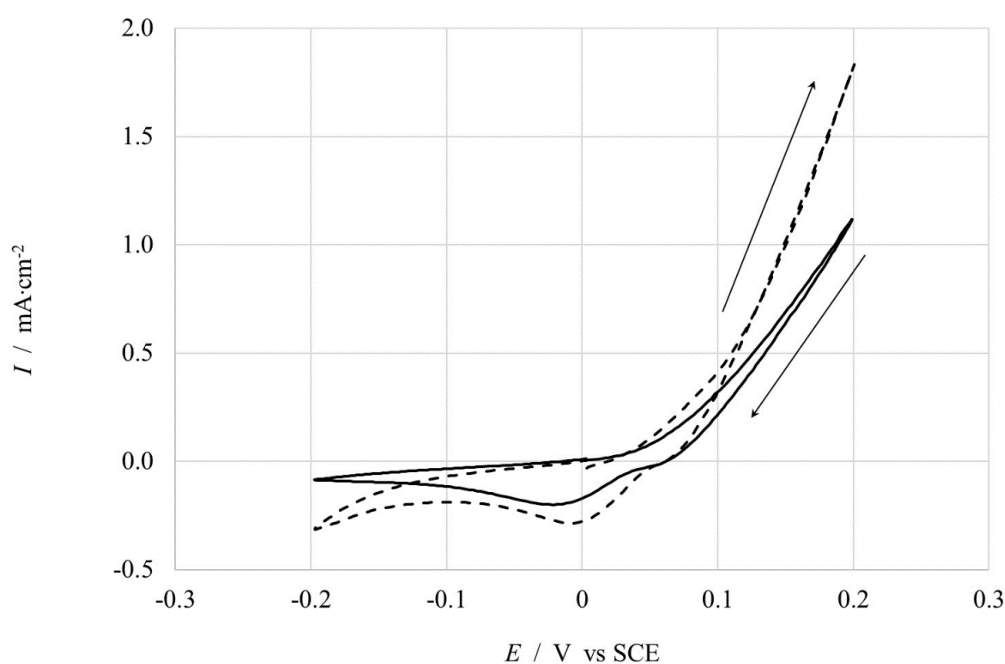
Before investigating the Cu pipe inner surface, Cyclic Voltammetry (CVs) have been used to identify the potential at which it is possible to highlight the surface degradation process that, for our purpose, is directly connected with the modification, both, of the surface area, affecting C_{dl} , and the electron transfer process for Cu oxidation, acting on R_{ct} . Figure 8 shows CVs for two different samples: new pipe (black continuous curve) and aged 8 weeks (dotted curve) Cu tubes. It emerges that aged Cu shows higher values of current density, both for oxidation and reduction processes, probably connected with a more electro-active metallic surface after the contact with ClO_2 . In particular, at the start potential of 0 V, the current is almost zero for both samples; then, during the anodic scan, current increases much more for aged than pristine samples, due to the corrosion process occurring at the Cu surface; during the backward scan, it is possible to see a cathodic bump at about 0 V, probably due to the reduction of Cu ions formed during the anodic scan. After this analysis, the selected investigating potentials for EIS measurements have been 0, 0.05V, and 0.1 V vs. SCE.

Figure 8. CV in 0.5 M KNO_3 at 20 mV s^{-1} ; new pipe (continuous), Cu aged 8 weeks (dotted).

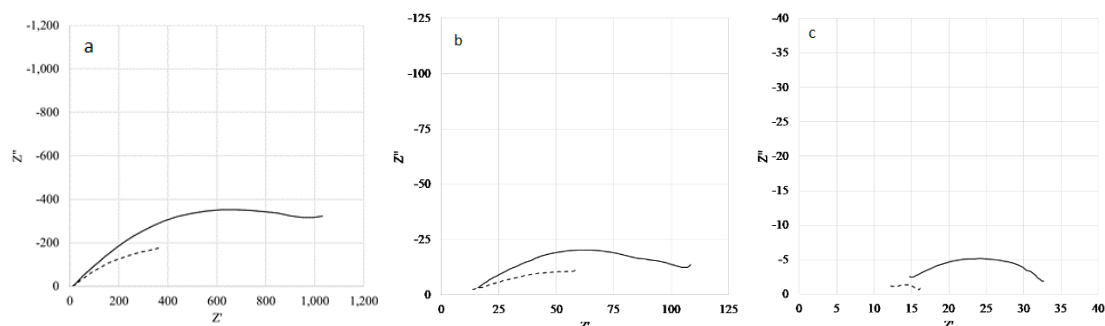
Figure 9a,b shows the Nyquist diagram for new (continuous curve) and aged (dotted curve) samples at different polarization potentials for the frequency range selected to highlight the behavior of electron transfer resistance, R_{ct} , and double layer capacitance, C_{dl} . Fitting was carried out using an R_1 in series to a parallel R_{ct} CPE. The use of a constant phase element (CPE) is necessary due to the presence of rough metallic surfaces and pores, and in the case of the aged sample, due to the corrosion product film on the metallic surface, thus evidencing a diffusion step in the same frequency domain.

Figure 9. Cu new pipe (continuous curve) and after 8 weeks aging (dotted curve) at 0.0 V (a), 0.05 V (b), and 0.1 V (c) vs. the saturated calomel electrode (SCE).

The reduction in the R_{ct} values (from the semicircle amplitude) is evident, increasing the polarization potential from 0 to 0.05 V versus SCE (Figure 9a vs. Figure 9b), due to the increase of the Cu corrosion process rate. At 0.1 V, the Nyquist plot presents two almost overlapped semicircles, as at this higher potential, the $t = 0$ sample is prone to the anodic degradation process. At a lower potential, this phenomenon is much more evident for the aged Cu (see R_{ct} in Table 4), as its surface is already modified and damaged by ClO_2 action, and at 0.05 V vs. SCE, the anodic polarization accelerates the corrosion process.

The higher R_{ct} value for Cu at $t = 8$ weeks compared to $t = 0$, when polarized at 0.05V, is probably connected with the CPE exponent value, which is about 0.6 for Cu at $t = 0$ at all potentials and about 0.5 for Cu at 8 weeks of aging at 0 and 0.1 V, while it becomes 0.23 at 0.05 V (see 4th column Table 4). This is most likely due to the modification of pore sizes and the shape present in the corrosion film on the Cu surface; a phenomena that can deeply affect the diffusion of ions back and forth towards the underlying metallic surface, thus reducing the electron transfer rate evidenced by the increase of R_{ct} . In any case, this behavior is strictly connected with the film layer on the Cu surface produced during the aging process in the presence of ClO_2 . No such behavior has been detected for the pristine Cu. Lastly, the C_{dl} values for the pristine sample are smaller, of about one order of magnitude, than the aged values (Table 4), thus indicating a more corrugated metallic surface due to the damaging action of ClO_2 .
