# Power mezzanine PDB-LTM: Status of the boards production

### M. Citterio, M. Lazzaroni, S. Latorre, F. Tartarelli

LAr March 2019 (March 5, 2019)

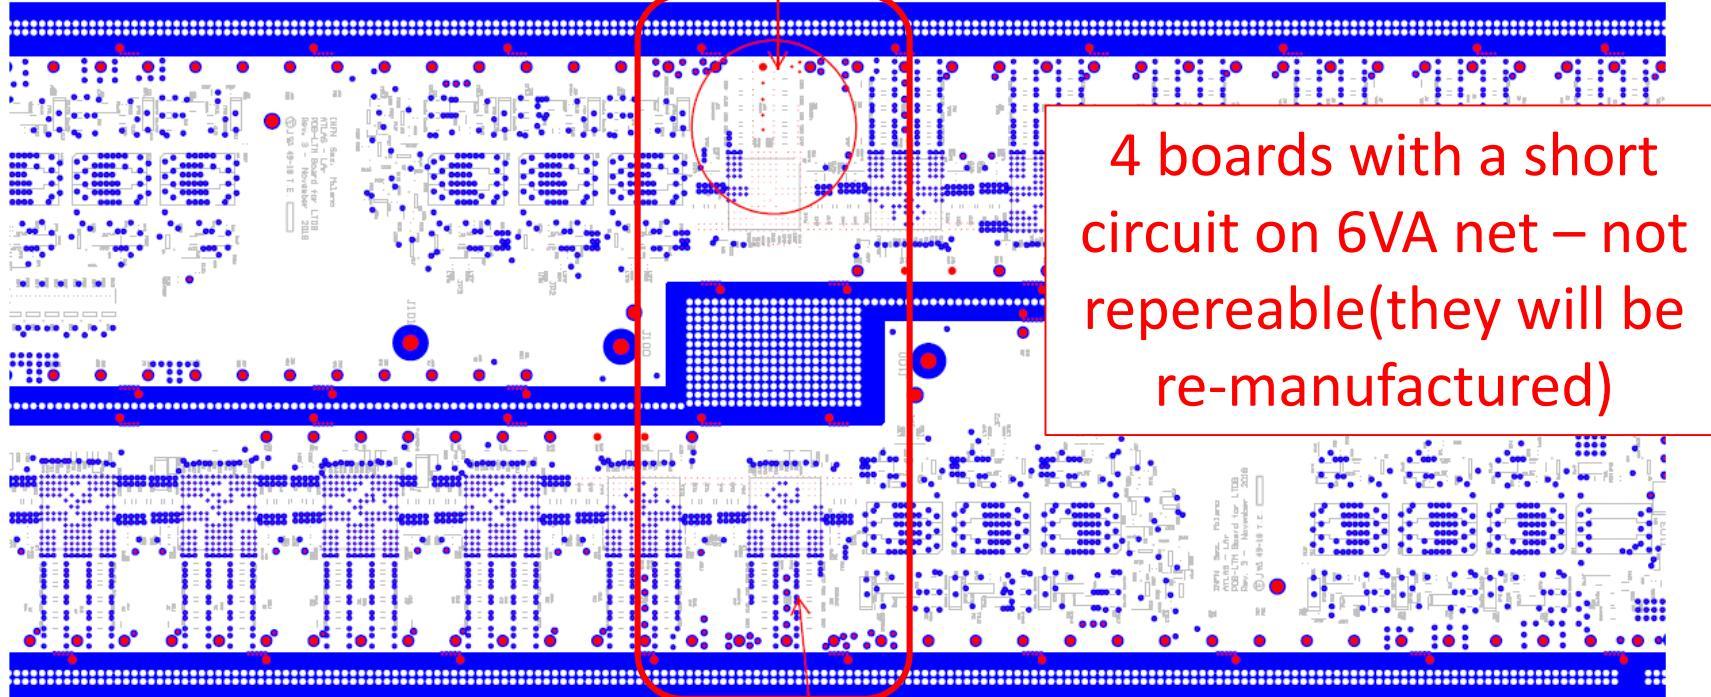
# Subset of the panel

#### The upper board has been realized in the wrong way!

The upper board is a «rotated» copy of the lower (original) board During the "panelization", the pads that create the insulation (antipad) from all the holes not connected to the 6VA plane have been accidentally removed

#### Short circuit on 6VA net!

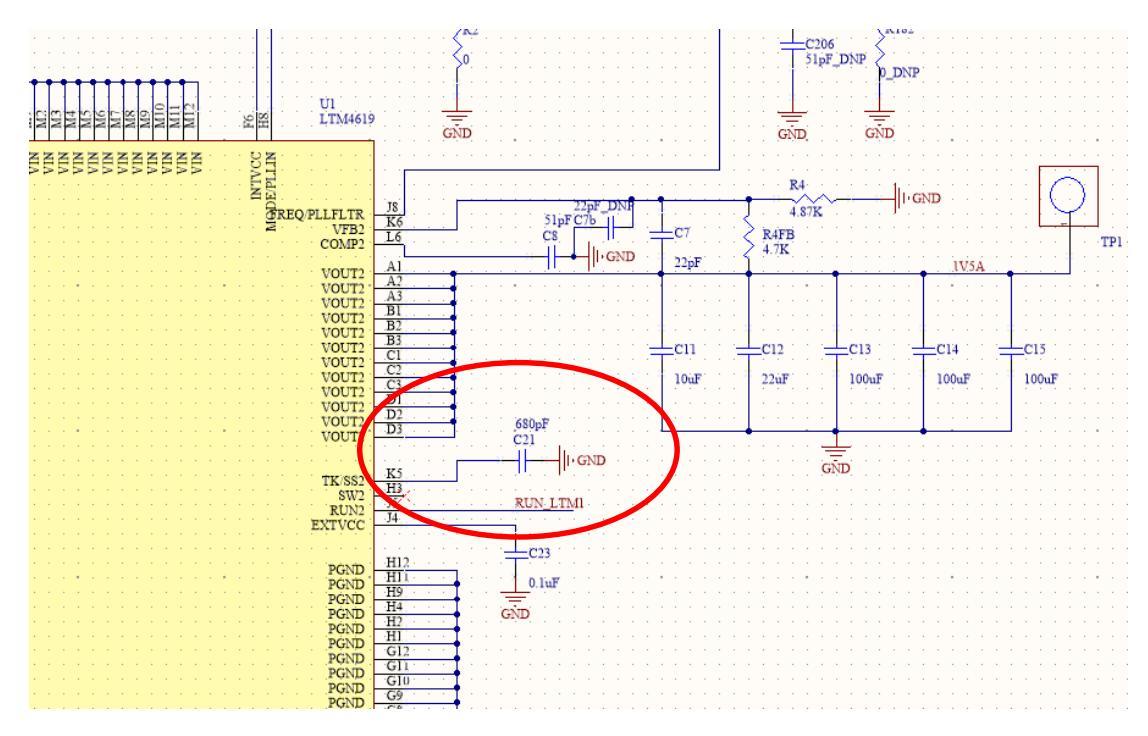
# Issue of the 1v5 net

Capacitor C21 for LTM1 (and C67 for LTM3) should have been changed from

$0.1\,\mu\text{F}$  to 680 pF in this release of the PDB-LTM.

WHY: to have a more rapid soft start

Reason: this new value was not updated in the BOM

The circuit with the new capacitor operates correctly in Milan but does not operate correctly at BNL.

Tests are ongoing to understand why such a different behavior in the two set-up

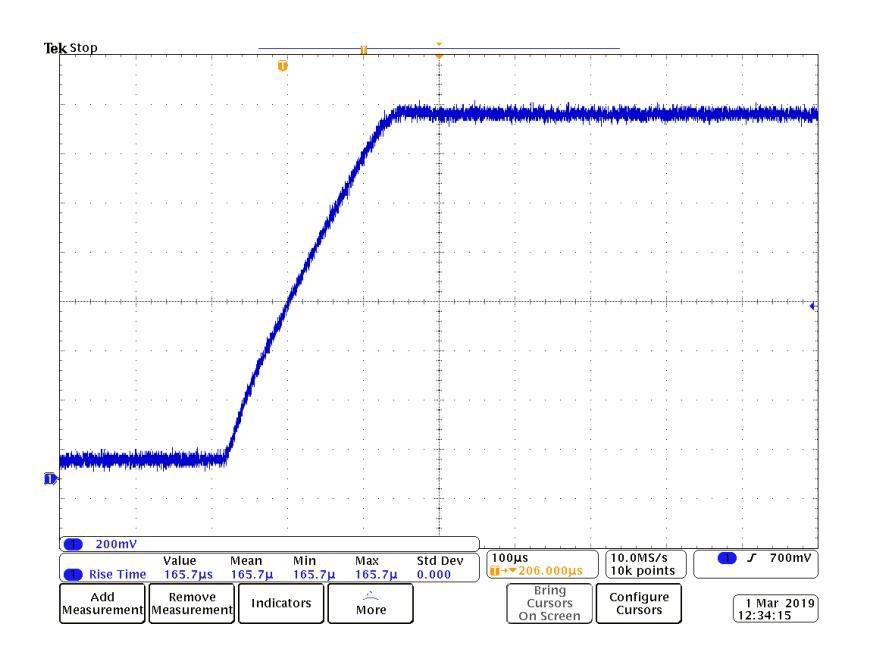
PDB LTM #7 LTM 1, C = 470 pF, Net Name= 1V5A,

#### Proper operation of the LTM 1

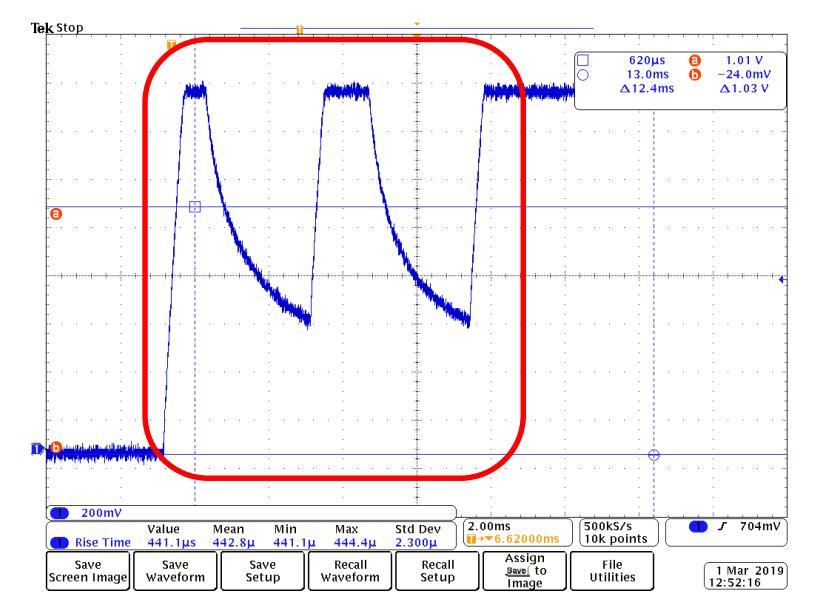
#### PDB LTM #7 LTM 3, C = 470 pF, Net Name= 1V5B

### Repetitive shutdown during the soft start up of the LTM 3

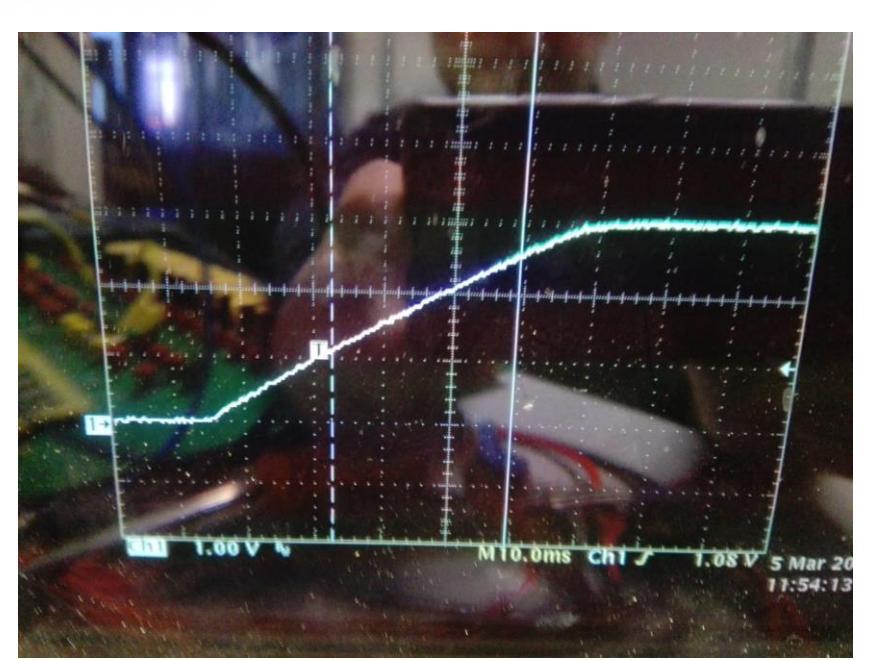
### Test at Milano (by Stefano) – 1 of 4

Test obtained on LTM 1 with the old value of C21 (0.1  $\mu$ F)

Time to ramp up about  $\sim 55$  ms (0 – 100%).

#### Output voltage work properly

The experimental ramp up time is in compliance with the charts from manufacturer (please note that charts are obtained for different value of input voltage and output voltage, @0A and4 A of load current, resistive load).

From chart: about 25 - 60 ms
