The Additional Value of Three-Dimensional Transesophageal Echocardiography in the Diagnosis of Unusual Complication of Bioprosthetic Mitral Valve

How to cite this article: Evangelista M, Barletta M, Corciu AI, Mantovani V, Paoli LD, Guazzi M, *et al.* The additional value of three-dimensional transesophageal echocardiography in the diagnosis of unusual complication of bioprosthetic mitral valve. *J Cardiovasc Echography* 2019;29:78-81.

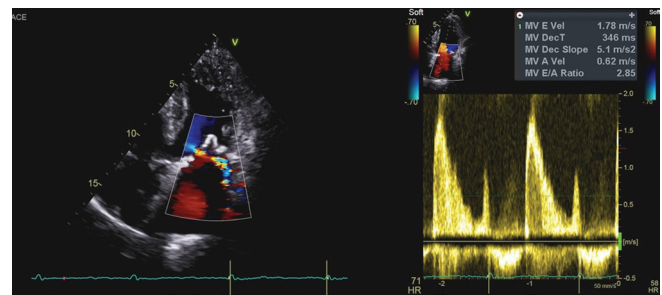
Notably, transthoracic echocardiography identified an apparently severe MR considering the depth and the width of the regurgitant jet, above all taking into account the evident Coanda effect, and the increased E-wave (1.55 m/s). The precise diagnosis and an accurate MR quantification have been limited by the apparently small vena contracta (3 mm) and the impossibility to perform an adequate, effective regurgitant orifice area (EROA), due to the excessively eccentric jet [Figure 1]. Due to the poor acoustic window and the presence of numerous artifacts, no clear information about valve morphology and the pathological mechanism of MR might be obtained.

Figure 1: Color Doppler in four-chamber view at transthoracic echocardiography permitted to identify a severe regurgitant jet; the increased E-wave supported the hypothesis that the mitral regurgitation was severe. Due to the excessively oriented jet was not possible to perform the PISA measures

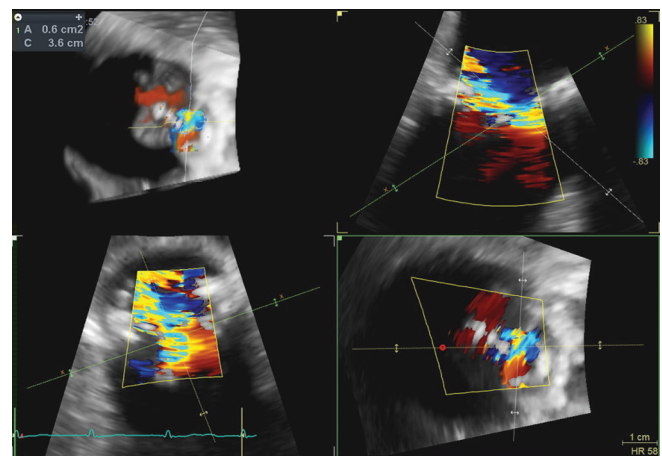
Conversely, 3D TOE allowed to identify the pathophysiological mechanisms of the MR and FlexiSlice allowed a precise quantification of MR. In this context, the 3D TOE with FlexiSlice tool permitted to assess the severity of the MR by looking at the valve from a parallel plane perfectly aligned to the origin of the regurgitant jet and subsequently measure directly the EROA (obtaining a dimension of 0.6 cm²) [Figure 2].

Figure 2: The three-dimensional tool FlexiSlice allows to measure directly the effective regurgitant orifice area

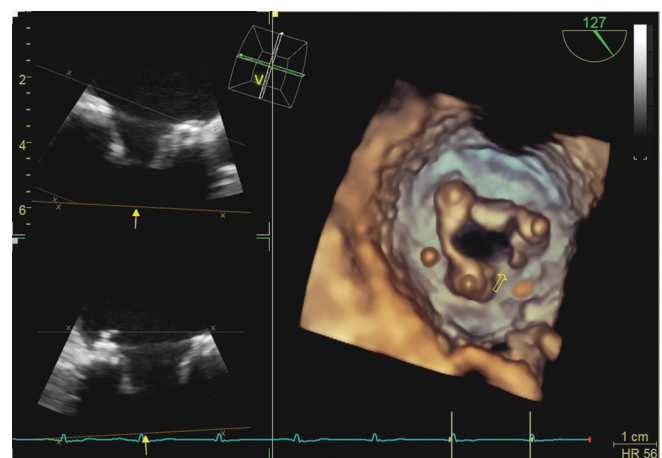
Moreover, the underlying anatomical mechanism of the MR was also unclear at the 2D TOE, and only the 3D has allowed us to understand the morphological aspects. In fact, once acquired, the 3D dataset can be rotated from both atrial and the ventricular perspectives leading, in this particular case, to identify the coaptation defect in correspondence of one bioprosthetic cusp.

In Figure 3, the liable cusp presents a rupture on its tip and develops a reversal movement in the left atrium during the systole, behaving like a flail with the eccentric regurgitation jet directed toward the lateral atrial wall.

Figure 3: The three-dimensional tool FlexiSlice permits to look at the valve from both the atrium and the ventricle sides, leading to the identification of a coaptation defect of only one cusp

fibrillation were part of the patient's history. Currently, the patient had a preserved functional status and was physically active. The case was discussed by the heart team who opted for valve replacement. Considering all the comorbidities and the growing evidence of feasibility and safeness of valve-in-valve treatment for bioprosthetic mitral valve degeneration,^[11,12] the patient was consensually proposed as a candidate for valve-in-valve treatment of MR.
