## AIR QUALITY CHARACTERIZATION IN THE SANCTUARY OF THE BEATA VERGINE DEI MIRACOLI IN SARONNO, ITALY.

Andrea Bergomi<sup>1\*</sup>, Valeria Comite<sup>1</sup>, Vittoria Guglielmi<sup>1</sup>, Mattia Borelli<sup>1</sup>, Roberto Bonomi<sup>2</sup>, Carola Ciprandi<sup>2</sup>, Carlo Mariani<sup>3</sup>, Antonio Faggiano<sup>4</sup>, Maria Ricciardi<sup>4</sup>, Antonio Proto<sup>4</sup>, Paola Fermo<sup>4</sup>

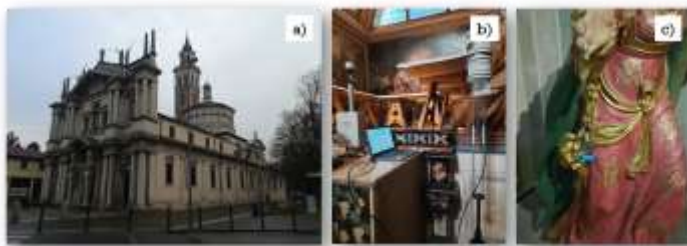
Figure 1. a) Street view of the Sanctuary; b) P-Dust Monit and MQA; c) Diffusive passive samplers

In order to achieve a complete characterization of the air quality, the presence of several air pollutants and the microclimatic conditions were monitored in different sites inside the Sanctuary (Figure 1). Data was also compared with outdoor values in order to evaluate potential sources and study accumulation phenomena. During the course of the different monitoring campaigns carried out throughout the year, temperature and relative humidity values were collected using data loggers (USB Mini TH, XS Instruments) and the results showed a large variability depending both on outdoor microclimatic conditions and indoor factors, such as the use of heating. Daily average values of the thermohygro-metric variables were often outside the suggested ranges for the conservation of cultural heritage in museums [2], indicating poor microclimatic conditions in the Sanctuary.

Particulate matter was sampled using an optical particle counter (P-Dust Monit, conTec Engineering Srl) and indoor concentrations were consistently higher than outdoor values, indicating the presence of specific indoor sources in addition to the penetration of particles from outdoors. Indeed, a significant correlation was observed between the number of people attending religious ceremonies and the concentration of particulate matter. Moreover, several gaseous pollutants were detected inside the Sanctuary (CO, NO, NO<sub>2</sub>, SO<sub>2</sub>, O<sub>3</sub>, and H<sub>2</sub>S) thanks to the use of an air quality monitoring unit (MQA, conTec Engineering Srl). In particular, the nitrogen dioxide levels exceeded the 4.7 µg/m<sup>3</sup> limit suggested by the Italian Ministry for the conservation of cultural heritage [2]. These concentrations were mainly due to the proximity of the Sanctuary to a very busy road which resulted in the penetration of outdoor polluted air. The hypothesis of the vehicular traffic source was further supported by the presence of other pollutants belonging to the BTEX family, such as benzene and toluene, which were collected using diffusive passive samplers (Radiello®, Fondazione Salvatore Maugeri-IRCCS). In fact, these compounds are considered to be tracers of vehicular exhaust [3].
