# CULTURAL HERITAGE DAMAGE ASSESSMENT AT KHIRBET AL-KHALDE IN A *LONGUE DURÉE* PERSPECTIVE

## Multiscalar Methodologies and Survey Results

The aim of this contribution is twofold. Firstly, we present a damage-and-destruction assessment of the site of Khirbet al-Khalde undertaken during a survey in the summer of 2023. Secondly, we present the multiscale

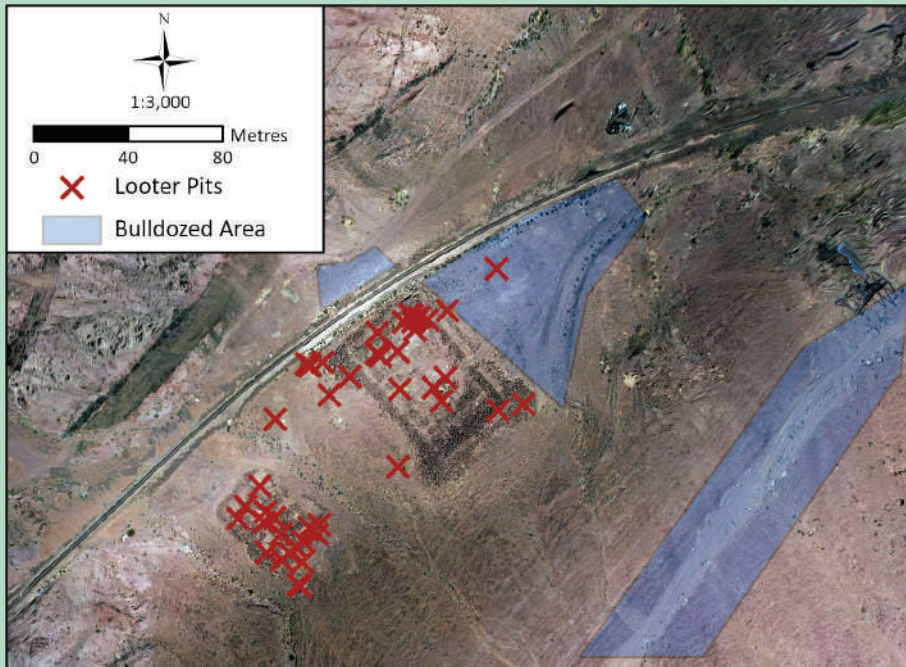
**FIG. 5**  
Map of the site showing the extent of bulldozed areas and looters' pits. (Courtesy of the Khirbet al-Khalde Archaeological Project.)

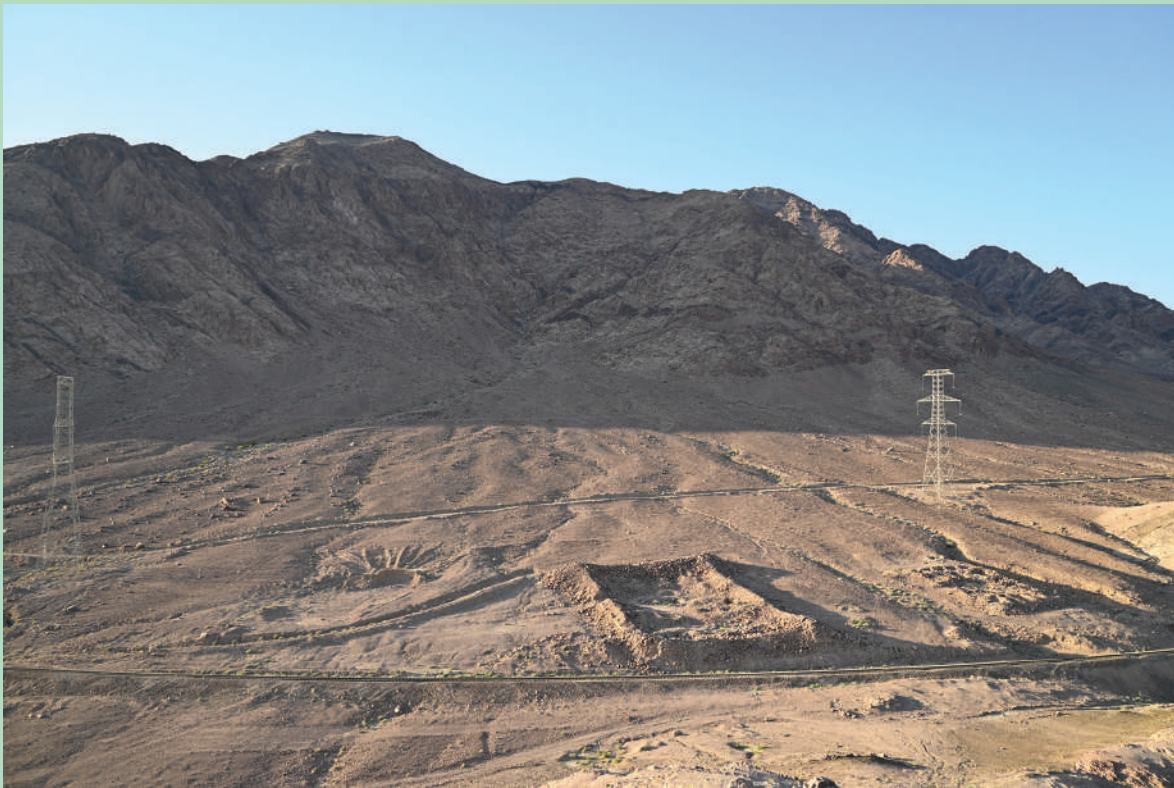
**FIG. 6**  
Overview photograph of Khirbet al-Khalde showing bulldozing, trench to redirect runoff, and numerous small channels carved by runoff water, facing southeast. (Courtesy of the Khirbet al-Khalde Archaeological Project.)

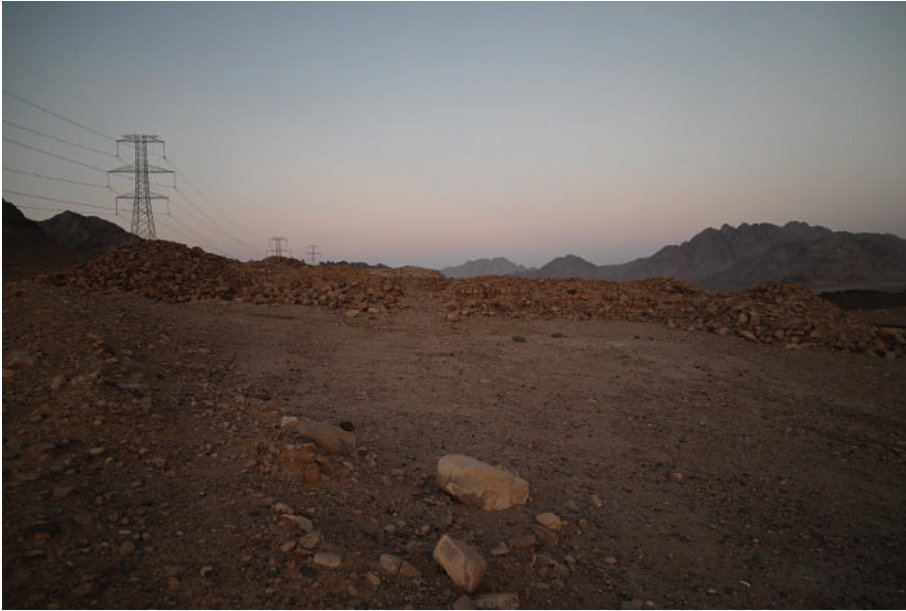
FIG. 7

to the north and northeast of this compound shows evident traces of invasive bulldozing (Fig. 7). To the south, there is a service dirt road associated with the north-east-southwest power line, and this cuts through the aqueduct, which comes from the hill southeast of the site and runs in a more or less straight line into the fort

Photograph showing the bulldozing area in front of the northeast facade of fort, facing southwest. (Courtesy of the Khirbet al-Khalde Archaeological Project.)

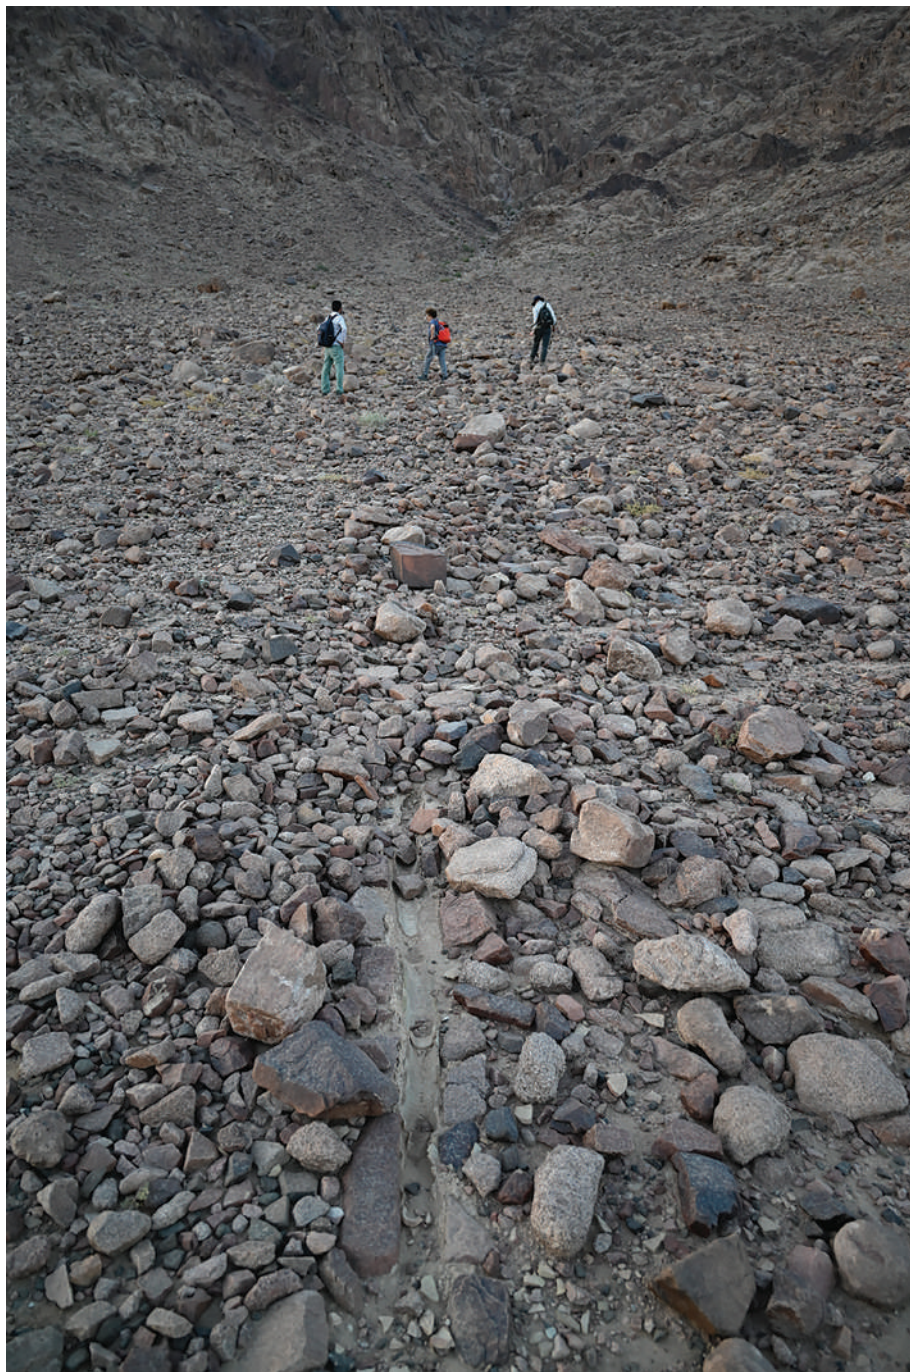
**FIG. 8**  
 Photograph of partially exposed  
 aqueduct with the run-off from the  
 hill visible in the background, facing  
 southeast. (Courtesy of the Khirbet  
 al-Khalde Archaeological Project.)

The now-disused railroad tracks run alongside the northwest wall of the fort. The railroad's construction in 1975 caused the partial demolition of the north-projecting corner tower (Bisheh et al. 1993: 124–25) through the earth-moving operations for the building of the high embankment on which the railroad sits (Fig. 9). A dirt road is situated north of the railroad and runs parallel to it. The role of this feature is unknown, but since it follows the railroad, it might be interpreted as its service road. The installation of the transmission line saw the creation of a northeast–southwest 10 m wide access dirt road situated some 80 m south of the fort. The construction of this road resulted in extensive leveling and bulldozing activities that affected the visibility and integrity of nearby archaeological features. Particularly disturbed were the remains of the aqueduct, which was cut through by the dirt road.

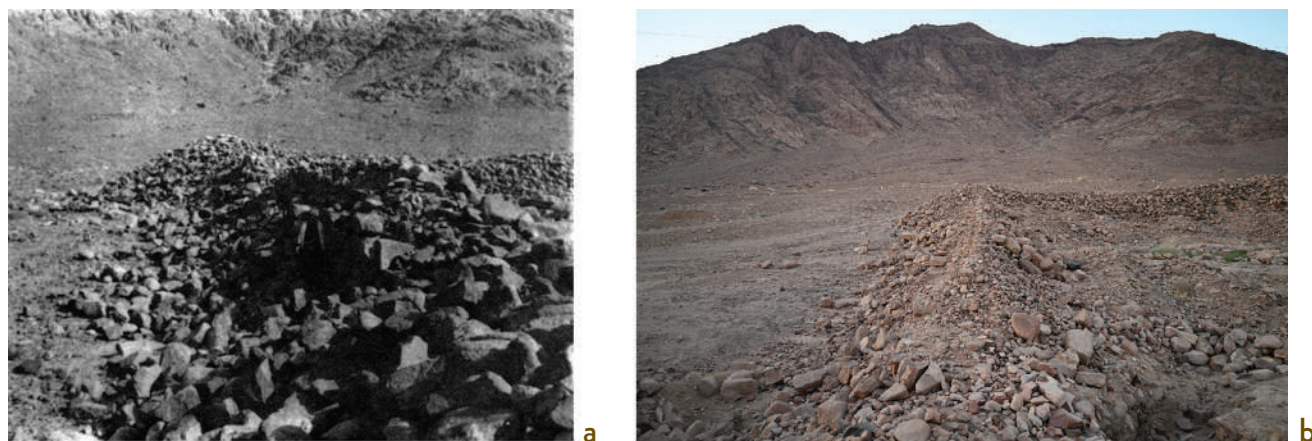
Traveler's photographs and satellite and aerial imagery show no traces of infrastructural works at the site prior to the late 1960s. Stein's late-1930s photograph of the northwestern side of the fort shows a small section of Sector C still covered by collapsed blocks and with no evident traces of recent earthworks (see Fig. 9a). A photo taken during the Hunting Aerial Survey of Jordan, which documents the state of the site in 1953, shows only a winding dirt road from the Wadi to the fort's gate and the presumed caravansera (Fig. 10). Despite its lower resolution, a Corona satellite image confirms that no significant infrastructural works were conducted until at least 1967 (Fig. 11). However, it shows a dirt road not present in the Hunting Aerial Survey photograph that circumvents the hill and reaches the site from the northwest. This road was later cut by the railroad. In both aerial and satellite

FIG. 9  
Northeast side fort showing development since 1930s: (a) Photo from Stein in the 1930s; (b) current situation.  
(Courtesy of the Khirbet al-Khalde Archaeological Project.)

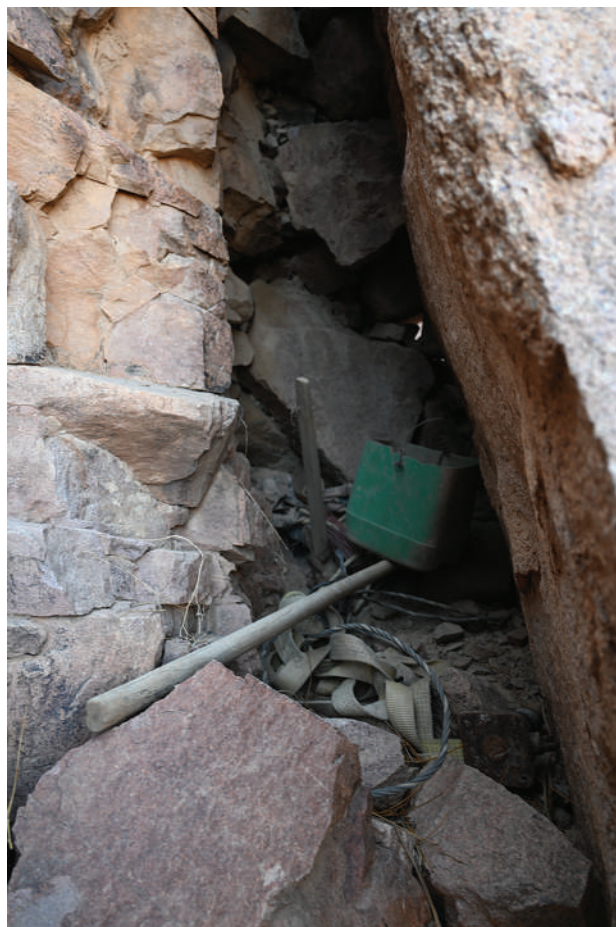
The goal of the surface assessments of modern disturbances at and around Khirbet al-Khalde was to understand the nature of these disturbances and, where possible, their temporal sequence. Each of the modern disturbances was individually recorded (coordinates, orientation), measured (width, length, and depth), photographed, and described (basic characteristics such as shape, overall condition, and stray finds). The resulting dataset provided crucial three-dimensionality to the looting activities at Khirbet al-Khalde, used to monitor and assess the risk of future looting as well. The areas of the site particularly affected by the modern disturbance were the fort, the caravanserai, and the cemetery. Additional looting was present at both watchtowers, as well as at the spring, which was the source that fed the aqueduct, where recent illicit activity was confirmed by the left-behind looter's tools (Fig. 12).

FIG. 12  
Photograph of looter's tools at the source of the aqueduct showing recent illicit activity. (Courtesy of the Khirbet al-Khalde Archaeological Project.)

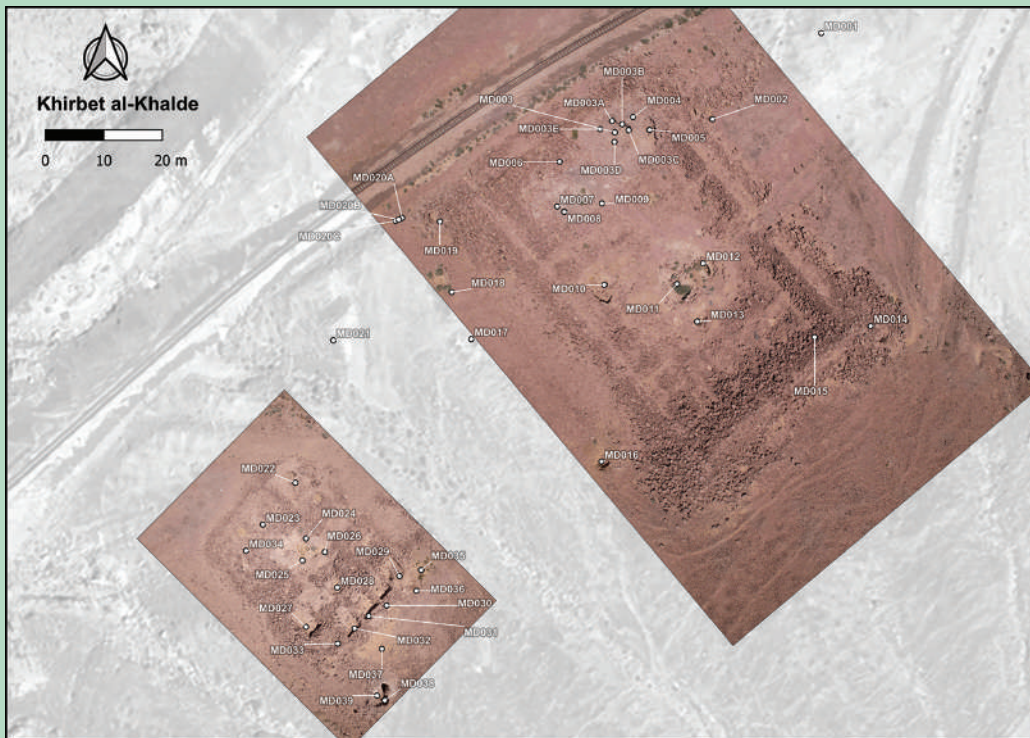
**FIG. 13**

Altogether, 52 modern disturbances were recorded at and around the fort and caravanserai of Khirbet al-Khalde (Fig. 13). These included looting pits of varying sizes and shapes (although semirectangular to semioval shapes prevail), some of which crosscut. The heaviest looting activity occurred within the standing perimeters of the fort (18 pits) and the caravanserai (15 pits) and continued extramurally, with additional looting also visible in between and in the space around these two structures. The fact that most looting had taken place within the ruined structures is not surprising, since the looters would have expected to make finds most likely within the structures.

Satellite image with embedded overview of modern disturbances at and around the fort and the caravanserai, as recorded in 2023 by the Khirbet al-Khalde Project. (Courtesy of the Khirbet al-Khalde Archaeological Project.)

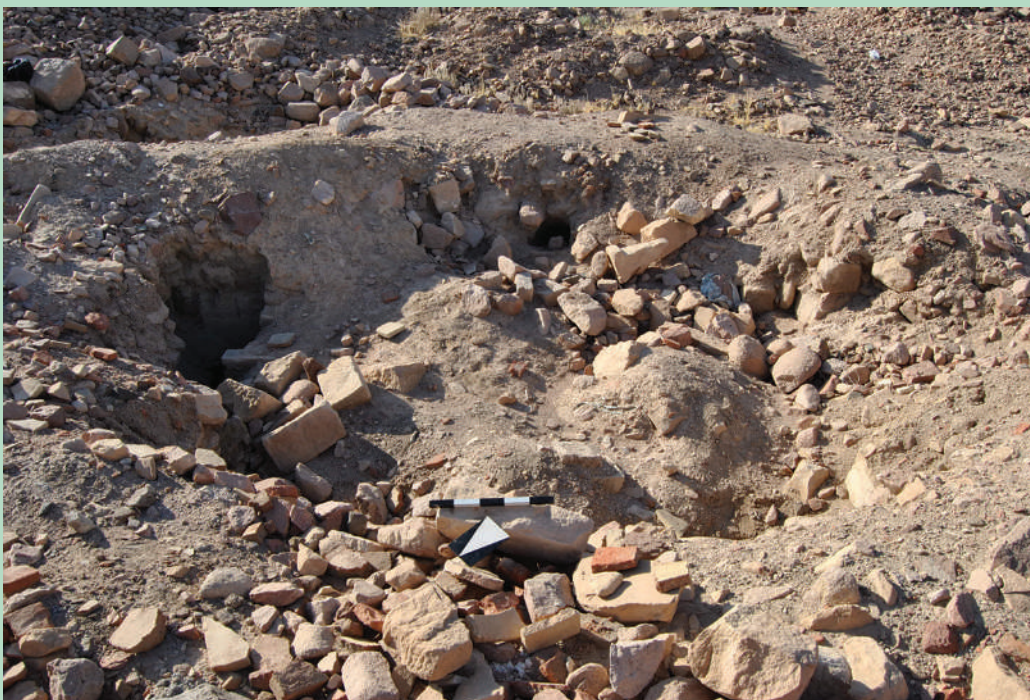
**FIG. 14**

The largest of the looting pits (MD003) was over 7 m in diameter. Located inside the main fort, it significantly disturbed the hypocaust installation, further damaged by additional crosscutting pits (MD003A–MD003E) (Figs. 14–15). The deepest recorded pit (MD010) was

Photograph showing the looting pit (MD003) and the crosscutting smaller pits. (Courtesy of the Khirbet al-Khalde Archaeological Project.)

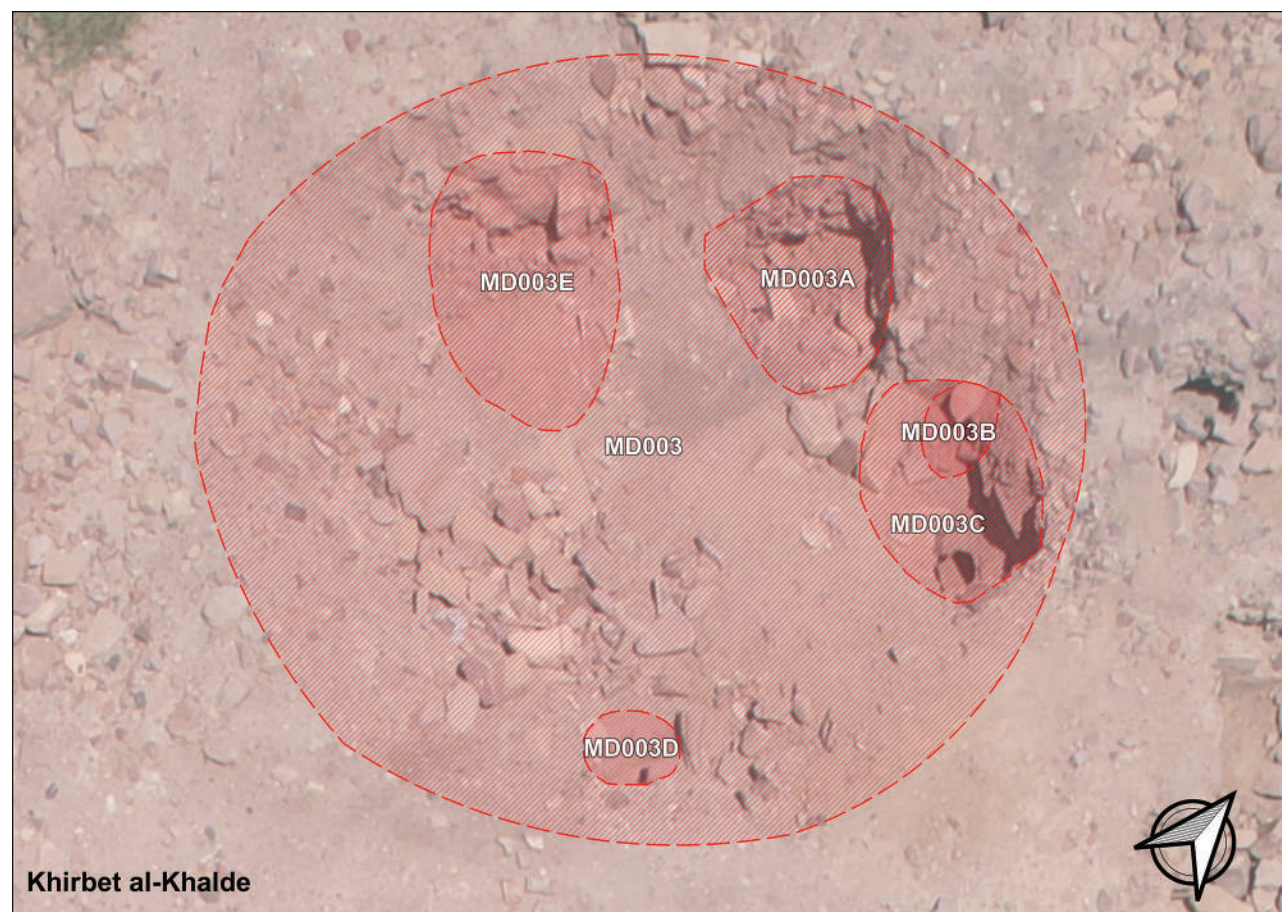
FIG. 15

Spatial representation of the relationship of crosscutting pits within the larger pit (MD003). The smaller pits are distinguished by letters rather than numbers to preserve contextual association with the main pit (MD003A–E). MD003 is earlier than the rest of the smaller pits. (Graphics by K. Mokráňová; courtesy of the Khirbet al-Khalde Archaeological Project.)

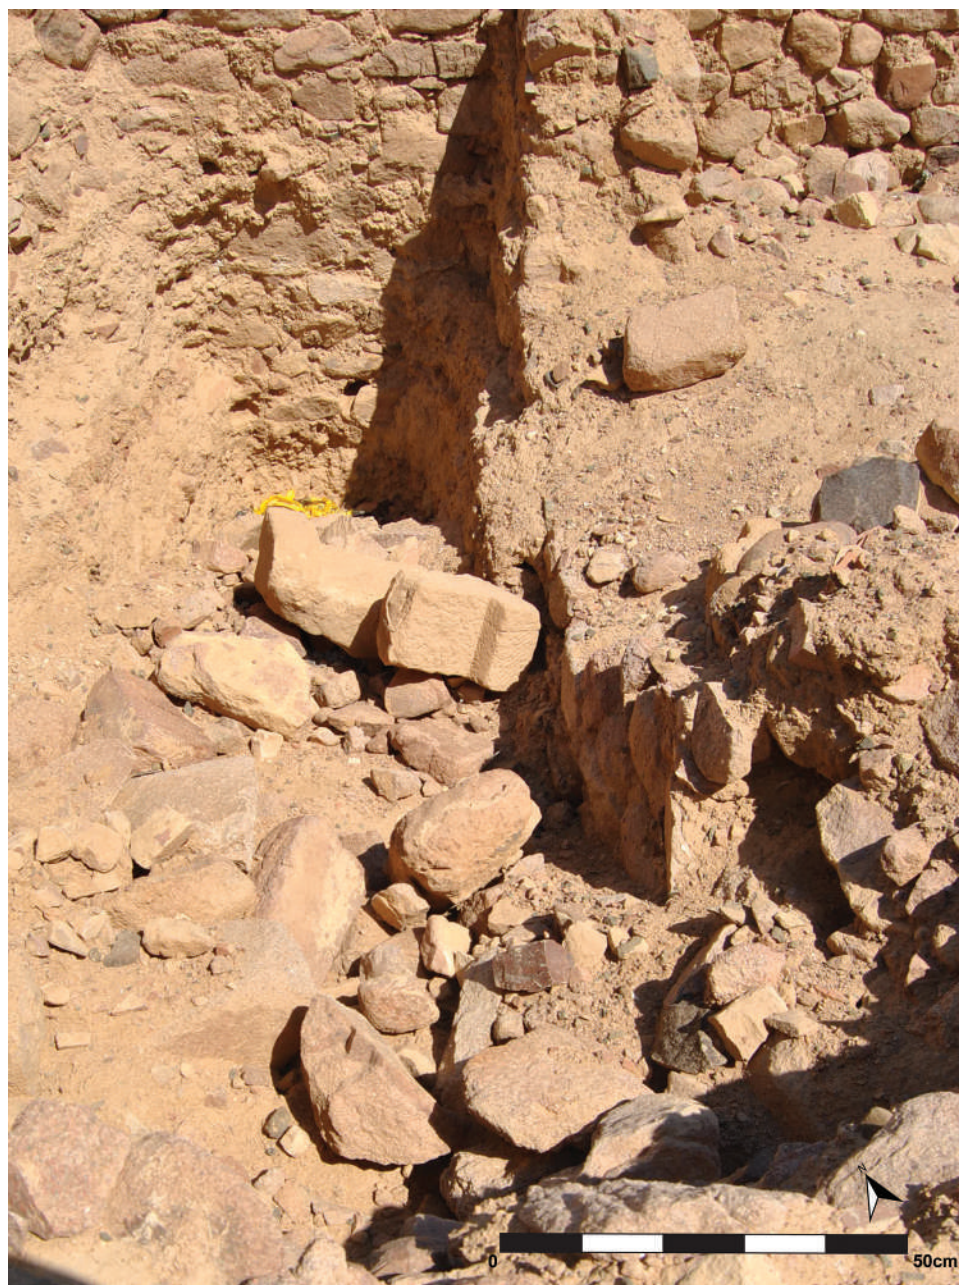
located in the southwestern part of the caravanserai's courtyard and was some 2.8 m deep (Fig. 16). MD010 exposed stone walls of a room cleared by this illicit activity down to the floor level. The total exposure of the archaeological features from looting occurred in several instances. In the presumed caravanserai, the almost complete outline of four adjacent rooms, each lined by a stone wall, was revealed to a depth of about 0.6–0.8 m (MD029–MD032) (Fig. 17). The lime kiln, situated to the south of the presumed caravanserai, was cleared entirely by illicit digging activity (MD038 and MD039) (Fig. 18). Here, a 2 m deep hole showed the masonry outline of the lime kiln, comprising round walls from which a still largely intact draw hole protruded.

**FIG. 16**  
Overview of MD010, the deepest pit, in the southwest part of the fort. (Courtesy of the Khirbet al-Khalde Archaeological Project.)

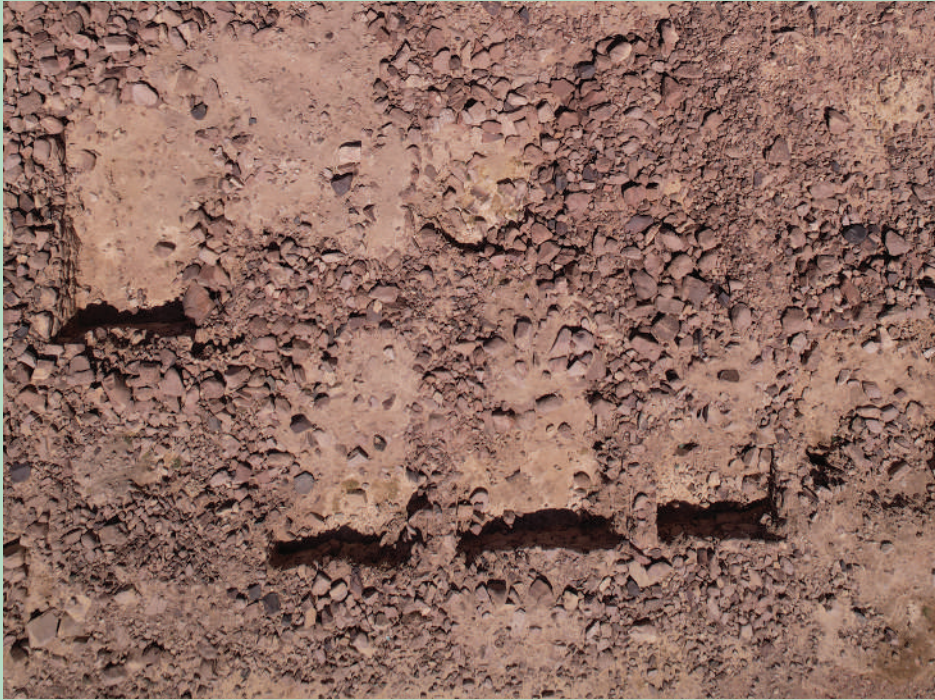
**FIG. 17**  
Overview photograph of the modern disturbances (MD029-MD033) in the southeastern part of the caravanserai, exposing a series of rooms. (Courtesy of the Khirbet al-Khalde Archaeological Project.)

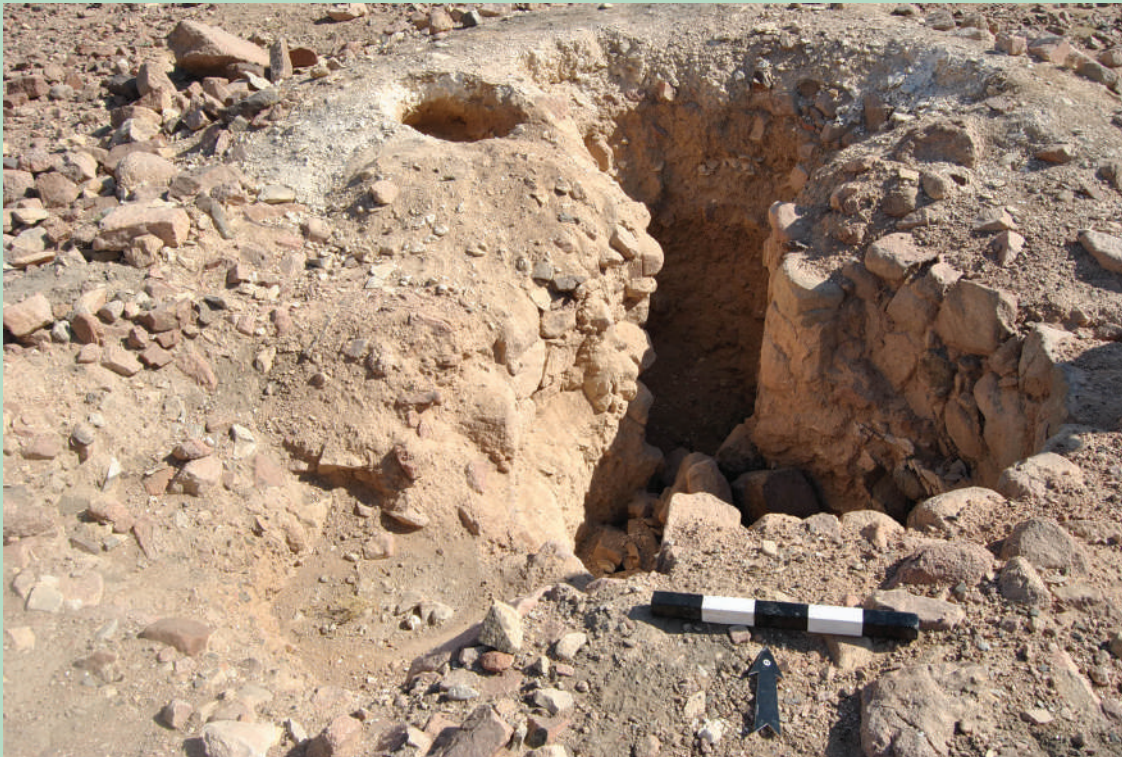
**FIG. 18**  
Overview photograph of the lime kiln, MD038, heavily damaged by illicit digging activities. (Courtesy of the Khirbet al-Khalde Archaeological Project.)

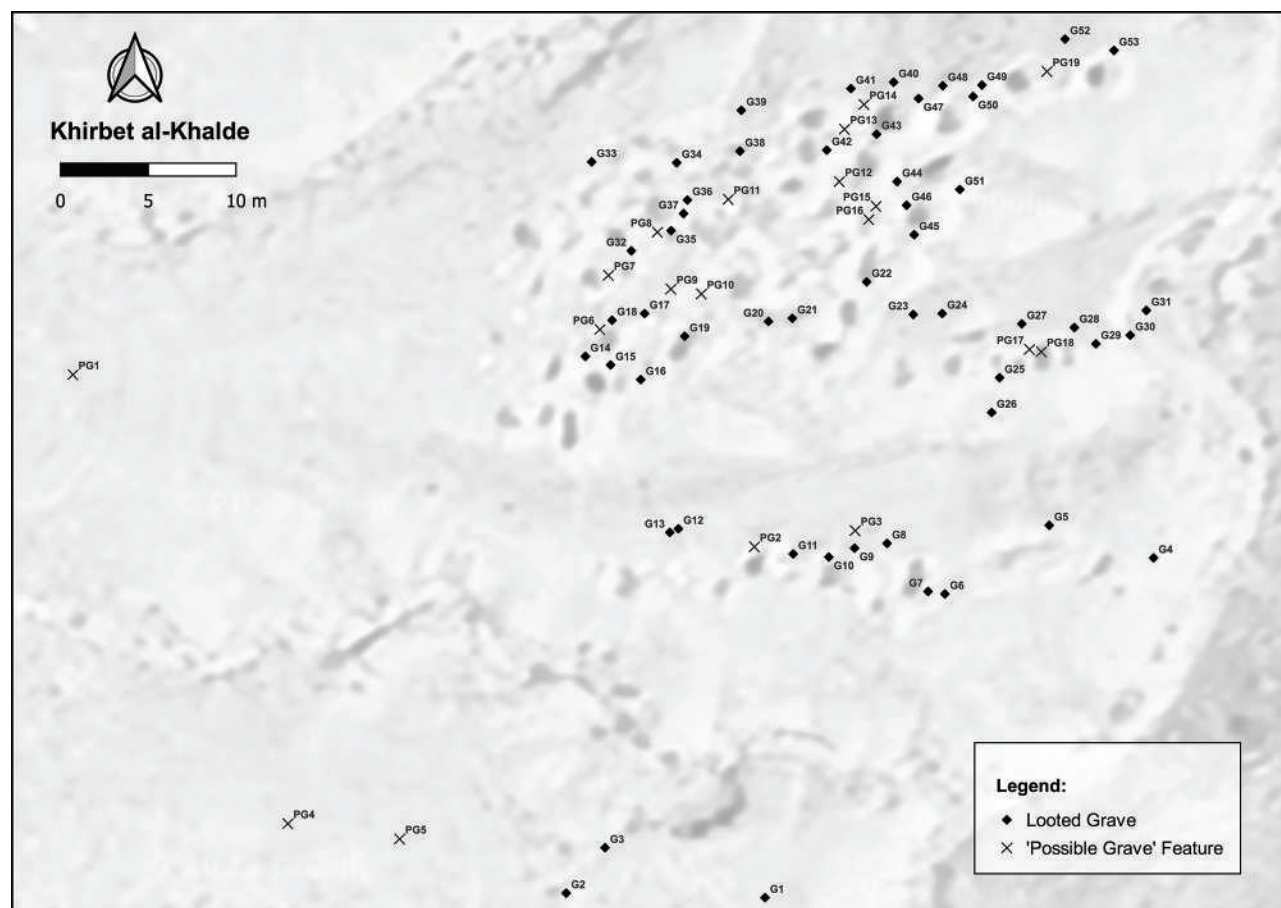
FIG. 19

The cemetery is located on a hill slope approximately 250 m northeast of the fort. It houses 53 looted and heavily damaged graves (G001–G053) as found and recorded by the ground survey (Fig. 19). Additionally, 19 pit features of less than 0.3 m depth, recorded as “possible graves” (PG001–PG019), were identified and documented separately from the graves. Perhaps these are failed attempts or tests of the illicit diggers trying to understand the nature of the soil and the position of the burials, or these might possibly be graves left unexcavated because of a lack of funerary goods (Fig. 20).

Map showing all the modern disturbances—graves (G) and possible graves (PG)—in the cemetery area. Aerial photo is taken during the drone survey. (Courtesy of the Khirbet al-Khalde Archaeological Project.)

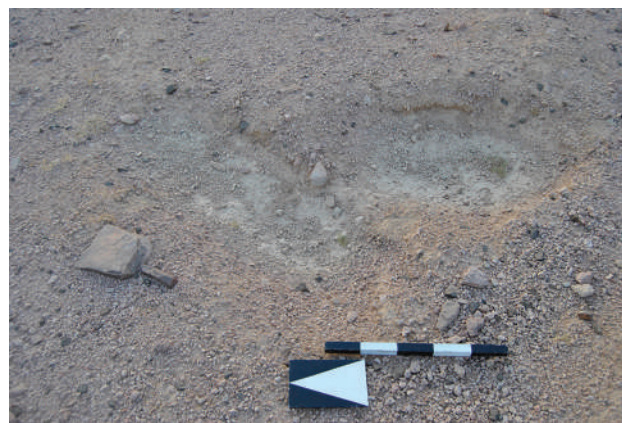
FIG. 20

Photograph of a possible grave feature, facing east. (Courtesy of the Khirbet al-Khalde Archaeological Project.)

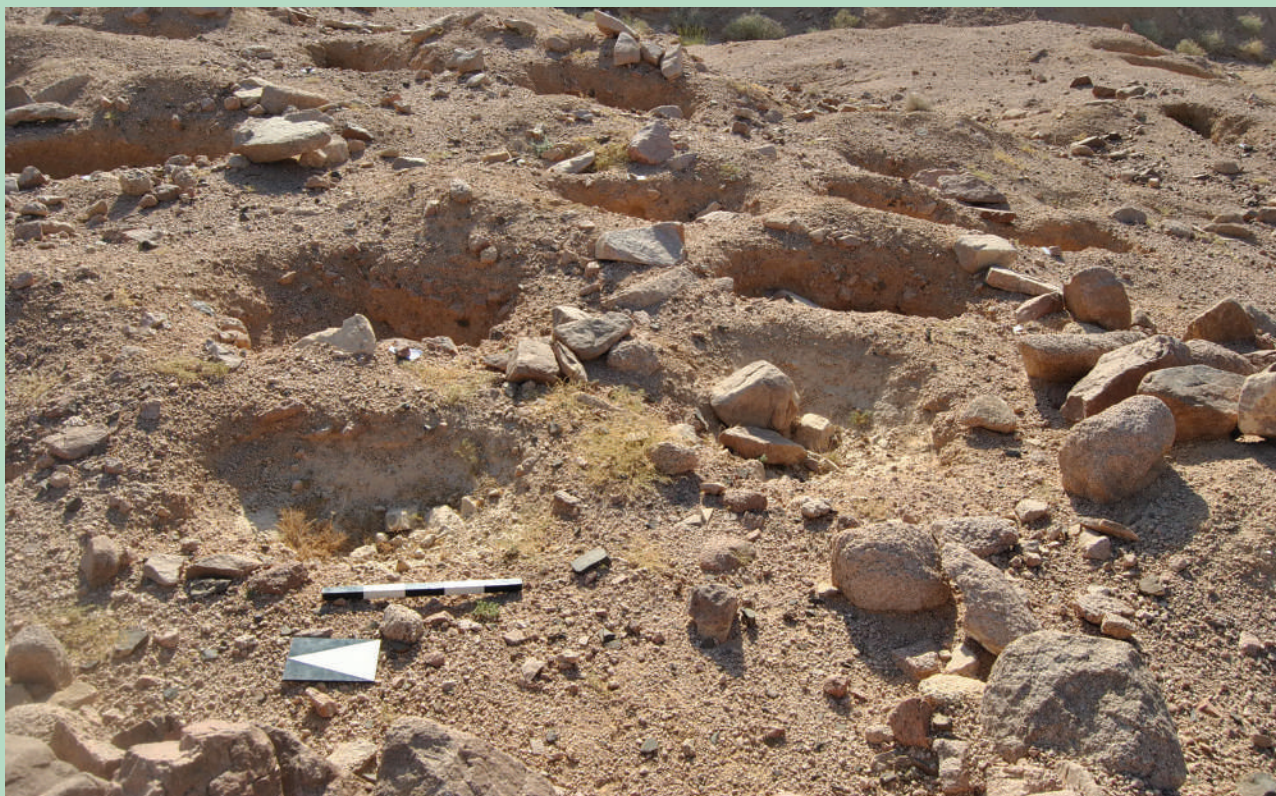
The grave features differ in orientation, with 79% of the graves being oriented north–south, 15% east–west, and the rest are undetermined (Fig. 21). The graves have

**FIG. 21**  
Photograph of parts of the cemetery area heavily damaged by modern disturbances (G048, G047, G046, G045, G044, G043, G042), facing east. (Courtesy of the Khirbet al-Khalde Archaeological Project.)

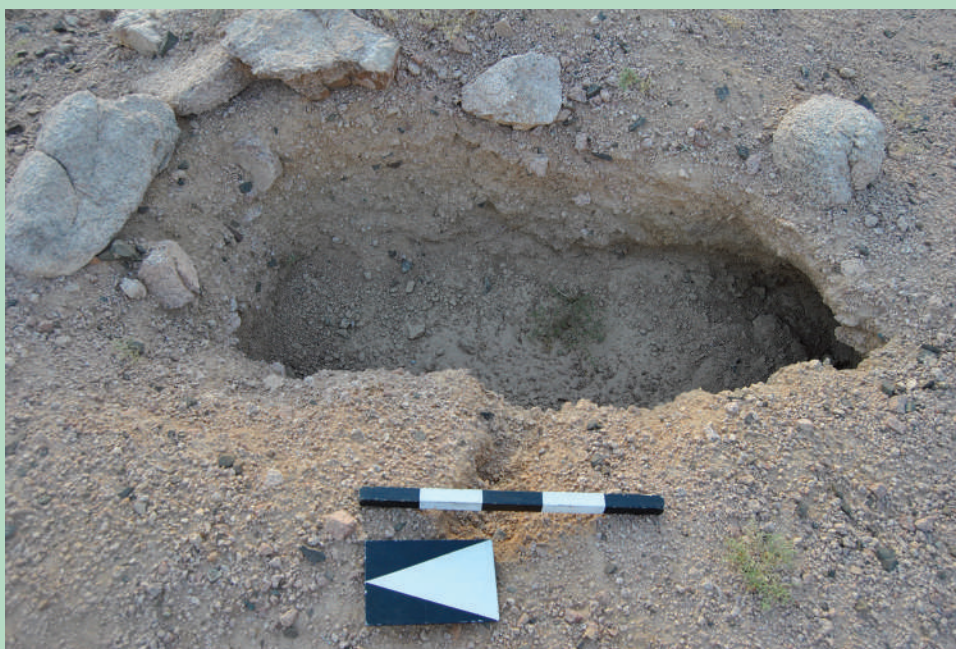
a rather uniform shape, roughly rectangular to roughly oval, and size of about 1.5–2.0 m in length and 0.5–1.0 m in width. The largest grave is over 1.6 m wide (Go18), the longest is over 2.5 m in length (Go16), and the deepest is about 1.6 m in depth (Go17). Most graves have clusters of medium-sized stones either placed both on their long sides and their short sides or fallen to the bottom (Figs. 22–23)—these might be fallen grave markers.

**FIG. 22**  
Photograph of stone outline of G018, north-south oriented. (Courtesy of the Khirbet al-Khalde Archaeological Project.)

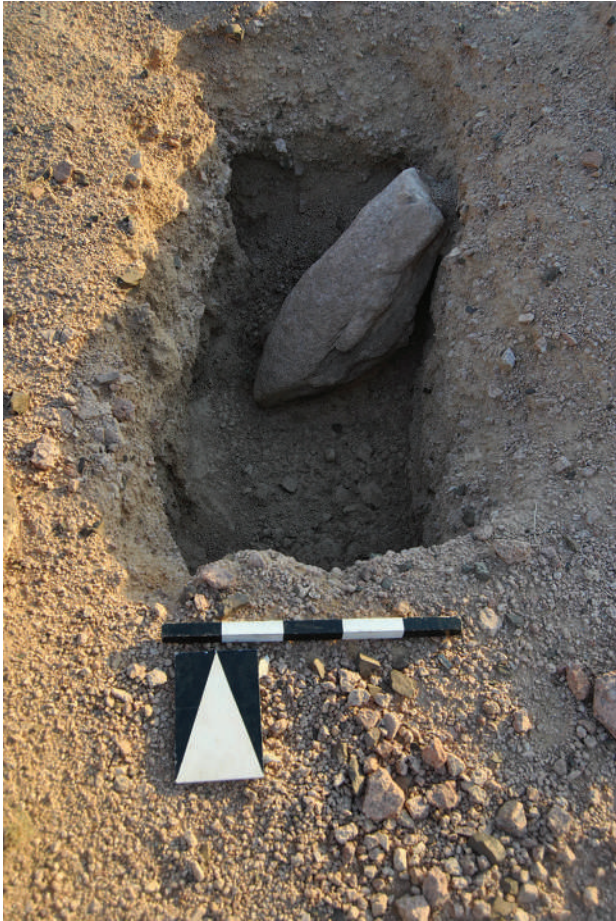
**FIG. 23**  
Overview photograph of G021 facing north: a rectangular shaped stone is clearly visible at the base of the grave. (Courtesy of the Khirbet al-Khalde Archaeological Project.)

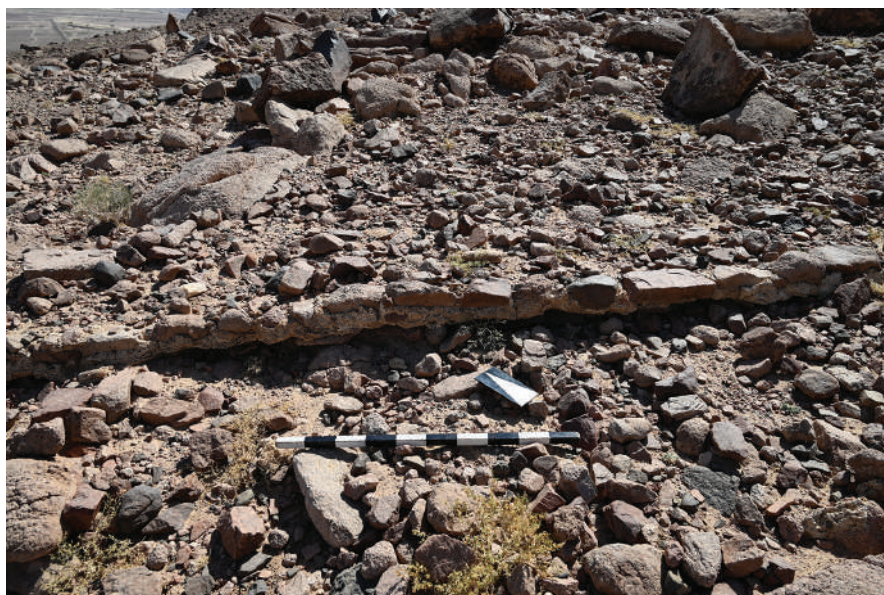
waters rushing through the wadi. Still, the site remains susceptible to the erosive action of runoff water flowing from the mountains to its southeast. This runoff has carved numerous small channels that cut through the main site and have slowly encroached on its remains. Damage from natural erosion is most pronounced along the course of the site's aqueduct, which once carried water to the fort from a still-active spring to the southeast. As a result of this runoff, large sections of the aqueduct have been completely washed away, while in other places only the line of its foundation or packing stones remain extant (Fig. 24). This damage was recorded during our survey of the aqueduct's course and, in many instances, prevented a complete mapping of its entire route. The force of the water, and doubtlessly the millennia of human and animal movement over these slopes, has caused fragments of the ceramic pipeline to dislodge and scatter downslope, aiding the tracing of the aqueduct line and allowing the collection of pipe samples during the survey.

**FIG. 24**  
 Photograph of a section of aqueduct showing undercutting of mortared bedding due to natural erosion. (Courtesy of the Khirbet al-Khalde Archaeological Project.)

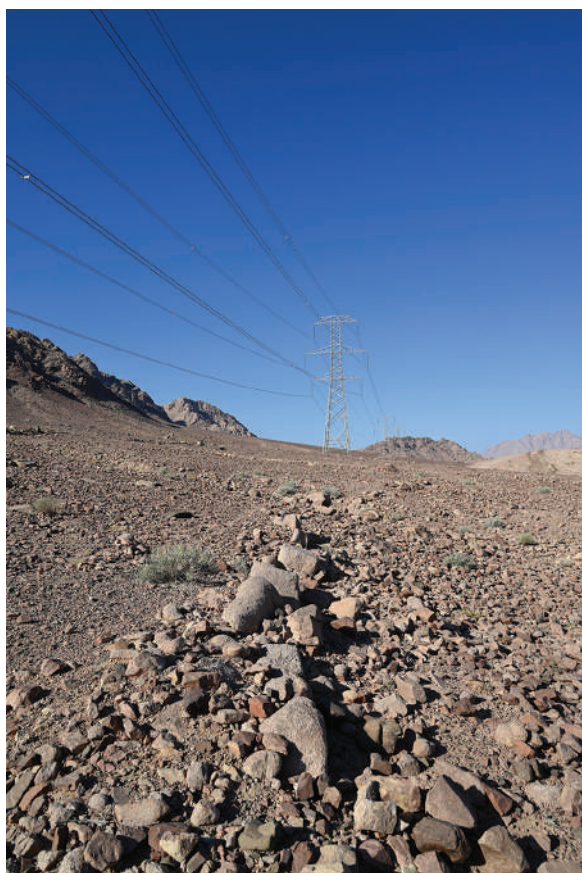
Our survey of the site also identified a wall line to the southeast of the fort (Fig. 25). This nonlinear wall is approximately 43 m long and does not appear to have been part of a roofed structure. Although the function of the wall remains uncertain, one hypothesis is that it may have similarly served as a diversion wall for runoff, directing water away from the fort. This hypothesis remains tentative, however, and further analysis is required.

**FIG. 25**  
 Photograph of wall line southeast of fort, facing southwest. (Courtesy of the Khirbet al-Khalde Archaeological Project.)
