Article

Preliminary Air Quality and Microclimatic Conditions Study in the Santuario della Beata Vergine dei Miracoli in Saronno (VA)

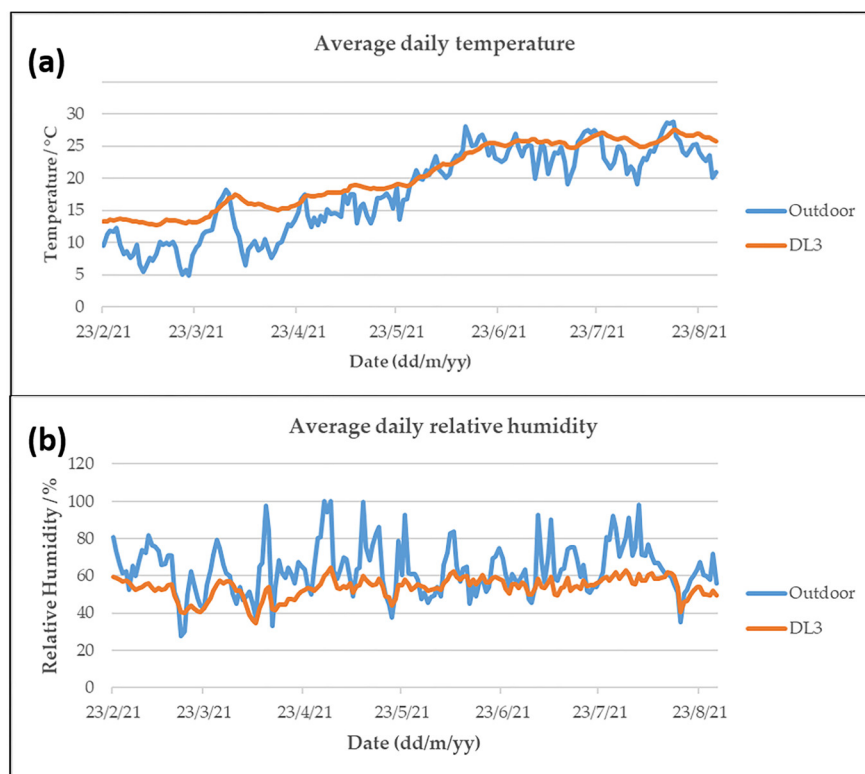
Figure 1. (a) The average daily temperature and (b) average daily relative humidity values reported for DL3 compared to the outdoor trends.

In Figure 1, the average daily temperature and relative humidity values are reported for DL3, along with a comparison with the outdoor values (ARPA Sensing Station, Saronno Santuario). Similar trends were observed for the other sampling sites and no significant differences in terms of the absolute values were found (Figures S1 and S2), indicating the presence of homogenous conditions within the Sanctuary.

The trends observed in Figure 1 show a lower indoor temperature and relative humidity variability than outdoors. On the one hand, with a view to avoiding abrupt variations, the fact of not being significantly affected by external events is positive for the conservation of cultural heritage. However, compared to the recommended ranges and maximum values indicated in the UNI 10829:1999 technical standard, there were significant days in which these limits were overrun (Table 3).

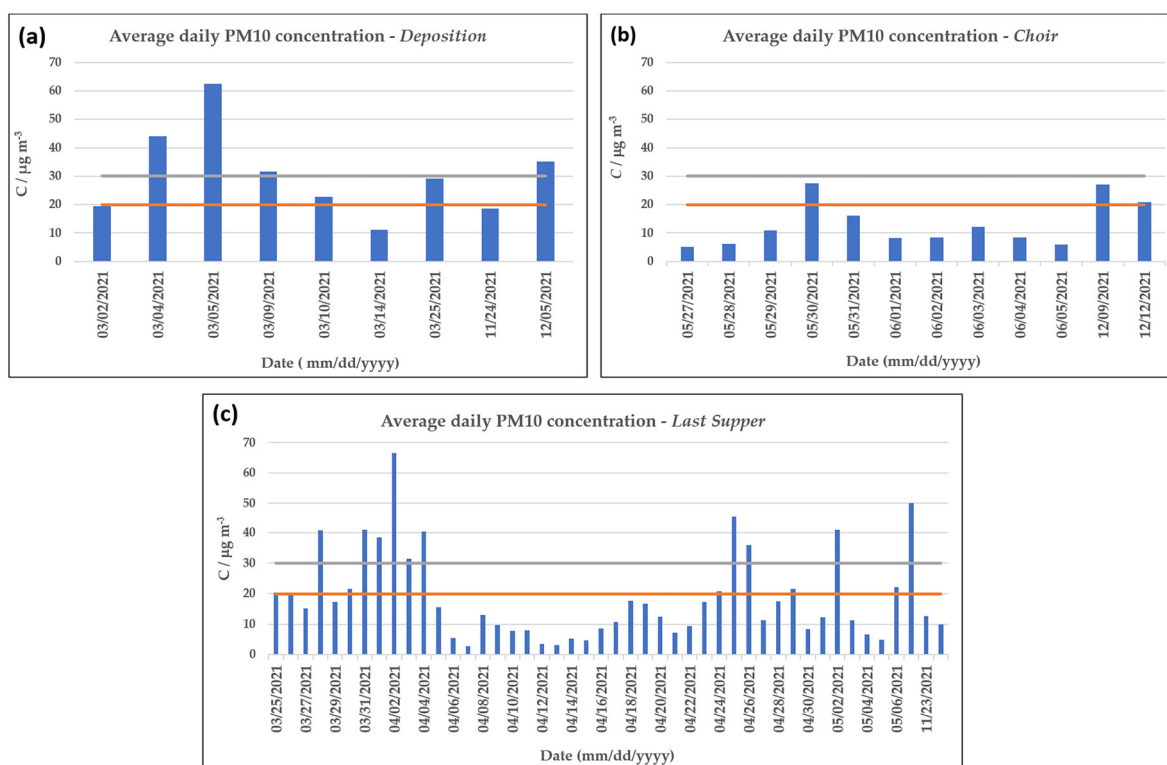
Figure 2. Average daily PM10 concentrations in the three sampling sites: (a) *Deposition*, (b) *Choir*, and (c) *Last Supper*. The orange and grey horizontal lines indicate the two maximum concentration limits indicated in the D.M. 10 May 2001.

For most of the monitored days, the PM10 concentration levels were below or within the specified range. However, occasional days of overrun were observed for the sampling sites in the two main later chapels, *Deposition* and *Last Supper*. Despite not performing the monitoring campaigns in parallel for the three sites, these preliminary results seem to suggest that particulate matter is mostly concentrated on the ground floor of the Sanctuary and is not transported quantitatively at greater heights.

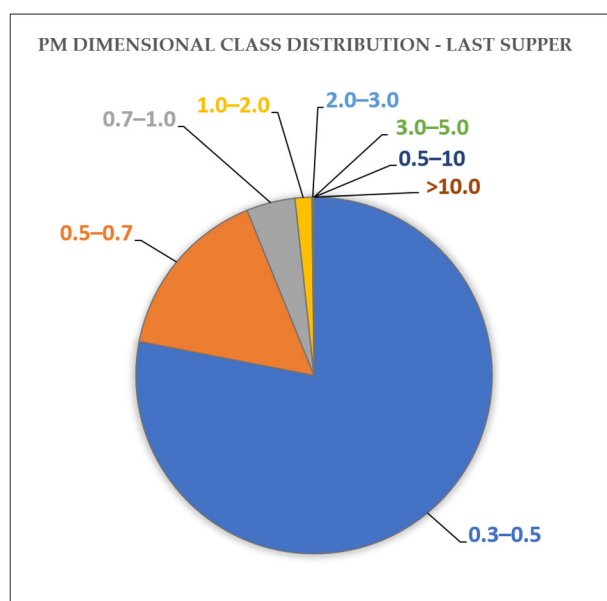
Figure 3. Dimensional class distribution of the particulate matter for the sampling site at the *Last Supper*. The ranges of the dimensional class are expressed in μm .

Thanks to the use of the optical particle counter, more detailed information regarding the dimensional speciation of the particles was obtained. As an example, the results relating to the *Last Supper* sampling site are reported in Figure 3, but similar values were also obtained for the other two sites (Figures S3 and S4).

The results show the predominance of smaller particles ($0.3\text{--}0.5\ \mu\text{m}$) and an overall decreasing contribution to the total number of particles with increasing size. This is also reflected in the mass concentration values since PM1 (particles with an aerodynamic diameter of less than $1\ \mu\text{m}$) almost always accounts for more than 50% of the mass of PM10 (Table 5).

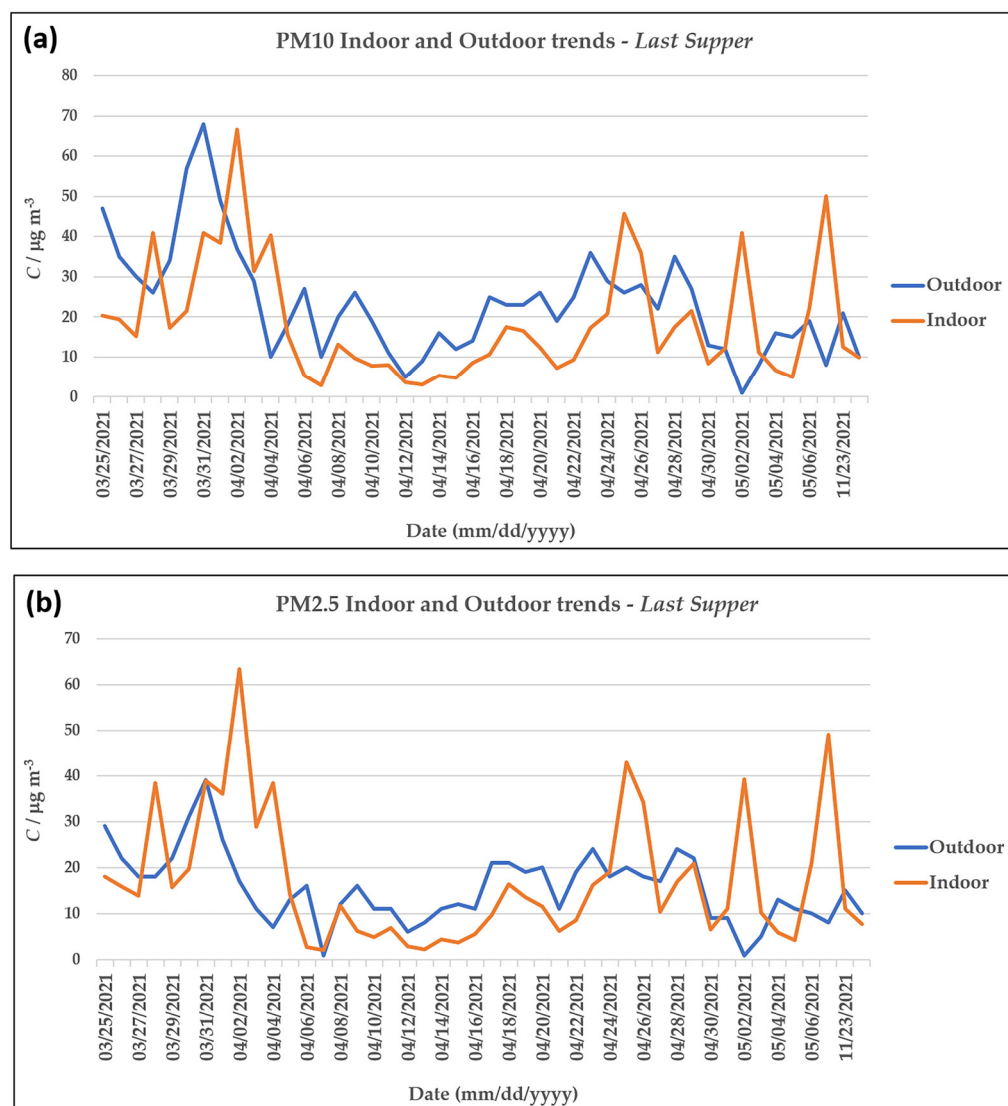
Figure 4. (a) The PM10 and (b) PM2.5 indoor and outdoor trends for the sampling site at the *Last Supper*.

For most of the sampling periods, the indoor values followed the outdoor trends whilst remaining at lower concentrations, highlighting a shielding effect of the Sanctuary, which prevents the penetration of a fraction of the particles. However, occasional days in which the indoor values were higher than the outdoor ones were observed. Almost all these cases coincided with weekends or public holidays, which are known to attract a greater number of visitors and worshippers. Indeed, the sampling conducted during the Holy Week (28 March 2021–3 April 2021) highlighted numerous days in which the outdoor concentrations were overrun for both PM10 and PM2.5.

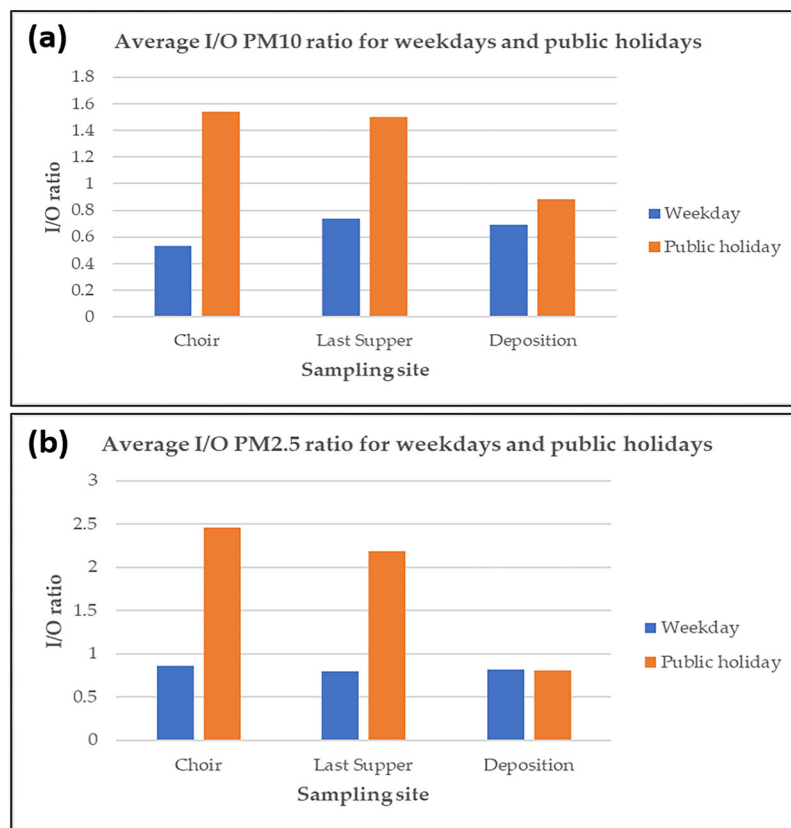
Figure 5. Average I/O ratio for (a) PM10 and (b) PM2.5 during the weekdays and public holidays for the three sampling sites.

Moreover, the indoor/outdoor (I/O) ratios were calculated for weekdays and public holidays (Figure 5). For the sampling sites at the *Last Supper* and *Choir*, a clear difference could be observed between the two different periods. The average I/O ratios were lower than 1 during weekdays, confirming a partial shielding effect of the Sanctuary, whereas they were higher than 1 during the public holidays, indicating the presence of specific sources to the days in question such as a higher influx of people, the use of candles, and incense burning. The effect was less pronounced for the sampling site at the *Deposition*; this was probably due to a minor impact of the sources on the days on which sampling was carried out for this site. Indeed, the monitoring campaigns were not carried out in

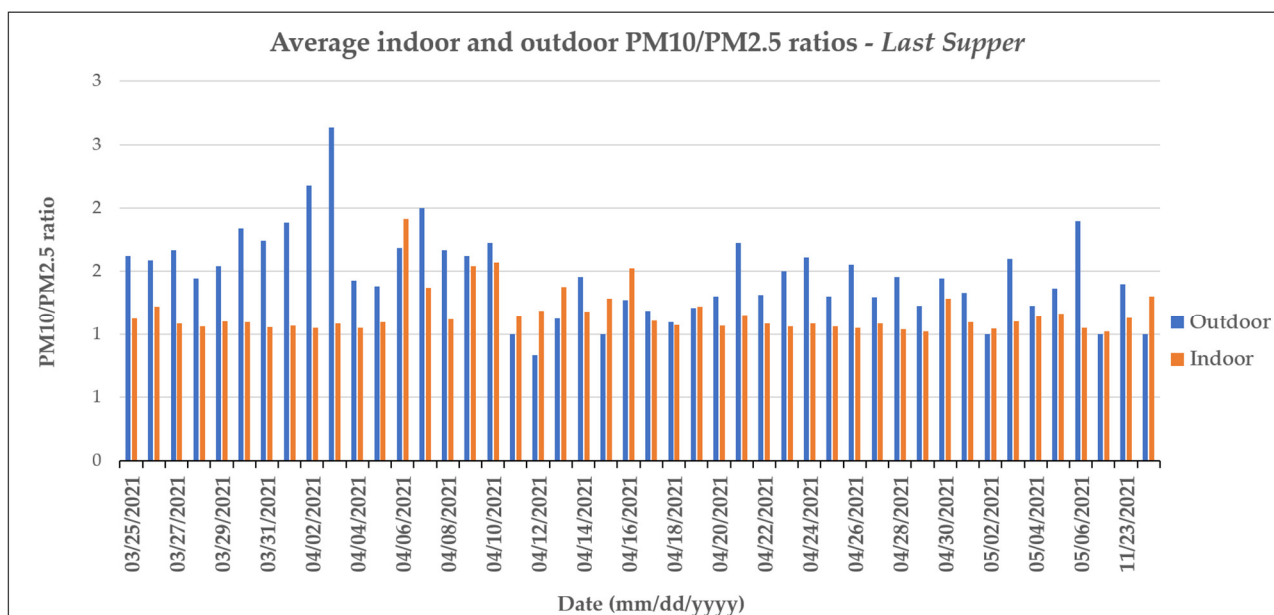
Figure 6. Average indoor and outdoor PM10/PM2.5 ratios for the sampling site at the *Last Supper*.

More in-depth analysis of the PM10 and PM2.5 values also enabled us to conclude that smaller particles are the ones that tend to accumulate indoors during public holidays and other festivities. Indeed, the PM10/PM2.5 ratios calculated for both the indoor and outdoor environments show that while these values were comparable during the weekdays, during the public holidays, the outdoor PM10/PM2.5 ratios were often higher than those indoors (Figure 6).

These differences were particularly evident at the *Last Supper* sampling site because the monitoring campaign was carried out partly during Holy Week, in which numerous festivities and religious ceremonies are concentrated. Indeed, the results showed that on the same days in which the indoor concentrations were higher than those outdoors, the difference between the PM10/PM2.5 ratio increased in favor of the outdoors. This suggests that the transport of larger particles from the outdoors to indoors is limited compared to the smaller ones, which tend to accumulate in closed spaces, leading to higher average indoor daily concentrations of particulate matter.

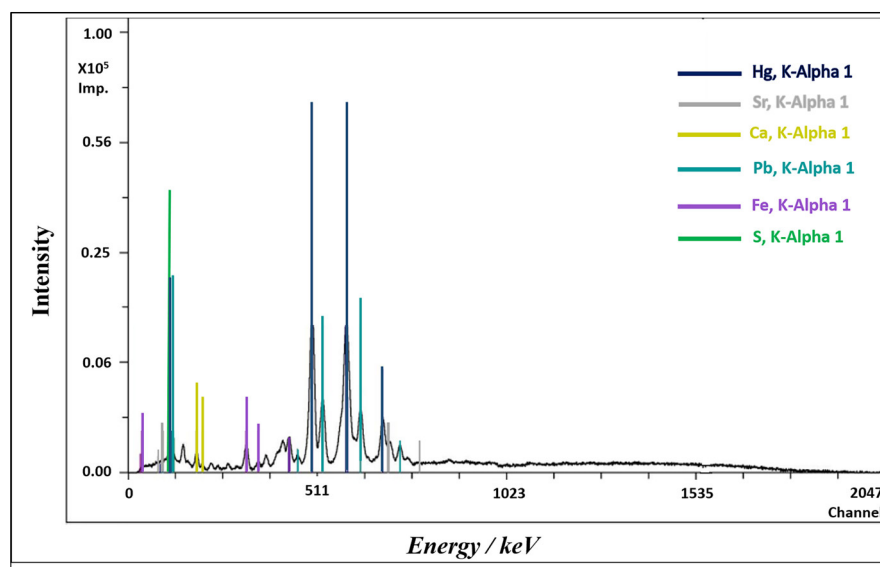
Figure 8. X-ray fluorescence spectrum of the wooden sculptural group.

Preliminary analyses on the conditions of some of the wooden sculptures present in the two main chapels of the Sanctuary were carried out using X-ray fluorescence (XRF) directly on the works of art and scanning electron microscopy coupled with energy-dispersive X-ray spectroscopy (SEM-EDX) on the dust deposited on the sculptures. This enabled us to establish the presence of degradation phenomena originating from poor indoor air quality and microclimatic conditions. Indeed, the X-ray fluorescence spectra highlighted the presence of cinnabar (HgS) as the main pigment used to decorate the sculptures (Figure 8), and the same elements (Hg and S) were identified in the EDX spectra of the retrieved dust (Figure 9).

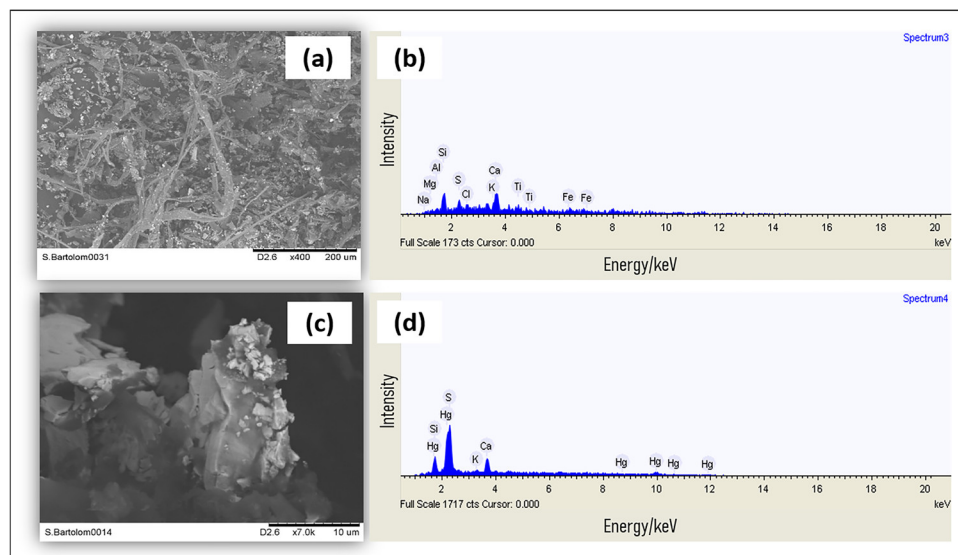
Figure 9. (a) SEM image of the dust deposited on the wooden sculptures (area = 0.80 mm × 0.60 mm, 400× magnification). (b) EDX spectrum of the image presented in (a). (c) Point image of the dust deposited on the wooden sculptures (Area = 0.04 mm × 0.03 mm, 7000× magnification). (d) EDX spectrum of the image presented in (c). Experimental parameters: accelerating voltage = 15 kV; working distance = 6500 μm; emission current = 65 mA; acquisition time = 150 s.

SEM analysis of the dust deposited on the wooden sculptures highlighted the presence of all the main constituents of atmospheric dust [27] including magnesium, sodium, calcium, chlorine, silicon, potassium, and iron. However, point analyses at greater magnifications enabled the detection of mercury, which is an element that is hardly ever found in concentrations above the instrumental SEM-EDX detection limits in atmospheric dust. The presence of this element is most certainly derived from the underlying substrate, which is represented by the wooden statue, highlighting the partial detachment of the pictorial film.

The combined results of the two techniques indicate a poor state of conservation of the wooden sculptures. Considering that the powder was retrieved with the simple use of a brush, the fact that the same elements making up the substrate (identified thanks to the use of XRF) were also found in the deposited powder highlights the fragility of the artifact. The partial detachment of the pigment that was observed could be due to the chemical–

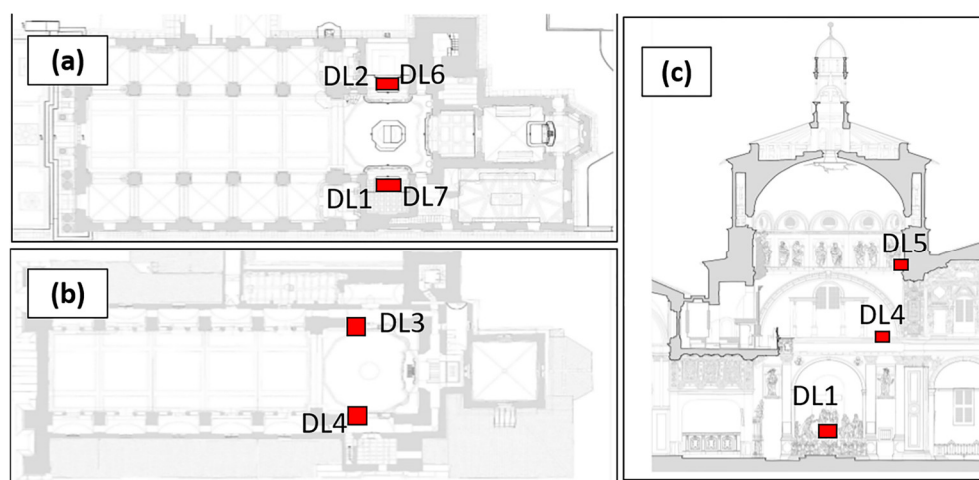
Figure 10. The floor plans and sections of the sanctuary showing the placement of the dataloggers: (a) Ground floor plan, (b) first floor plan, (c) right-side section (*Deposition*).

A total of seven dataloggers were used in this study (DL1–7), five measuring temperature and relative humidity (DL1–5), and two measuring illuminance (DL6–7). The instruments were placed in five different sampling sites and at three different heights in the Sanctuary (Figure 10). On the ground floor, dataloggers were placed close to the two main lateral chapels hosting the wooden sculptural groups *Last Supper* and *Deposition*. On the first floor, the instruments were positioned on the two ledges directly above the chapels, and on the second floor, one datalogger was placed on the side of the dome. Table 7 summarizes the locations and parameters monitored by each of the dataloggers.

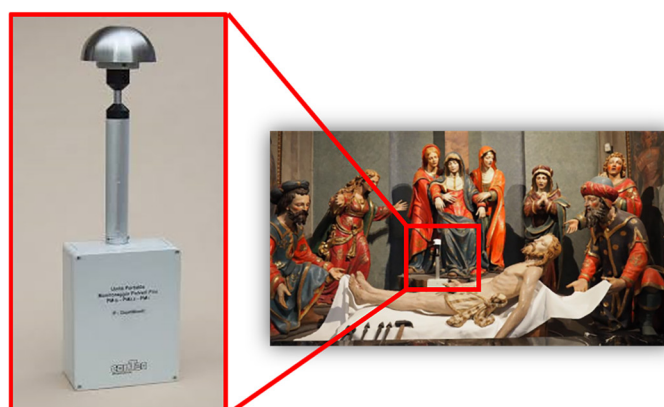
Figure 11. P-Dust Monit positioned in one of the main chapels close to the sculptural group of the *Deposition*.

An optical particle counter (P-Dust Monit, conTec Engineering Srl, Milano, Italy) was employed to monitor the particulate matter concentrations (Figure 11).

The aerosol particles were aspirated with a constant-flow pump, which sucks in air through a radially symmetrical probe and conveys it into a chamber where they are individually hit by a laser light beam. The energy reflected by each particle, which is proportional to its size, is measured by a high-speed photodiode that outputs both the counting and dimensional characterization signals. The measurement sampling range was between 0 and 1000 $\mu\text{g m}^{-3}$ with a sensitivity of 0.1 $\mu\text{g m}^{-3}$. Measurements were performed in real-time with a detection every 60 s.

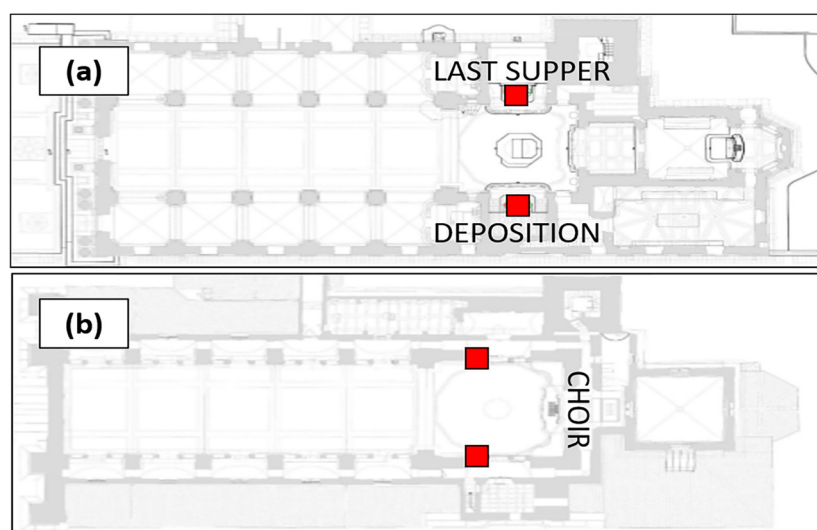
Figure 12. Planimetry of (a) the ground floor and (b) the first floor showing the three sampling sites.

The particles were classified into eight different dimensional classes (0.3–0.5 μm ; 0.5–0.7 μm ; 0.7–1.0 μm ; 1.0–2.0 μm ; 2.0–3.0 μm ; 3.0–5.0 μm ; 5.0–10 μm ; >10 μm) and PM concentrations were expressed as PM10, PM2.5, and PM1. The campaign was carried out between 2 March 2021 and 12 December 2021, in which the P-Dust Monit was placed alternatively at three different sampling sites: the two main lateral chapels (*Deposition* and *Last Supper*) and the *Choir* on the first floor (Figure 12).

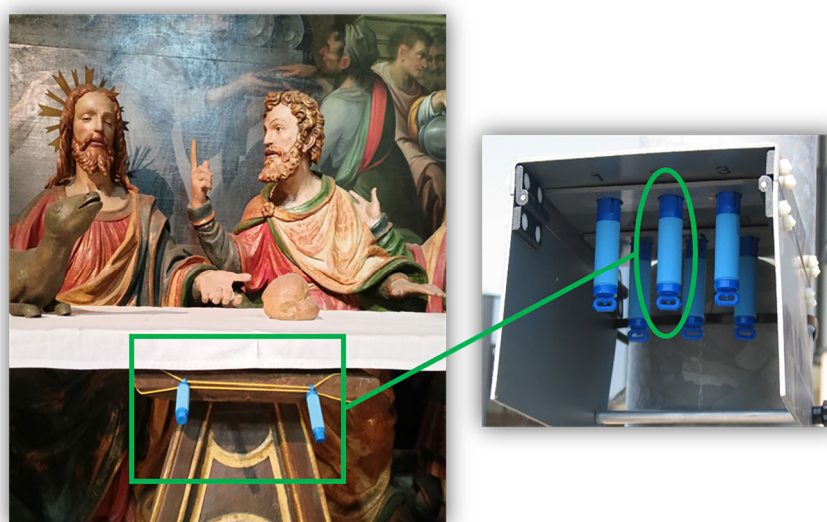
Figure 13. Diffusive passive samplers positioned in one of the main chapels close to the sculptural group of the *Last Supper*.

Passive samplers, RING[®] radial diffusive devices purchased from Aquaria (Aquaria Srl, Milan, Italy), were used for pollutant sampling (Figure 13) according to NIOSH methodologies no. 1500 for BTEX and no. 6014 for NO_2 . The devices were positioned at the same sampling sites chosen for the monitoring of PM (Figure 3). Nitrogen dioxide was sampled from 23 March 2021 to 2 April 2021 (*Deposition* and *Last Supper*) and from 14 December 2021 to 28 December 2021 (*Deposition*, *Last Supper*, and *Choir*). Instead, BTEX were sampled from 23 March 2021 to 2 April 2021 (*Deposition*).
