Abstract: The Piuro 1618 landslide represents a well-known case history of a large Alpine landslide. It destroyed the ancient village of Piuro (Italian Bregaglia Valley), renowned as an important trading center between the Mediterranean region and Northern Europe. The event had a significant impact among communities of all Alpine regions and was well documented by chronicles and paintings during subsequent decades. However, some aspects, such as the geometry reconstruction of the landslide body, the location of the landslide scarp, and its dynamics, remained undefined in previous studies, and a geomechanical characterization of the failure area is completely missing. Using field and laboratory analysis followed by stress-strain numerical modelling, this work develops a 3D conceptual geomechanical model of the slope considering its complex geological framework. The aim is to back-analyze the 1618 event, defining predisposing and triggering factors of the sliding event, and providing verifications on the geometry and location of the failure scar, as well as on the landslide dynamics. A coupled hydro-mechanical analysis with a 3D numerical approach is presented, assuming a rainfall sc

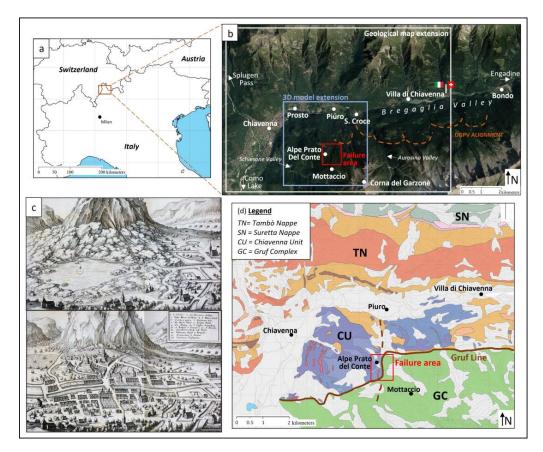
Figure 1. (a) Location of the study area; (b) Satellite photo of the study area showing the location of the failure area, the extent of the 3D model, and geomorphological features characterizing the Valley; (c) Historical drawings showing the village of Piuro before and after the 1618 event [2]; (d) Geological settings of the Italian Bregaglia Valley (from CROP project, [46]); geological cross section are reported in [3].

The village of Piuro is located in the Italian Bregaglia Valley, between the village of Chiavenna and the border with Switzerland (Figure 1a,b). The failure area of the 1618 event is placed on the southern slope of the valley, between 1300 and 1700 m a.s.l., east to the locality "Alpe Prato del Conte". The dynamic of the landslide event is described in historical writings and chronicles collected by [1]. The sliding mass is described as a "mixture of rocks, mud and water that slid down the slope", reaching the bottom of the valley and wiping out the ancient village of Piuro (Figure 1c). Dust and debris covered the entire valley as far as the nearby town of Chiavenna, where the event was distinctly heard. The Mera River, which flows through the valley, was dammed for a few hours. According to historical writings, a large area upstream of the landslide deposit was submerged by a lake created by the Mera River, until the water overflowed, without flooding the town of Chiavenna [47]. The volume of the sliding mass is estimated at values of 5–9.5 Mm³ based on the stratigraphical reconstruction of the landslide deposit on the Piuro Plain [3]. Historical sources [2] testify that the catastrophic event was preceded by heavy rainfall that affected the area for the whole week preceding the event. The day before the failure event, instabilities such as new fractures and noises were noted along the slope. Mudslides and rockfalls also reached the village area only a few hours before the event, destroying some forests and crops.

The model domain develops along the south slope of the Bregaglia Valley. It extends from Prosto to Santa Croce villages to the north and from the Corna di Garzonè peak to the Schiesone Valley to the south (Figure 1b). It includes Bregaglia Valley with Mera River, Aurosina Valley with Aurosina River, and Schiesone Valley with Schiesone River. Domain borders were placed far enough from the area of interest to avoid mechanical boundary effects (Figure 1b). The base of the model has a rectangular shape with a short side (the E-W side, parallel to the Bregaglia Valley) of 3600 m in length and the long side (the S-N side, perpendicular to the Bregaglia Valley) of 4200 m. It covers an area of 15,768,800 m² calculated on the topographical surface. The highest elevation of the model is 2385 m a.s.l., in correspondence of the Corna di Garzonè peak, and the lower one is 364 m a.s.l., in correspondence of the Prosto Village along the Mera River.

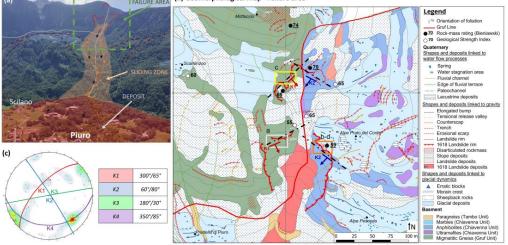
(b) Geomorphological Map - Failure area

Figure 2. (a) Photo of the Piuro landslide as seen from the opposite slope. Failure, sliding and deposit zones are highlighted; (b) Geomorphological and geological features of the 1618 failure area; (c) Geomechanical features of the study area. Lower hemisphere stereographic projection of the main discontinuity sets. Joint orientation is expressed by dip direction/dip.

To characterize the geomorphological features related to the 1618 landslide event, field surveys were carried out along the slope, identifying a failure zone, a sliding/accumulation zone and a deposition zone (Figure 2a).

The rock scarps are tens of meters high and have a variable orientation moving eastward. At the Alpe Prato del Conte locality they are consistent with the direction of the trenches (ESE-WNW), varying to E-W and then NE-SW, moving eastward (Figures 2b and 3a–c). Other rock scarps with NE-SW orientation are clearly evident upstream of the Alpe Prato del Conte toward the Mottaccio locality, at an elevation of about 1700 m a.s.l. (Figures 2b and 3a–c).

The calculated RMR (rock mass rating; [57]) and the evaluated GSI (geological strength index; [58]) reveal a generally discrete to good rock mass mechanical quality (RMR ranging from 59 to 74, GSI ranging from 55 to 65; see Figure 2b). Due to a more intense fracturing and a higher weathering degree of the rock masses, lower values were detected at the Alpe Prato del Conte close to the traction fractures and along the main scarps of the lower niche.

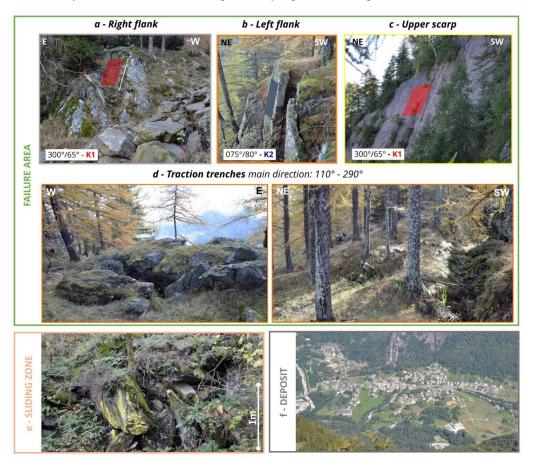
Figure 3. (**a**–**c**) Rock masses outcropping along the slope. Two main discontinuity sets are highlighted with different colors—also plotted on the stereographic projection of Figure 2c (lower hemisphere); (**d**) Traction trenches outcropping at Alpe Prato del Conte locality; (**e**) Landslide deposit outcropping in the sliding zone along the slope; (**f**) Aerial view of the landslide deposit on which the new village of Piuro stands.

Focusing around the area affected by the detachment, steep scarps are observed in correspondence of the Alpe Prato del Conte locality at an altitude of about 1430 m a.s.l. (Figures 2b and 3a–c). Here, flat morphologies covered by glacial deposits are abruptly interrupted by trenches and steep rock scarps. Trenches have an ESE-WNW orientation and are characterized by a metric opening whose walls consist of strongly disjointed rock masses (Figure 3d).

Moreover, in correspondence of the Mottaccio locality, upstream of the detachment zone, disjointed rock masses (with metric openings of discontinuities) were detected. The fracturing condition is predominantly subvertical with E-W and N-S directions; two sets of discontinuities with lower inclination are also present, one dipping toward NW and one dipping to E horizontally. The discontinuity network isolates cubic blocks greater than one cubic meter and represent a preferential zone of water infiltration during rainfalls.

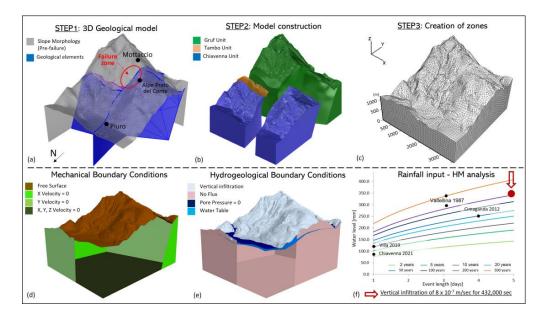
Figure 4. (a) 3D geological model built starting from the geological–structural features of the slope presented in Figure 1d; (b) FLAC3D model building; (c) Discretization into a finite-difference grid by the definition of hexahedral zones; (d) Boundary conditions of the mechanical model; (e) Boundary conditions of the hydrogeological model for the hydro-mechanical analysis; (f) Rainfall input of hydro-mechanical analysis. Identification of input values by evaluating rainfall scenarios in the study area.

A second step included the three-dimensional reconstruction of the geological elements outcropping along the slope, using the software Geomodeller (Version 3, [66]). Starting from geological maps (CROP project, [46]), it was possible to define the 3D geology by considering orientation data measured along the slope and their relationships with the topography (Figure 4a).

Boundary conditions of fixed zero velocity are specified along the bottom boundary of the model domain, and fixed normal zero velocity was set along the side boundaries (Figure 4d).

Based on the current meteorological data, a hypothesis coincident with a return period of 200 years, corresponding to a duration of 5 days, and total accumulated water of 345 mm, was made. This trigger rainfall value was divided into periods of constant rainfall intensity, and a vertical infiltration value of 8×10^{-7} m/s was calculated assuming the absence of surface runoff. The infiltration function evaluated over time represents the input data for the transient hydromechanical analysis, in which the hydrogeological boundary conditions are represented by (Figure 4e):

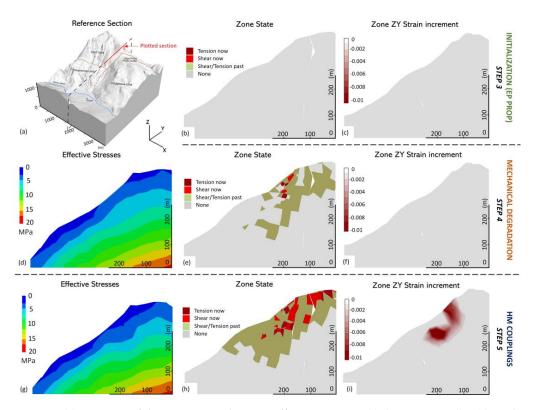
Figure 6. (a) Location of the 2D section showing effective stresses (**d**,**g**), zone state (**b**,**e**,**h**), and ZY strain increment (**c**,**f**,**i**) simulated for different steps of the analysis.

The distribution and magnitude of the simulated total displacements are consistent with the slope morphology: their vertical component (of the order of 1 m) is maximum in the upper portion of the slope, while the horizontal one (of the order of 0.9 m) is largest in its central part (Figure 5c). At step 3, using large strength parameters for the rock mass and with standard hydrogeological conditions, no failure conditions are reached, neither within rock mass elements nor along geological interfaces (Figure 6a–c).

The reduction of geomechanical properties (step 4) induces a significant increase in the number of yielded elements and a slight increase in the shear strain modulus. An area of large displacements (with maximum values of 1 m) develops along the N-S lineament at an altitude of about 1400 m a.s.l., close to the Alpe Prato del Conte locality. Consistently, plastic shear and tensile failures begin to develop in the same area up to a maximum depth of 200 m from the slope surface (Figure 6e). Even if an instability attitude is evident along this portion of the slope, a critical condition is not yet reached at this stage.

Finally, the introduction of vertical water infiltration with a fully coupled transient HM analysis (step 5) leads to the development of localized excess pore pressures along the slope. The simulated water flow moves toward the base of the slope, both northward (in the direction of Piuro) and southward (in the direction of the Schiesone Valley), consistent with the hydraulic conductivity values introduced in the model. Pore pressure increase occurs at the toe of the slope due to an accumulation of water and a consequent rise in the groundwater level. Significant pore pressure increase occurs also in correspondence of the Alpe Prato del Conte locality, where gentler dipping slopes allow water accumulation. In this portion, a significant decrease in the effective stresses until a depth of 300 m was observed (see Figure 6g compared to Figure 6d). This was sufficient to generate a large increase in shear and tensile straining leading to failure, as is apparent by comparing Figure 6h with Figure 6e. At the end of the simulated rainfall event, tensile zones are identified upstream from the Alpe Prato del Conte locality toward the top of the slope, whereas shear plastic zones are present at its base.

Focusing on the top portion of the slope, a surface along which shear strains concentrate is observed to develop during the HM simulation (Figure 6i). It extends from elevations of 1300 m up to 1600 m a.s.l. and reaches a maximum depth of 150 m.

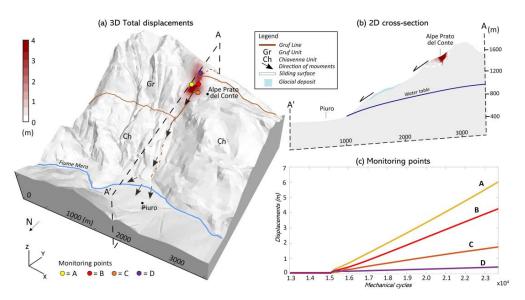
Figure 7. (a) 3D total displacements simulated at the end of the HM coupled analysis. (b) 2D total displacements along a N-S cross-section crossing the failure area. (c) Graph of measured displacements at monitoring points (Figure 6a) with mechanical cycles (defined as the number of timesteps performed).

In terms of total displacements (the resultant of the modulus of the 3D displacement vectors), the simulation results in large values localized along the N-S lineament at an altitude of about 1400 m a.s.l., in correspondence to the 1618 failure area (Figure 7a,b). Maximum values up to 5 m are reached at the end of the transient HM analysis.

Studying the evolution of the displacement values recorded by the monitoring points located in the failure area of the 1618 event, it can be observed that during the seepage process plastic conditions are reached. This is highlighted by the sudden rise in shear strain rate, indicating the achievement of irreversible conditions. This is most evident for the points located in the surroundings of the main failure zone of the slope (A, B, C points in Figure 7c) and is less evident in the upper part where the deformations are markedly smaller (D point in Figure 7c).

The maximum shear strain and total displacement distribution clearly show the presence of a critical, composite sliding surface approximately corresponding to the observed one.
