Preliminary air quality and microclimatic conditions study in the *Santuario della Beata Vergine dei Miracoli* in Saronno (VA)

Abstract: In the present work, microclimatic conditions (temperature (T), relative humidity (RH) 14 and illuminance (I)) together with air quality (both aerosol particulate matter (PM) and gaseous 15 pollutants) have been monitored to evaluate environmental conditions inside the Santuario della 16 Beata Vergine dei Miracoli in Saronno (VA), a masterpiece of Italian Renaissance. For this purpose, 17 dataloggers were used to carry out T, RH, and I measurements, whereas an optical particle counter 18 (OPC) was employed to perform the particle count and determine the concentration of aerosol PM. 19 Finally, diffusive passive samplers were used to determine the concentration of nitrogen dioxide 20 (NO₂) and BTEX (benzene, toluene, ethylbenzene, and xylenes). To identify possible spatial varia-21 tions, the studies were conducted at different sites and different heights in the Sanctuary. Particular 22 focus was given to the Easter week during which liturgical services attracting large numbers of 23 people were carried out. Also, a comparison with outdoor values

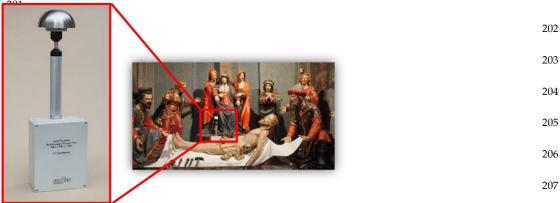
Figure 2. P-Dust Monit positioned in one of the main chapels, nearby the sculptural group of the 208 Deposition. 209

An optical particle counter (P-Dust Monit, conTec Engineering Srl, Milano, Italy) was 199 employed to monitor particulate matter concentrations (Figure 2). 200

The aerosol particles were aspirated with a constant-flow pump, which sucks in air 210 through a radially symmetrical probe and conveys it into a chamber where they are individually hit by a laser light beam. The energy reflected by each particle, which is proportional to its size, is measured by a high-speed photodiode that outputs both counting and 213 dimensional characterization signals. The measurement sampling range is between 0 and 214 1000 μ g m⁻³, with a sensitivity of 0.1 μ g m⁻³. Measurements were performed in real-time 215 with a detection every 60 seconds. 216

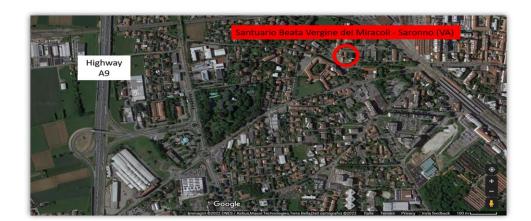
As opposed to nitrogen oxides, BTEX is a class of compounds that has not been extensively studied. 469 The amount of data regarding the possible effects on cultural heritage, both in literature and in 470 legislative documents, is lacking. However, volatile organic compounds (VOCs), including BTEX, 471 are known to have multiple outdoor and indoor sources [22] and diagnostic ratios between the dif-472 ferent species are useful to establish the most probable sources of pollution [21]. The preliminary 473 results of this campaign show similar concentrations of benzene and toluene (1.6 and 1.7 μ g m³, 474 respectively), while measurable amounts of ethylbenzene and xylenes were not observed. Similar 475 concentrations of toluene and benzene are an indication of vehicular traffic as the main source of 476pollution [21]. This is not surprising considering the location of the Sanctuary, which is found near 477 the A9 highway (Figure 11)Figure 11. Location of the Sanctuary with respect to the A9 Highway. 478
