Article

## Setup of Galvanic Sensors for the Monitoring of Gilded Bronzes

**Abstract:** Traditional electrochemical techniques, such as linear polarization resistance ( $R_p$ ), and electrochemical impedance spectroscopy (EIS), cannot be applied to gilded bronzes, as it may not be possible to interpret the results obtained due to the bimetallic nature of the studied material. The measurement of the macrocouple current generated by the gold/bronze galvanic couple can be used as an indicator of degradation processes. Nevertheless, this measurement cannot be performed directly on the original artifacts due to the systematic presence of short-circuits between the two metals. In the present work the use of galvanic sensors is proposed as a possible solution for the monitoring of gilded bronze artefacts. The sensors have been designed to simulate real gilded bronze surfaces in terms of composition and stratigraphy and have proved to be a reliable diagnostic tool for the *in situ* monitoring of the rates of deterioration of gilded bronze surfaces and to test new conservation treatments. Their set-up and application is reported and their performances discussed.

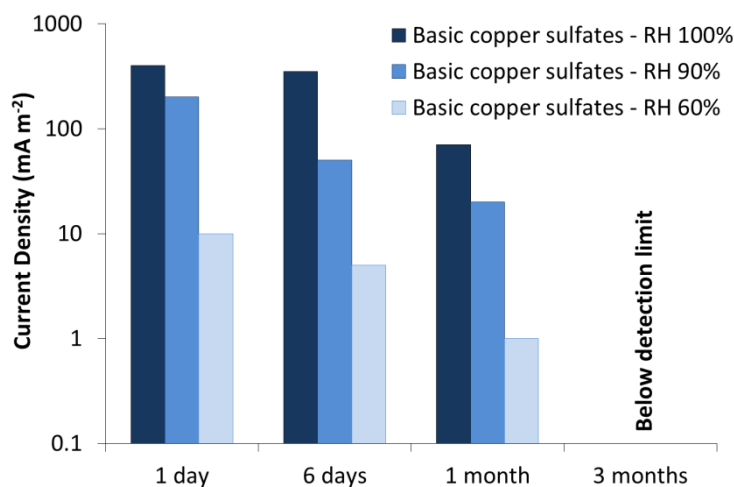
**Figure 1.** The galvanic sensors of the seventies [48,49]: macrocouple current as a function of time and relative humidity.

The first galvanic sensors simulating gilded bronzes were designed during the seventies to evaluate new conservation strategies for Lorenzo Ghiberti's *Porta del Paradiso* [48,49]. At that time the possibility to maintain the *Porta del Paradiso* in its original location was under discussion and the first sensors were therefore designed to operate in outdoor conditions under high relative humidity values: up to 100% RH with the presence of superficial moisture [48–50]. The metallic substrate of the sensors was a quaternary bronze (83.90% Cu, 5.80% Sn, 4.25% Pb, 5.30% Zn, 0.58% Ni), and the artificial patina of corrosion products was mainly constituted by basic copper sulfates. The gilding was obtained by applying a thin gold sheet glued along the lateral edges of the sensor. The maximum current density was reached during the first 24 h and for 100% RH (Figure 1). The current density then decreased quickly with time, falling below the detection limit after three months. Those sensors therefore could only be used to monitor gilded bronzes for a short time period and in quite humid conditions ( $RH \geq 60\%$ ).

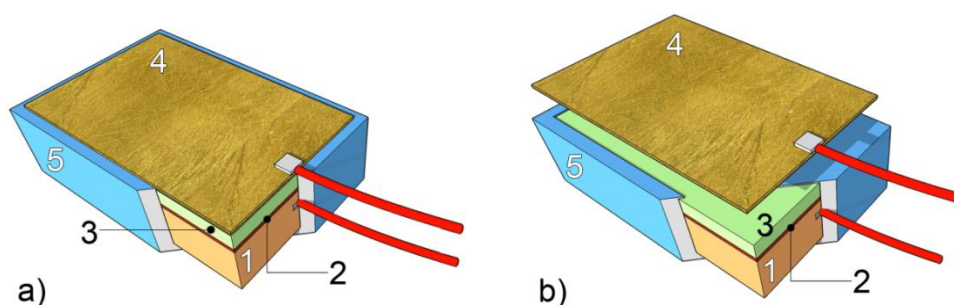
**Figure 2.** General model of a galvanic sensor (a) with detail of the gold leaf overlapped (b). The complete stratigraphy of the sensor includes: (1) metallic substrate; (2) cuprite layer; (3) patina of corrosion products; (4) gilding; (5) electric insulation cover.

The scheme and a picture of the galvanic sensors setup used in the present study are given in Figure 2.

Pure copper (Cu 99.90%) and a quaternary bronze alloy, (Cu 93,1%; Zn 3,2%; Sn 2,6%; Pb 1,1%) have been used as metallic substrates for the realization of the galvanic sensors. The stratigraphy of the sensors can be described as follows: (1) metallic substrate; (2) cuprite layer ( $\text{Cu}_2\text{O}$ ); (3) artificial patina of corrosion products; and (4) gilding.

Each sensor has electrical connections both to the metallic substrate and to the gilding for the measurement of the macrocouple current: the connection to the substrate is obtained by a metal rivet, while the gold leaf is connected by means of conductive silver-based glue applied on its external surface. The lateral sides, the back and all the connections of the sensor are coated with epoxy resin in order to ensure the electrical insulation of the entire system.

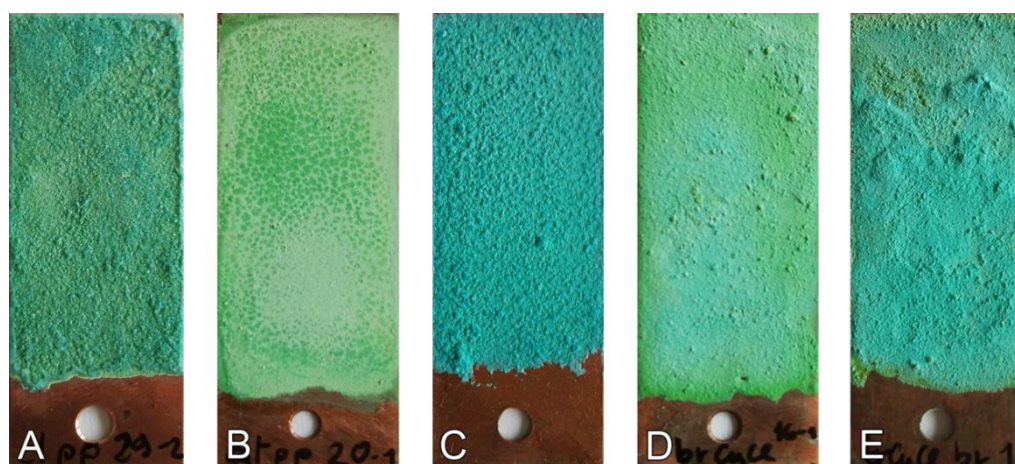
**Figure 3.** Photographic documentation of the different types of patina: S&C (A); BCC (B); BrocChal (C); BrocNan (D); BrocNan+Broc (E) (specimens dimensions: 60 × 20 mm).

Prior to the preparation of the sensors, the copper substrates have just been degreased in acetone, while the quaternary bronze substrates were milled in order to remove all the undesired corrosion products. This way, a homogeneous surface has been achieved. The cuprite layer is obtained after a 30–60 min immersion of the metallic substrate in a boiling solution containing: (a) 25 g/L copper sulfate for bronze, and (b) 6.5 g/L copper sulfate, 1.25 g/L copper acetate, 2 g/L sodium chloride and 1.25 g/L potassium nitrate for copper [45]. The cuprite layer could enhance the adhesion of the corrosion products to the sensor substrate and its efficiency is currently under evaluation. This layer should therefore be considered as optional with respect to the overall stratigraphy. Tests have been conducted on sensors with and without the cuprite layer; however the results presented here always refer to a complete stratigraphy, thus including the cuprite layer. The artificial patina of corrosion products has been prepared according to the “applied paste” method described by Hughes and Rowe [45]: copper compounds (selected according to the type of patina, see details in Table 1) are finely grounded in a mortar; water is added until a paste with adequate fluidity is obtained; the paste is then finally spread on the metallic surface by means of a stainless steel spatula. The “applied paste” method allows the preparation of artificial patinas with a wide range of different compositions, which are representative of the various conservation conditions of ancient gilded bronzes. Moreover, the thickness of the artificial patinas can be tuned by overlapping additional layers (up to three overlapped layers have been tested), having either a similar or a different mutual composition. The thickness has been verified by using a micrometric gauge. The characteristics and recipes of the artificial patinas which have been set up for the preparation of the galvanic sensor are summarized in Table 1. The types of patina to be reproduced and tested in the present study have been selected according to their relevance in the conservation of gilded bronze artifacts, as reported in the scientific literature [28,29,31,51–53]. All patinas have been used for the preparation of both copper and bronze sensors. Photographic documentation of the obtained patinas is shown in Figure 3.

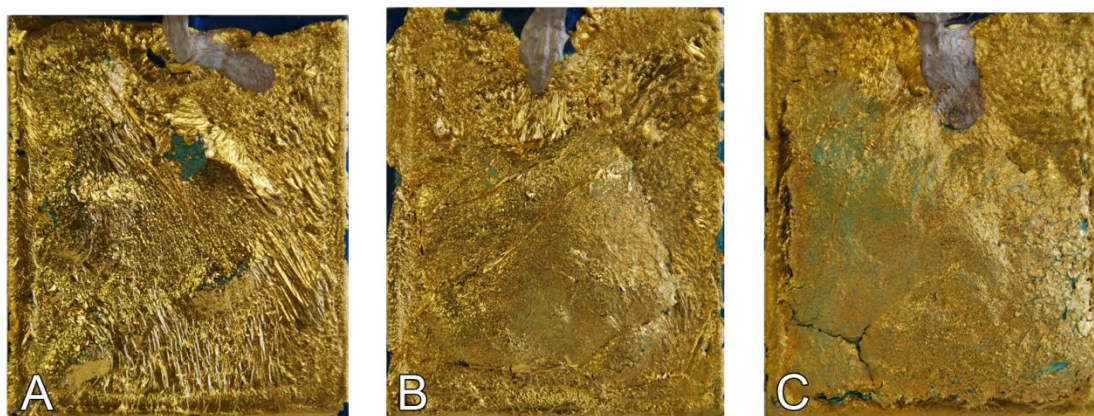
**Figure 4.** Photographic documentation of galvanic sensors with increasing thickness of the patina realized on copper substrate and with a S&C patina: single layer (A), double layer (B) and triple layer (C) (sensors dimensions: 60 × 50 mm).

On the one hand, the patina should be thick enough to avoid short circuits between the gilding and the metallic substrate. On the other hand as the thickness of the patina increases, the overall durability of the sensors tends to be reduced. This phenomenon is mainly associated to the presence of hygroscopic compounds (e.g., chlorides) within the patina, that tend to blister and to detach from the metallic substrate as a result of the volume change triggered by relative humidity variations. As it can be observed in Figure 4, after few months under laboratory conditions and variable RH (10%–70%), the S&C single layer shows limited blistering and gilding detachment and is much more stable and durable compared to the double and triple layer. The latter sensor, in particular, completely degrades showing an almost complete detachment of the artificial patina.

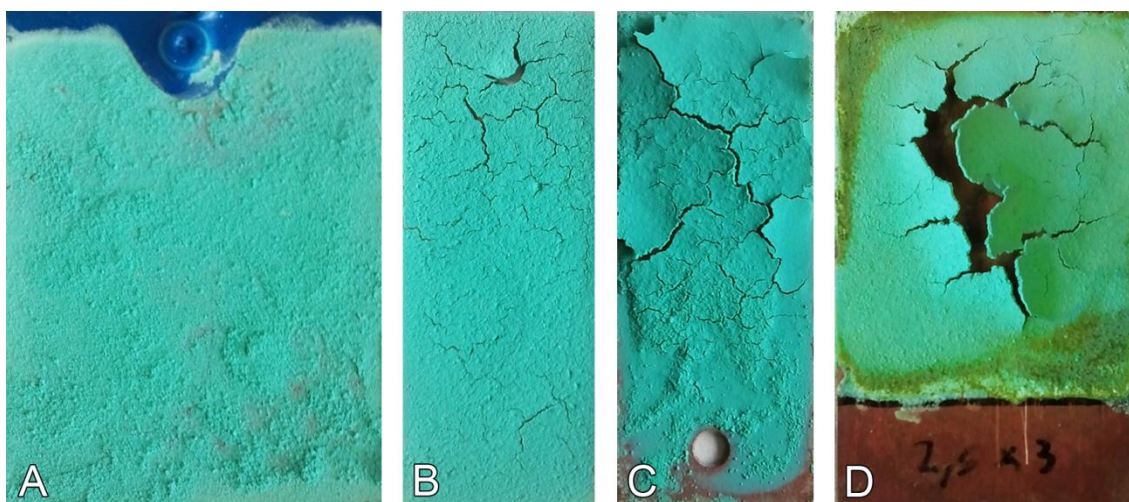
**Figure 5.** Brochantite patinas with increasing thickness (A) > (B) > (C) > (D) (sensors max. length: 60 mm).

The composition of the patina can be changed in order to reproduce as close as possible the actual stratigraphy of the original object to be monitored or to be treated with new conservative procedures. Unfortunately, it has not been possible to realize in a reproducible way pure brochantite sensors, which simulate the most diffuse corrosion product on copper alloys artifacts in urban environment. Brochantite patinas are generally characterized by a very low internal cohesion, a limited adhesion to the substrate and a high tendency to form cracks (Figure 5). In particular, as previously discussed, the number of cracks increases as the thickness of the patina grows. The only way to obtain a suitable

brochantite patina is to apply a very thin paste (Figure 5A), which however shows scarce cohesion and a rather powder-like aspect. Moreover, such a patina has a very high risk of short circuits between the gold and the metallic substrate.

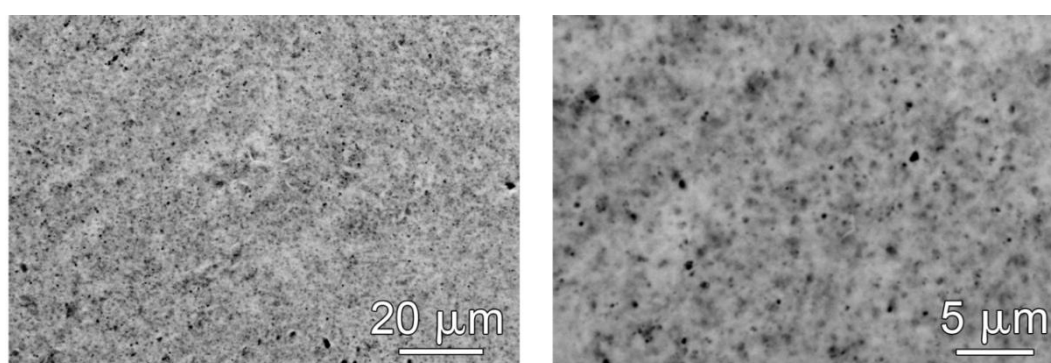
**Figure 6.** SEM documentation of the characteristic porosity of the gold leaf.

The timing for the application of the gilding is the key factor of this methodology. As previously discussed, the humid nature of the patina enhances the adherence to the metal substrates. Nevertheless, a too high moisture content of the patina can promote migration of soluble salts through the porosity of the gold leaf, thus causing surface crystallization. In Figure 6 the characteristic porosity of the gold leaf is reported. As it can be observed, the porosity is not homogeneous and the maximum pore diameter is generally below 1  $\mu\text{m}$ . Figure 7 shows the typical aspect of a sensor in which the gold leaf has been applied too early on a very humid patina.

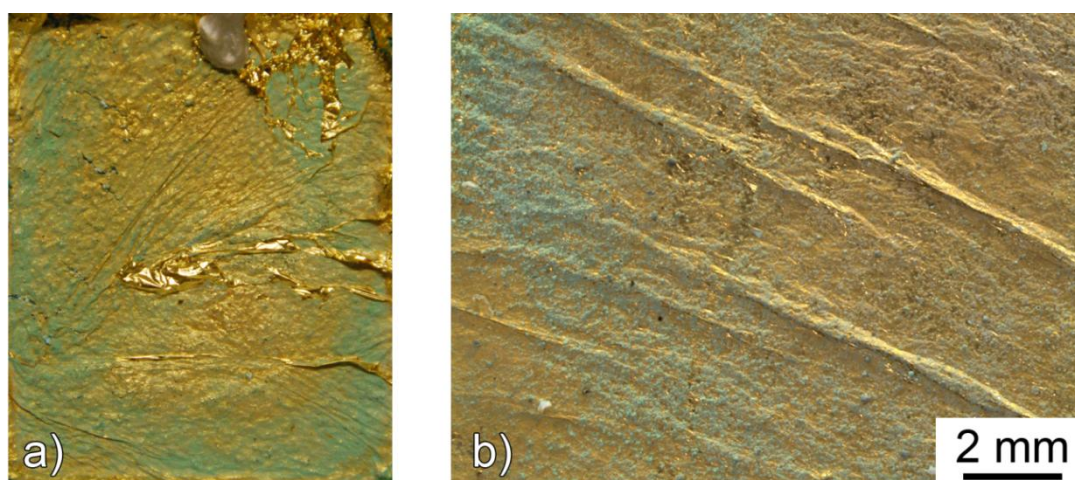
**Figure 7.** Macroscopic (sensor dimensions: 60  $\times$  50 mm) (a) and microscopic (b) documentation of a galvanic sensors resulting from the too early application of the gold leaf on a highly moistened patina.

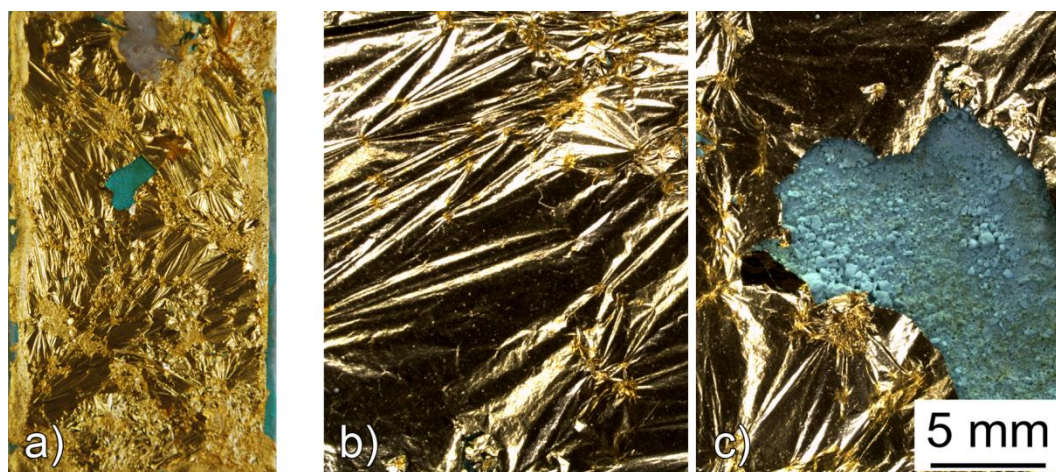
**Figure 8.** Macroscopic (sensors max. length: 60 mm) (a) and microscopic documentation (b,c) of a galvanic sensors showing a lack of adhesion of the gold leaf.

On the other hand, the application of the gold leaf on a too dry patina will determine a limited adhesion to the substrate, as shown in Figure 8.

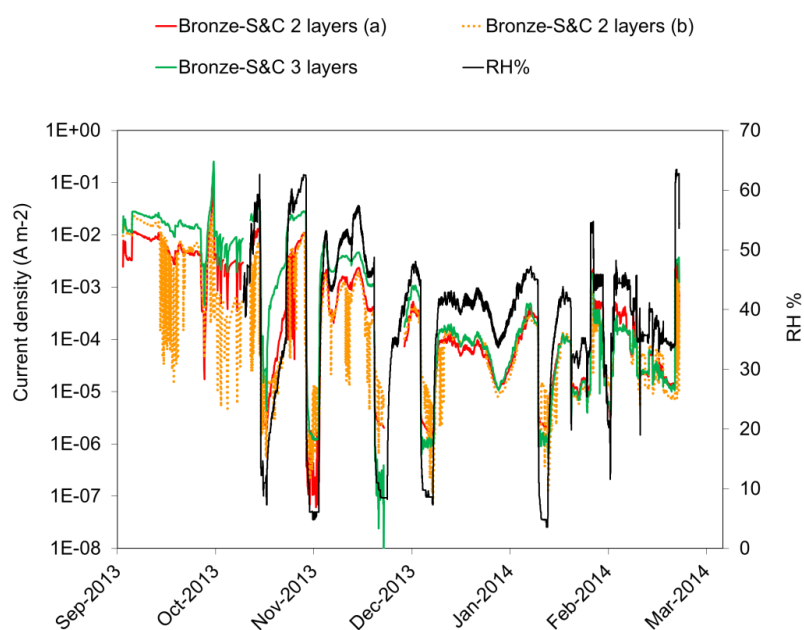
**Figure 9.** Macrocouple current as a function of time for three galvanic sensors with bronze substrate and double or triple layer of S&C artificial patina.

Galvanic sensors allow a continuous monitoring of the macrocouple current flowing between the gilding and the metallic substrate (Figure 9), of the driving force for the galvanic corrosion (Figure 10a) and of the electrical resistance of the artificial patina of corrosion products (Figure 10b). Data show that all these parameters are strongly linked to the variation of the relative humidity. Corrosion products such as copper chlorides are highly hygroscopic and tend to absorb moisture from the air when the RH rises. As a result, patinas become more conductive and the galvanic corrosion is enhanced. They also confirm that during the conditioning time the driving force and resistance trends are still affected by the initially high moisture content of the patina. The monitoring of these parameters therefore allows the evaluation of the effects induced by the environmental variations on the rate of corrosion of gilded bronzes. In particular, the macrocouple current is directly correlated by the Faraday's law to the corrosion rate. In this paper only macrocouple current data are reported and discussed, so that the assumptions required for the conversion from current density to corrosion rate (e.g.,  $\mu\text{m}\cdot\text{y}^{-1}$ ,  $\text{g}\cdot\text{m}^{-2}\cdot\text{y}^{-1}$ ) are avoided. These assumptions include: (a) corrosion is generalized; (b) if alloys are considered, the corroded elements and the involved anodic reactions have to be individuated; and (c) the effective cathodic and anodic areas have to be calculated, also taking into account the surface roughness. As it can be observed in Figure 9, galvanic sensors with the same composition of the artificial patina are characterized by a quite reproducible macrocouple current. This result confirms that the reproducibility of the galvanic sensors with the new setup has significantly improved compared to the previous version used for the study of the exposition conditions of the *Porta del Paradiso* [30].

The galvanic sensors require a certain conditioning time in order to reach stability. This is mostly related to the artificial patination procedure which produces highly moistened corrosion layers. As a consequence, the macrocouple current, and therefore the corrosion rate, is generally higher during the early stage of sensor exposition, as it can be observed in Figure 11, where the average macrocouple current density detected at constant temperature (25 °C) and relative humidity (60% and 45%) is reported. The values refer to a couple of galvanic sensors with copper substrate and double layer of

BCC artificial patina. In general a conditioning time of approximately two months appears to be sufficient for all the galvanic sensors realized so far. The conditioning time increases when the artificial patina is thicker. As it can be observed in Figure 9, for the first two months, the three layers sensor presents a higher macrocouple current density compared with the two double layer galvanic sensors, which can be ascribed to its initially higher water content. As the moisture evaporation proceeds, the three sensors show a very similar macrocouple current.

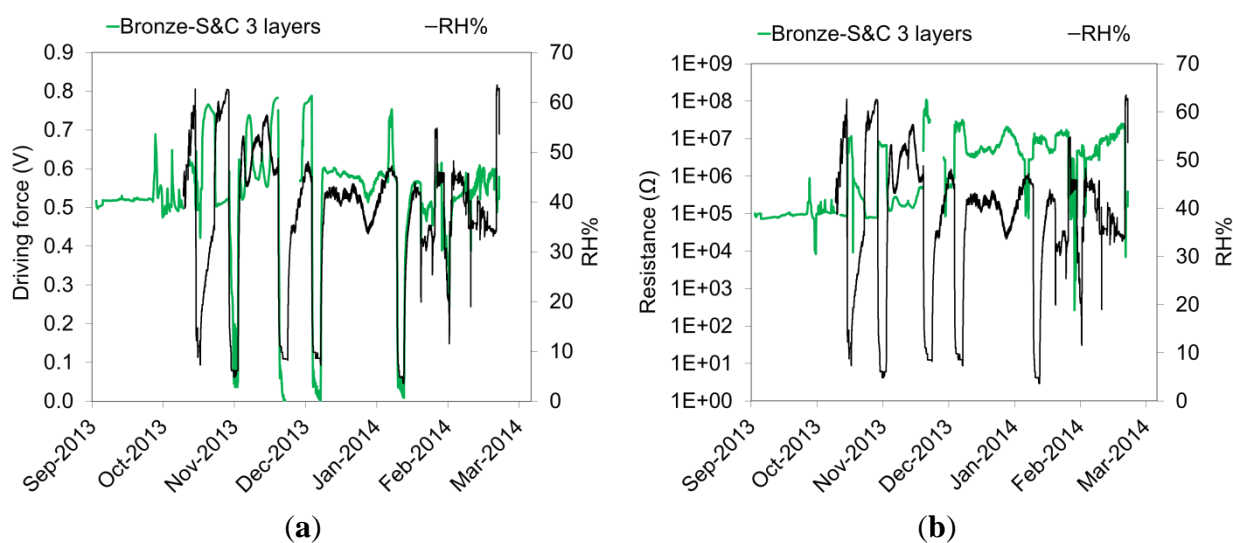
**Figure 10.** Driving force (a) and Resistance (b) as a function of time a galvanic sensors with bronze substrate and triple layer of S&C artificial patina.

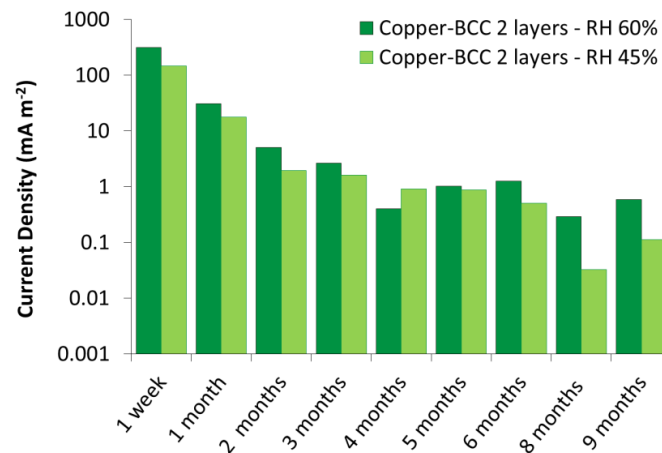
**Figure 11.** Average macrocouple current density detected at constant temperature (25 °C) and relative humidity (60% and 45%) for galvanic sensors with copper substrate and double layer of BCC artificial patina.

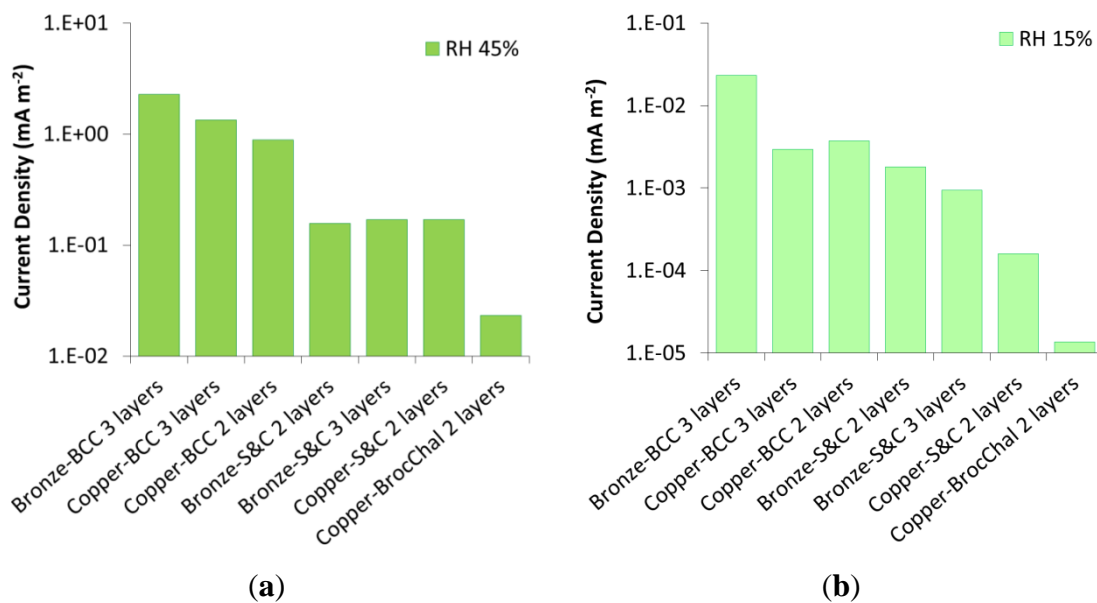
**Figure 12.** Average macrocouple current density as a function of the artificial patina composition and thickness, detected at constant temperature (25 °C) during the fifth month of life of the galvanic sensors at RH% 45% (a) and 15% (b).

As it can be observed in Figure 12, there are no significant differences in terms of macrocouple current between sensors realized on copper or bronze substrate. The slightly higher macrocouple current density observed for the bronze substrates has been mainly ascribed to their rougher surface before the application of the artificial patina that could have guaranteed a better adhesion. This aspect requires further investigation.

The composition of the artificial patina plays a very important role. Variations of almost one order of magnitude have been observed as a result of different compositions of the patina; being the basic copper chlorides the ones with the highest corrosion rates. Therefore, the design of the most suitable
