Title: Integrated Scientific Investigations On Constitutive Materials  
From Me-taw-ya Temple (n.1205a), Pagán Valley (Birmani)

Article Type: VSI: MetroArchaeo2017

# Integrated Scientific Investigations On Constitutive Materials From Me-taw-ya Temple (n.1205a), Pagán Valley (Birmani)

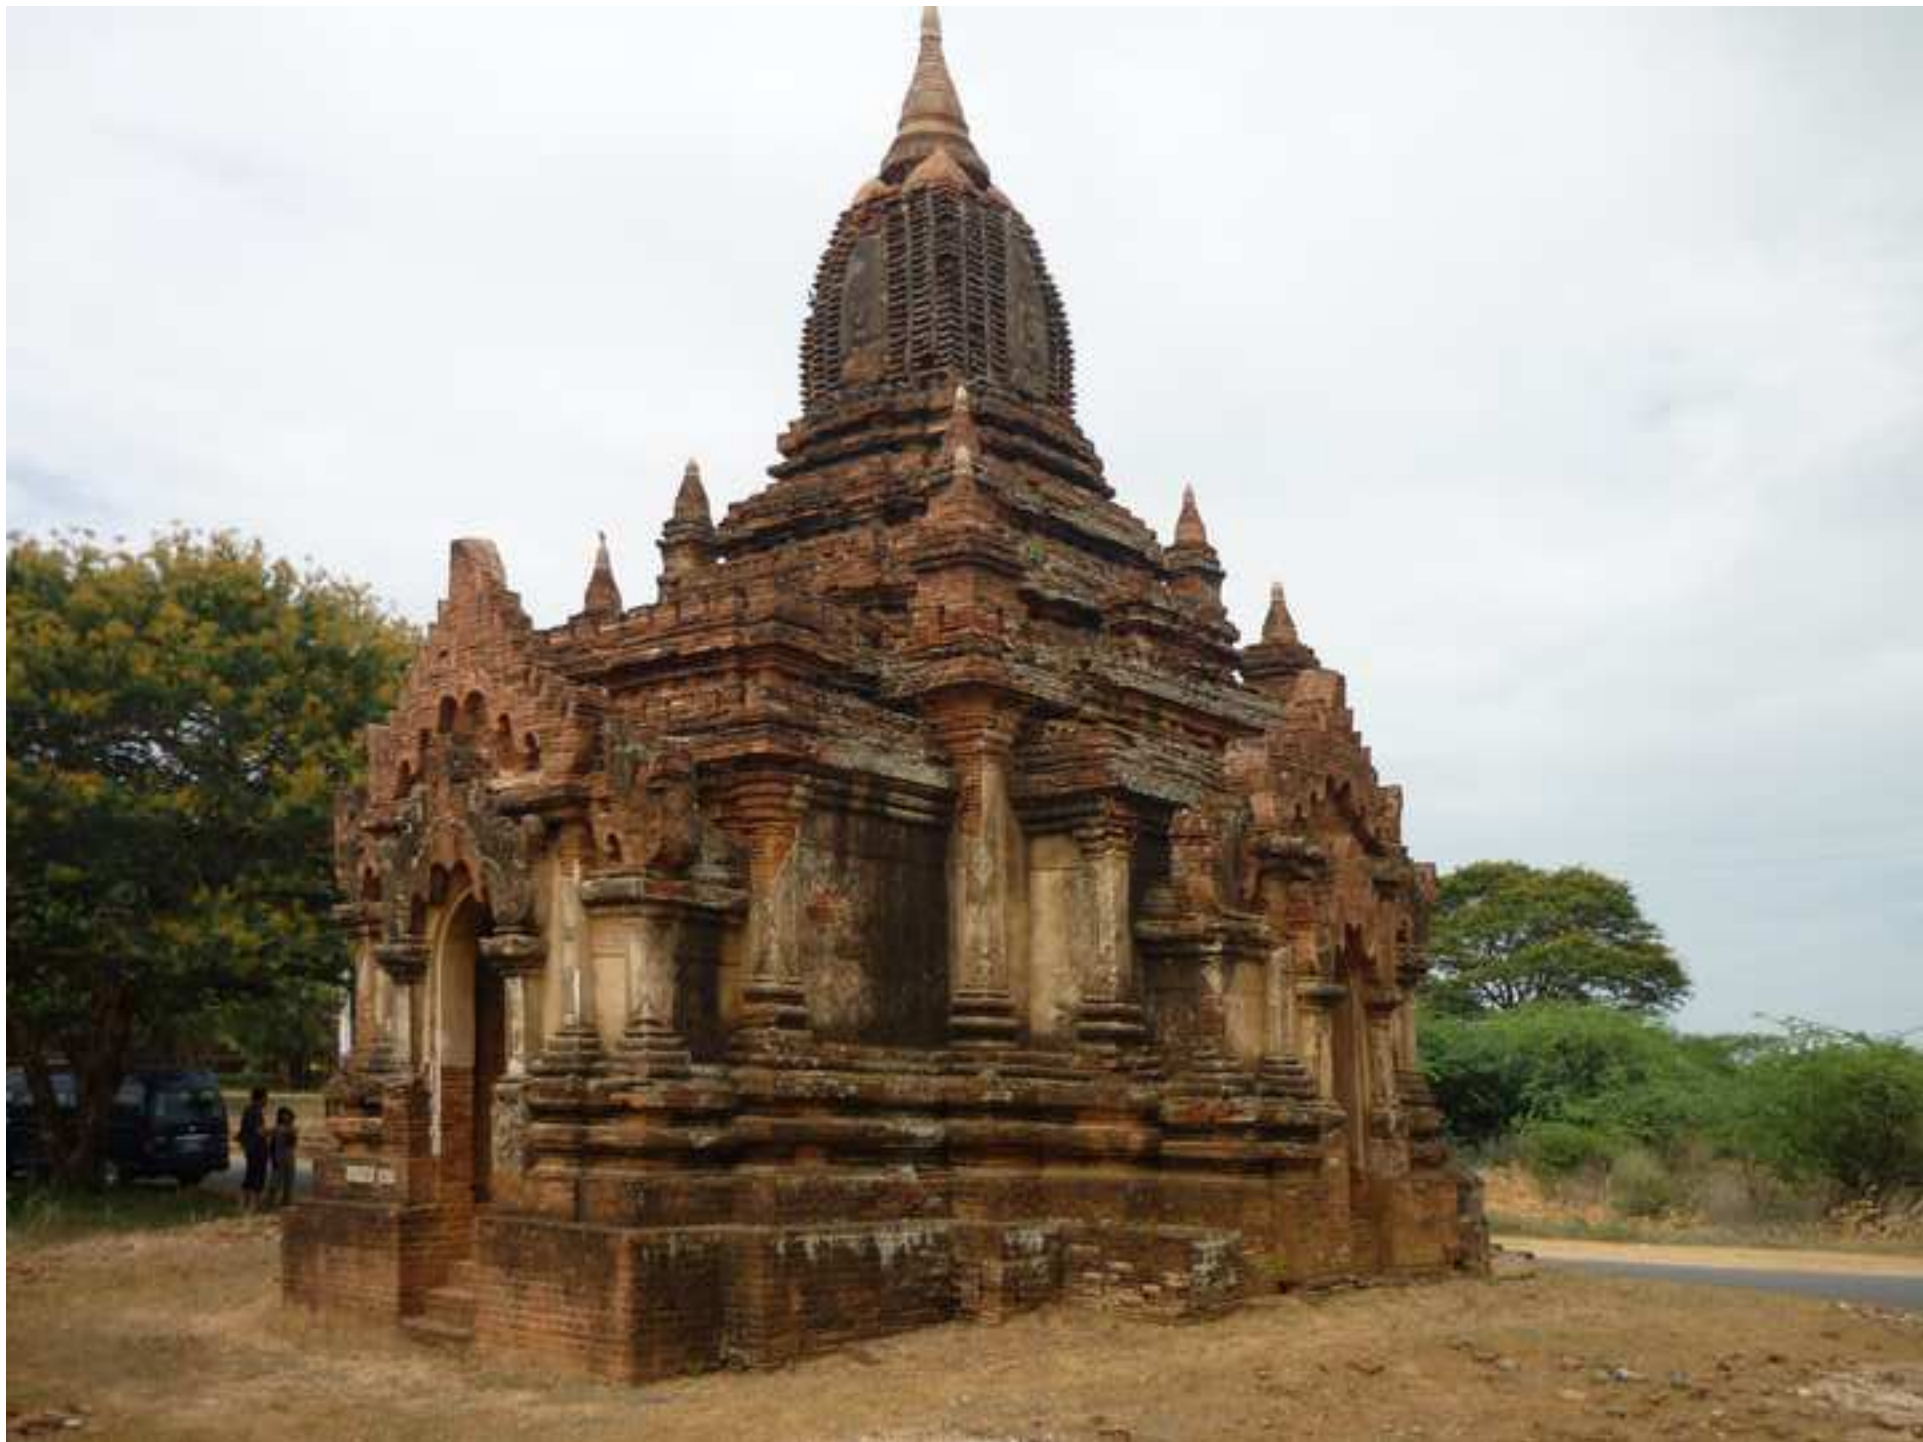
**Figure 1**  
[Click here to download high resolution image](#)

Fig. 1. Temple n. 1205a from Bagan Archaeological Area

Me-taw-ya temple (n. 1205a) is one of the temples involved in this project (fig. 1). The temple, dating XIII century, belongs to Pagán Dynasty and it is located in the middle of the Pagán Chauk Road, which connects Old Pagán and New Pagán , in the south of Myinkaba village in Pagán site. Constitutive materials and executive techniques are the ones traditionally used in Pagán . Temple's foundation are multi-layered, approximately three meters deep: directly in contact with soil a first layer of sand and petrified wood (woodstone) was applied; above it a second layer of lime sand and broken terracotta; a third final layer was made out of lime, sand and limestone.

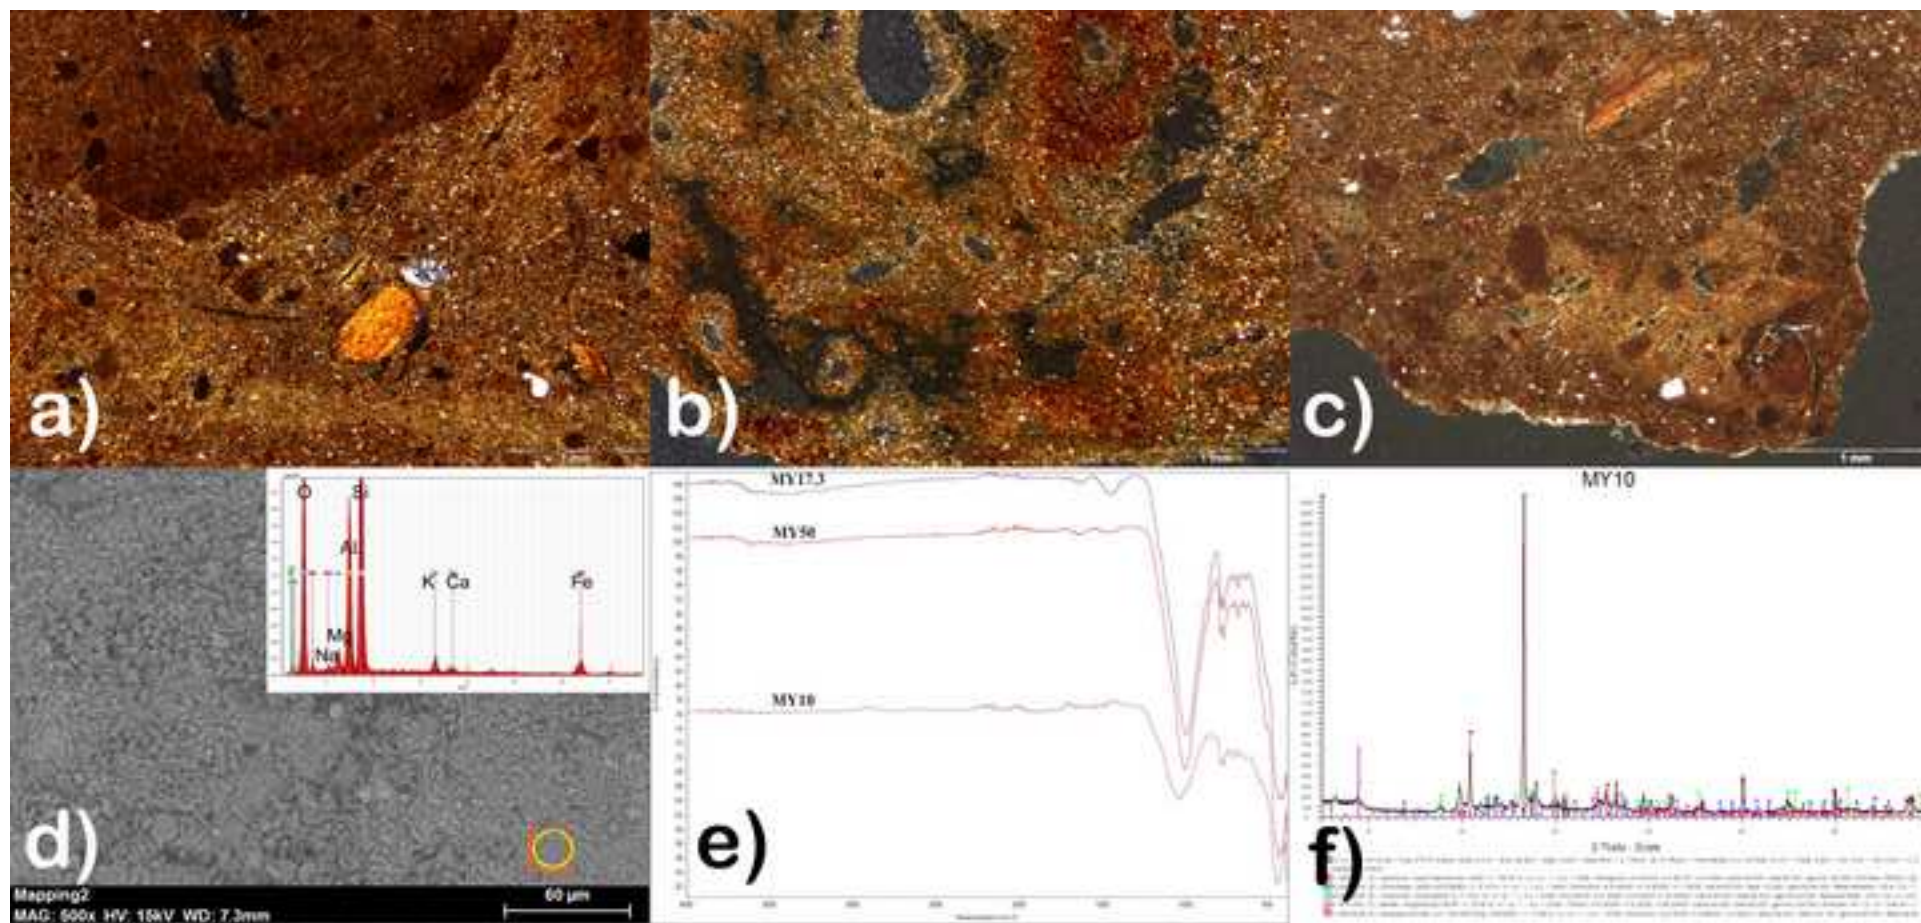
**Figure 4**  
[Click here to download high resolution image](#)

XRD analysis has confirmed the presence of the mineral phases observed by optical microscope, allowing to distinguish the presence of illite in the clay matrix. The presence of illite has been highlighted and confirmed by FT-IR analysis: the two signals related to this mineral are present in the spectra acquired on the original bricks MY17.3 and MY50 (at  $1455 \text{ cm}^{-1}$  and  $1620 \text{ cm}^{-1}$  [17]; together with the signals of calcium carbonate at about  $1420 \text{ cm}^{-1}$  (fig. 4e). It is worth noting that in case of sample MY10, in accordance with XRD data (table 3, fig 4f) the signals attributed to illite have not been identified by FT-IR analysis.

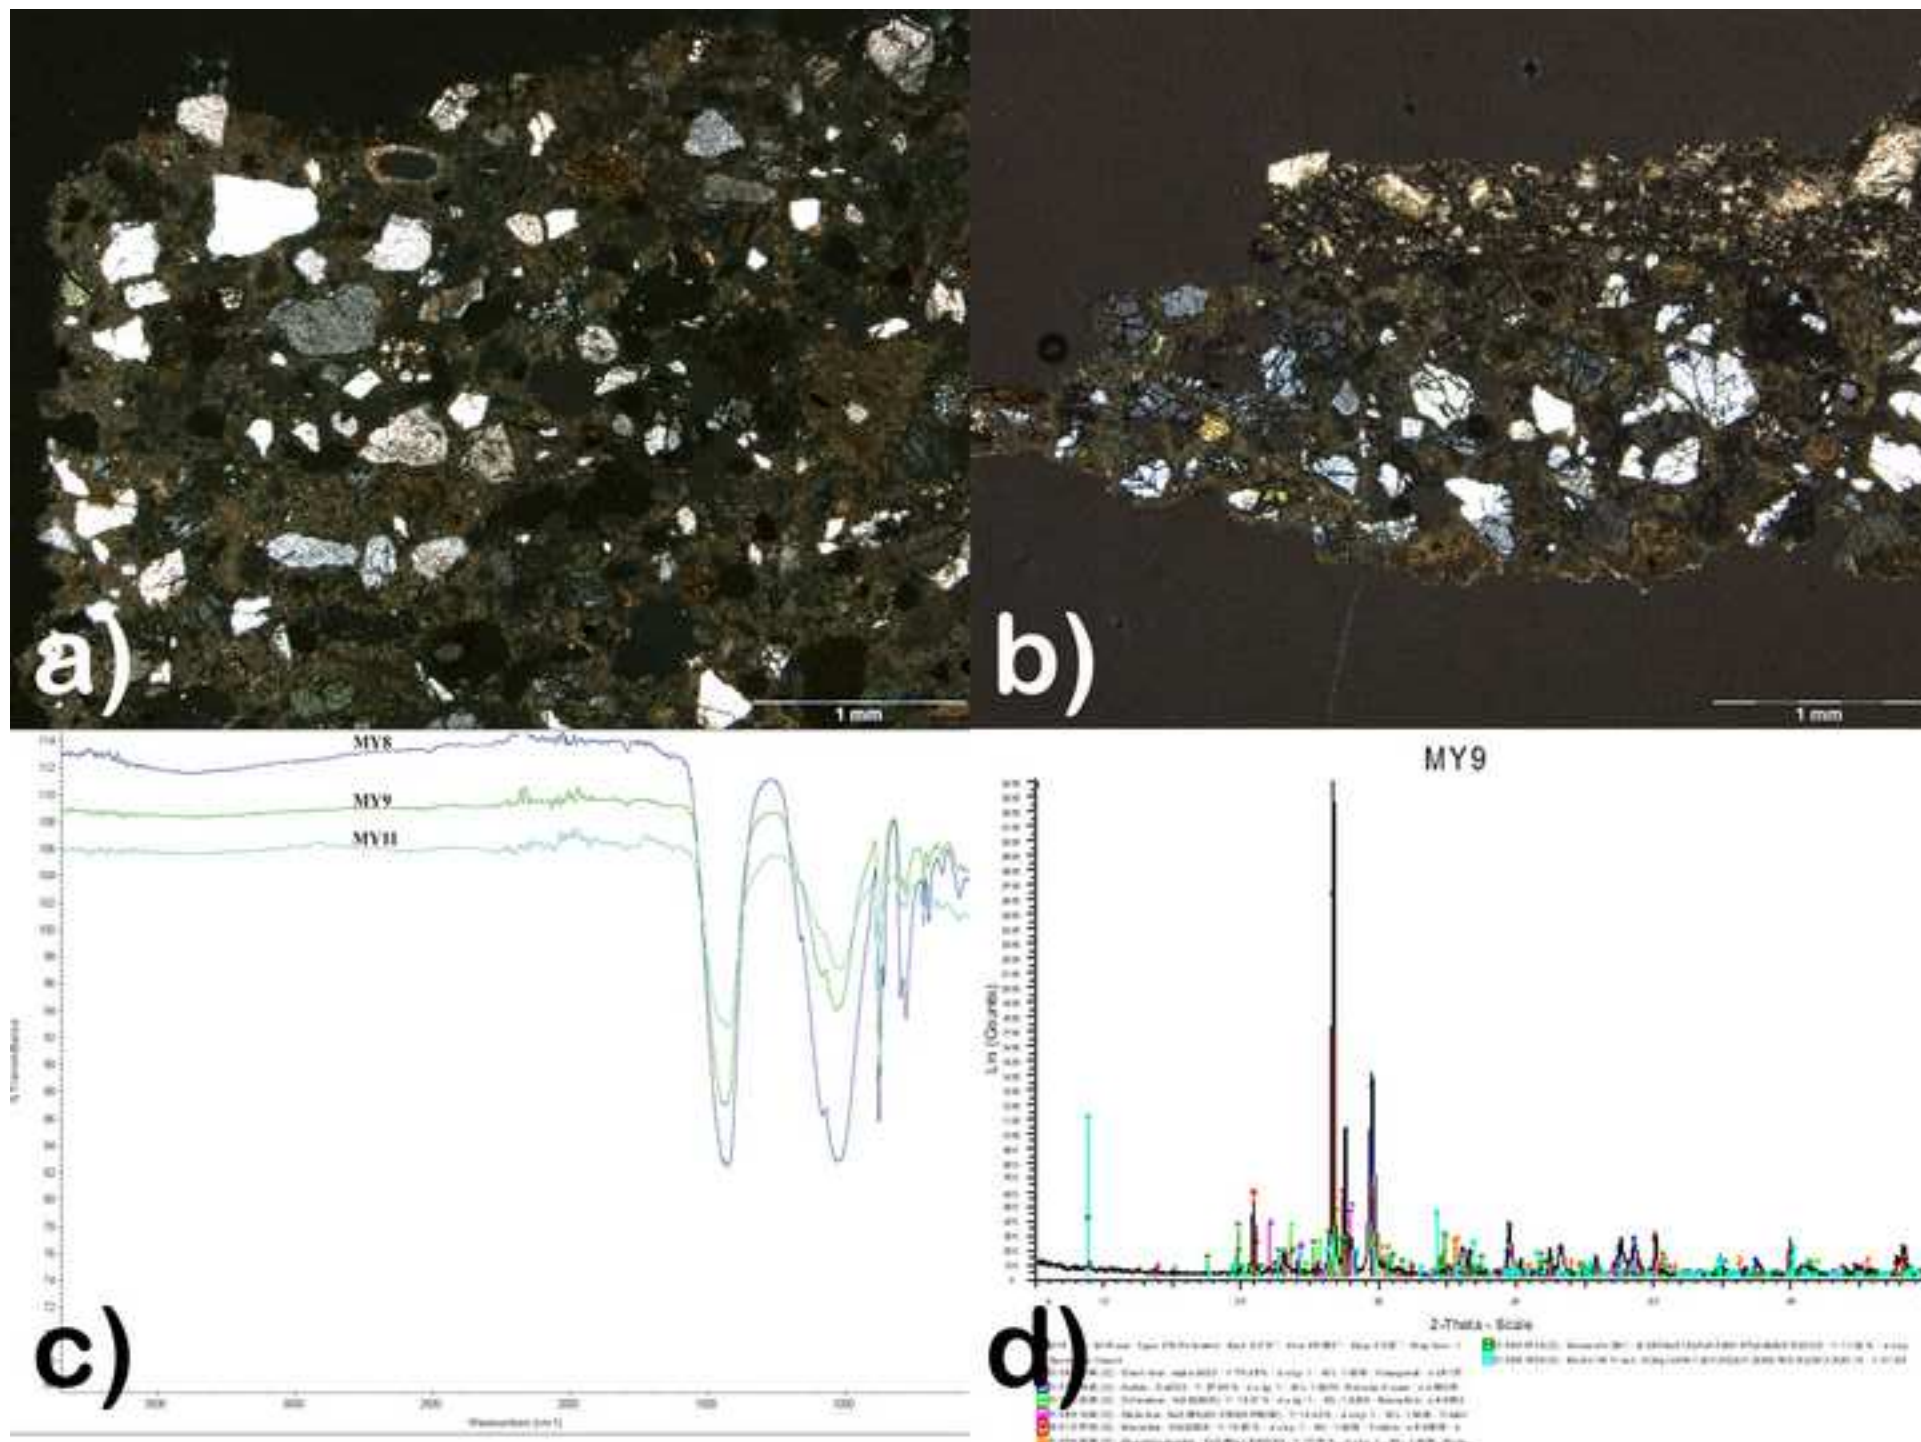
**Figure 7**  
[Click here to download high resolution image](#)

Polarized optical microscope observations of the stucco samples (Table 2) show a light brown colour (fig. 7a) and the presence of an inhomogeneous texture with a very heterogeneous composition. Groundmass has a prevailing calcic composition, micritic texture and greyish-light brown colour. A-plastic grain size ranges from few  $\mu\text{m}$  to 500 $\mu\text{m}$ , with rare coarser grains. The skeleton has a silicate composition. Among the non-plastic inclusions, mono- and polycrystalline quartz is the most widespread phase, often presenting undulose extinction. Quartz grain size is very variable, reaching 1 mm in diameter. The other main phases composing the aggregate are, in decreasing order of abundance: K-feldspars (orthoclase and microcline) plagioclase, clinopyroxene, Ca-amphibole, opaque minerals and garnet. Grog, stone fragments (quartzite and limestone) were detected. Traces of bioclasts (radiolaria, shells and vegetal frustules) are also present. Inclusions volume percentage is about 20-30%. Percentage of voids is about 5-10%. Macro-porosity is mainly given by sub-rounded micro-vacuoles.

In MY15 sample, two layers were identified (Table 2, fig 7b). The outer layer is mainly composed by a dark semi-isotropic carbonate/silicate matrix surrounding angular coarse carbonate grains (calcite). Regarding the inner layer, it is quite similar to the samples described above.

In the samples MY8, MY9 and MY11 as highlighted by the FT-IR spectra (fig. 7c) the carbonate signal at about  $1420\text{ cm}^{-1}$  was detected.

XRD analysis (Fig. 7d, Table 3) confirms the petrographic observations. Calcite is the main mineral phase followed by quartz.

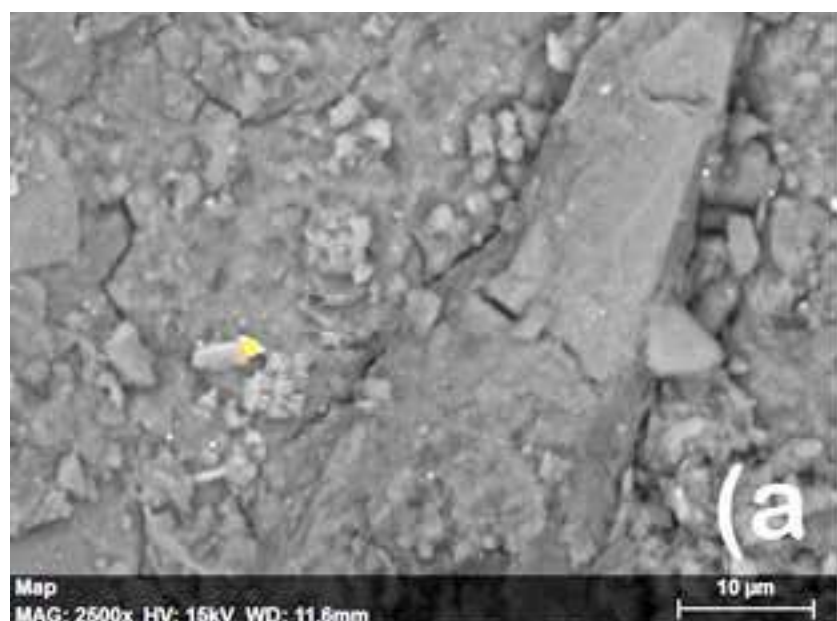
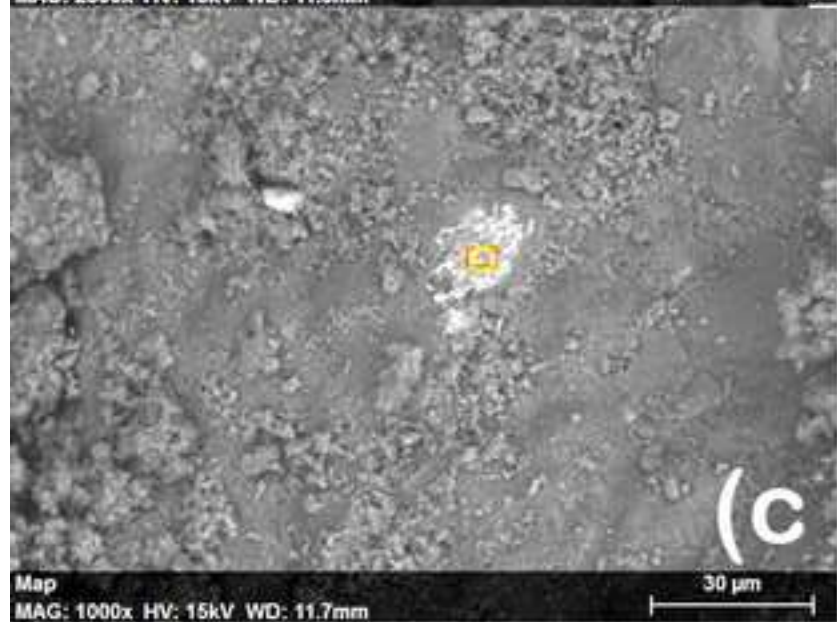
**Figure 9**  
[Click here to download high resolution image](#)

(spinel), Ti and Zr-rich particles, iron oxides, were detected as well. XRD (Table 3), FT-IR and TGA analyses further confirmed these results. Traces of silver and rare earths (lanthanum, cerium, praseodymium) were revealed in MY7 (Fig. 9a, 9b).

It should be noticed that in MY6 and MY17.1 several titanium-rich particles (titanite in association with ilmenite) were identified, maybe referred to titaniferous sand. Quartz, K-feldspars, Zr-rich particles were identified as well (MY13 and MY16 samples). Non-original mortars contain traces of silver and rare earths (lanthanum, cerium) (fig. 9c, 9d).

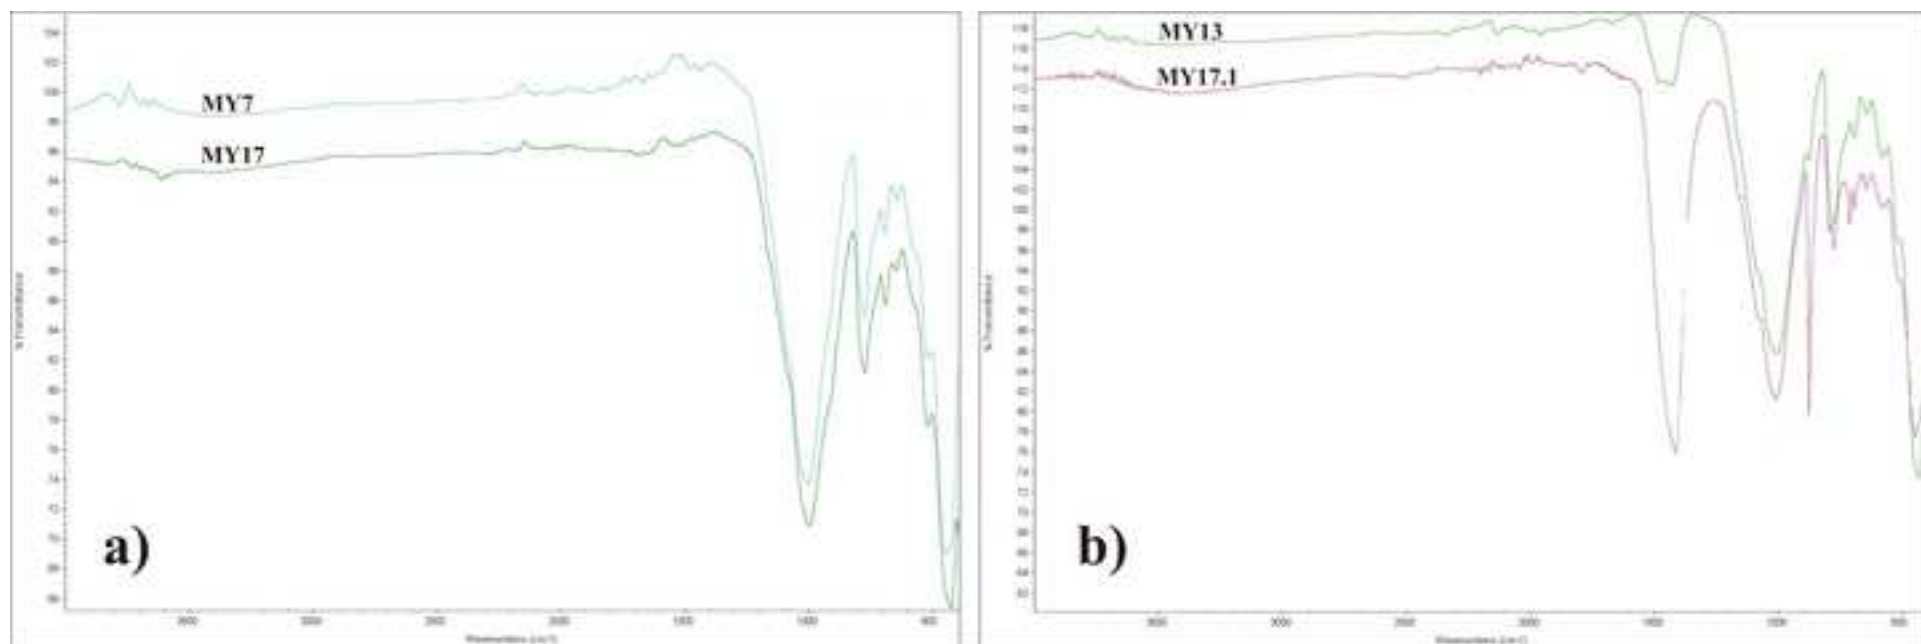
**Figure 10**  
[Click here to download high resolution image](#)

Some IR spectra acquired on original mortars (fig. 10a) clearly do not show the carbonate signal at about  $1420\text{ cm}^{-1}$ .
