<b>Manuscript number</b>	IBB_2019_1002_R1
<b>Title</b>	Characterization of a biofilm and the pattern outlined by its growth on a granite-built cloister in the Monastery of San Martiño Pinario (Santiago de Compostela, NW Spain)
<b>Article type</b>	Full Length Article

The upper zone of the background walls of the processional cloister of the Monastery of San Martiño Pinario (Santiago de Compostela, Galicia, Spain) is affected by a deep green, highly hydrophobic subaerial biofilm. The pattern that the biofilm follows the walls suggests that particular microclimatic conditions induce changes in the biofilm properties. To test this hypothesis, taxonomic and structural identification of the biofilm was carried out by respectively light microscopy and confocal laser scanning microscopy. In addition, the chemical composition was determined by quantification of extracellular polymeric substances in the extracellular matrix of the biofilm, and hydrophobicity was determined by contact angle and water drop penetration time of biofilm and cells. Furthermore, the bioprotective or biodeteriorative role of the biofilm on the cloister is discussed on the basis of the results of stereoscopic micros

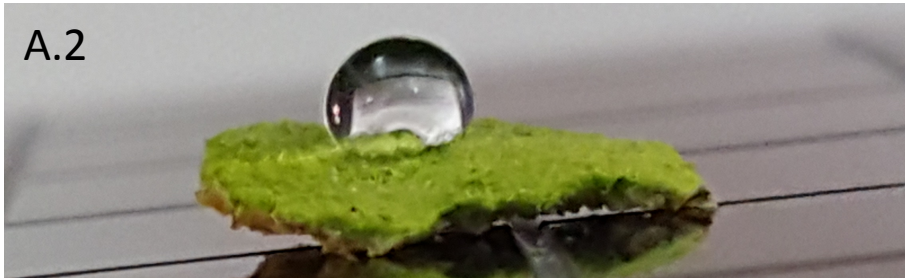
339 According to the categories of water repellency assigned by Leelamanie et al. (2008),  
340 both biofilm samples, seemingly more and less hydrophobic, were found to be  
341 extremely repellent to the water, with the time taken for the complete penetration of the  
342 water drop of more than an hour and water contact angles of  $133.5^\circ \pm 3.5^\circ$  and  $119.4^\circ \pm$   
343  $4.8^\circ$ , respectively (Figure 4). The contact angle could not be measured on uncolonized  
344 granite as the drop was absorbed immediately upon falling. The water drop penetration  
345 time (WDPT) was less than 0.2 s, corresponding to instantaneous penetration and non-  
346 repellent character. The hydrophobicity of the rock where the biofilm was formed was  
347 still notable after biofilm removal (contact angle of  $101.9^\circ \pm 4.9^\circ$ ), although the WDPT  
348 value was greatly reduced, by up to 60-600 s, considered strongly repellent (Figure 4).

Contact angle (degree):

$133.5 \pm 3.5$

$\geq 3600$ , Extremely repellent

$119.4 \pm 4.8$

Contact angle (degree)\*:

$101.9 \pm 4.9$

60-600, Strongly repellent

$85.6 \pm 2.7$

$\leq 1$ , Non-repellent

$58.7 \pm 1.0$

WDPT (s):

341 According to the categories of water repellency assigned by Leelamanie et al. (2008),  
342 both biofilm samples, seemingly more and less hydrophobic, were found to be  
343 extremely repellent to the water, with the time taken for the complete penetration of the  
344 water drop of more than an hour and water contact angles of  $133.5^\circ \pm 3.5^\circ$  and  $119.4^\circ \pm$   
345  $4.8^\circ$ , respectively (Figure 4). The contact angle could not be measured on uncolonized  
346 granite as the drop was absorbed immediately upon falling. The water drop penetration  
347 time (WDPT) was less than 0.2 s, corresponding to instantaneous penetration and non-  
348 repellent character. The hydrophobicity of the rock where the biofilm was formed was  
349 still notable after biofilm removal (contact angle of  $101.9^\circ \pm 4.9^\circ$ ), although the WDPT  
350 value was greatly reduced, by up to 60-600 s, considered strongly repellent (Figure 4).
