Mechanisms of failure on terraced slopes: the Valtellina case (northern Italy)

Corrado A. S. Camera^{*✉}, Tiziana Apuani^{*}, and Marco Masetti^{*}

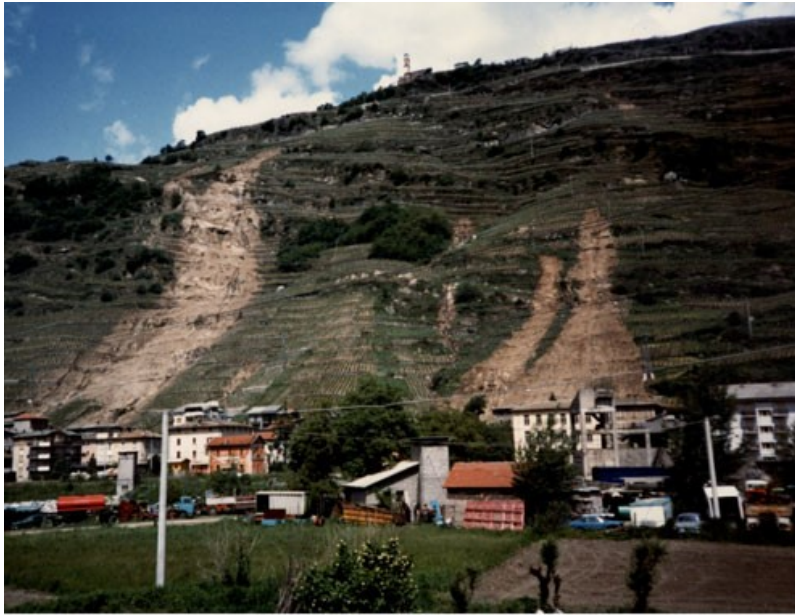
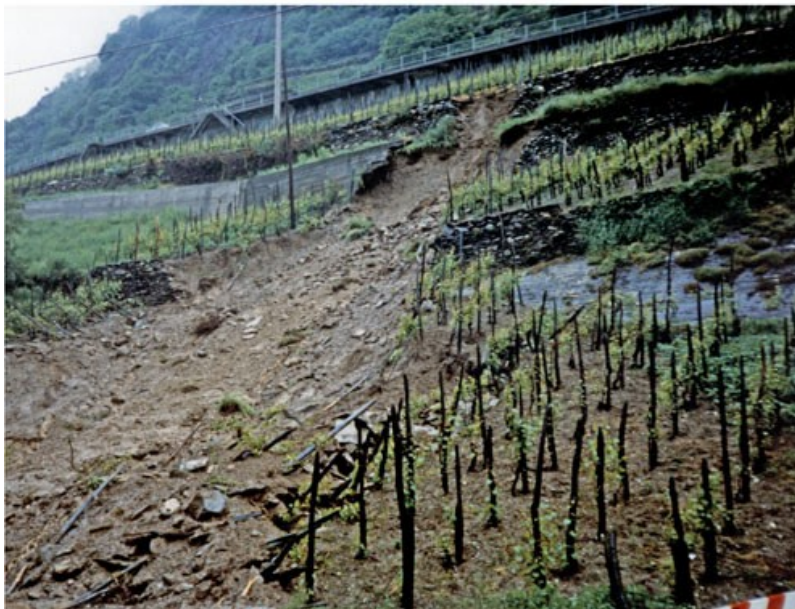
723 *Fig. 3 Two photos of the soil slip/debris avalanche events that in May 1983 affected the slope of*
724 *Tresenda. Top: a panoramic of the slope; bottom: a detail of the source area of the event on the*
725 *left in the top image. Photos by Maurizio Azzola*

131 Terraced slopes for vineyard cultivation are present on the northern flank in the
132 central part of the valley, covering a surface of 17 km² (Crosta et al. 2003). One of
133 these areas is the slope uphill of the village of Tresenda. Tresenda was chosen as a
134 study area because it possesses representative characteristics of Valtellina terraced
135 slopes and also because it was investigated in 1983 and 2002 for soil slip/debris
136 avalanche (Hungar et al. 2001, 2012) events (Fig. 3) that caused damage to
137 vineyards, buildings, roads, and other infrastructure and resulted in human
138 casualties (Azzola and Tuia 1983; Cancelli and Nova 1985; Quan Luna et al.
139 2010; Blahut et al. 2012; Camera et al. 2012).

140 Figure 3: two photos of the soil slip/debris avalanche events that in May 1983 affected the slope of
141 Tresenda. Top: a panoramic of the slope; bottom: a detail of the source area of the event on the left
142 in the top image. Photos by Maurizio Azzola.

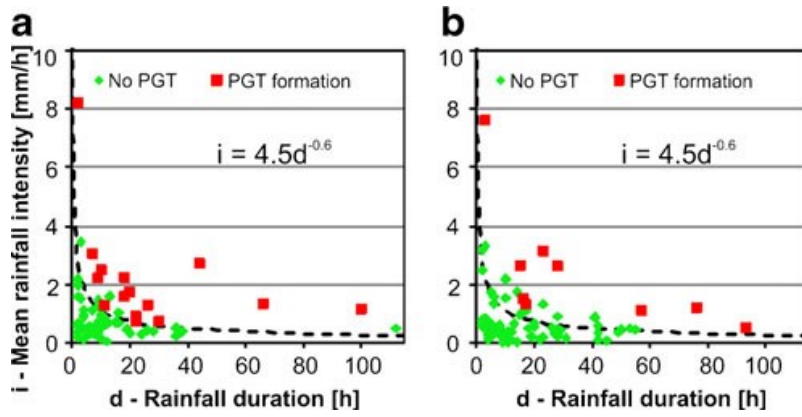
730 *Fig. 4 Rainfall intensity–duration threshold for PGT formation. a The threshold drawn from the*
 731 *data of the period August 2009 to August 2010 as presented in Camera et al. (2012). b Validation*
 732 *of the threshold performed with the data from August 2010 to August 2011*

202 on the duration of rainfall after its peak (Camera et al. 2012). The same data are
203 presented in the form of an intensity-duration rainfall threshold for PGT formation
204 (Fig. 4a), which is modeled after previous examples that were correlated to
205 landslide triggering in Valtellina (Cancelli and Nova 1985; Govi et al. 1985;
206 Ceriani et al. 1992; Agostoni et al. 1997; Crosta and Frattini 2001; Luino et al.
207 2008). This threshold was drawn using the data recorded between August 2009
208 and 2010, and it was then validated with data from 2011 (Fig. 4b). The aim was to
209 monitor the formation of perched groundwater tables and the trend of water
210 content in the soil in relation to rainfall events recorded on an hourly basis by a
211 meteorological station (Castelvetro/Somasassa) located 300 m north of study area.
212 It is important to note that the threshold in Fig. 4 is only a first and rough estimate

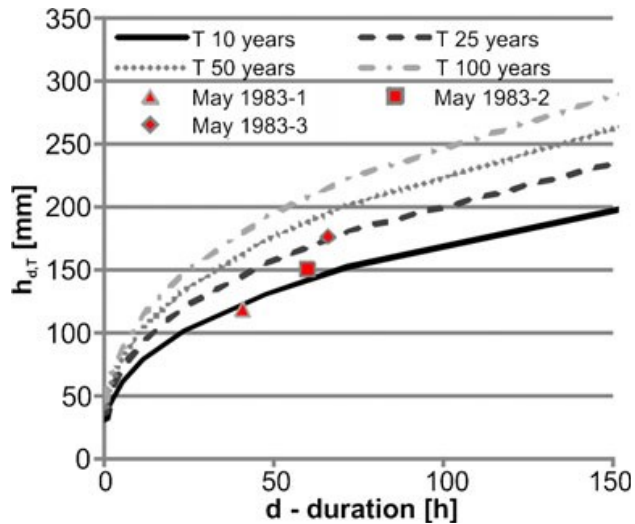
736 *Fig. 5 Rainfall intensity–duration frequency curves for return periods (T) of 10, 25, 50, and 100*
 737 *years. The three points on the graph depict the landslide triggering rainfall event of 1983 by*
 738 *associating the recurrence time to three pairs of cumulated duration–height recorded before the*
 739 *triggering of the three debris avalanches occurred on the 22nd and 23rd of May 1983*

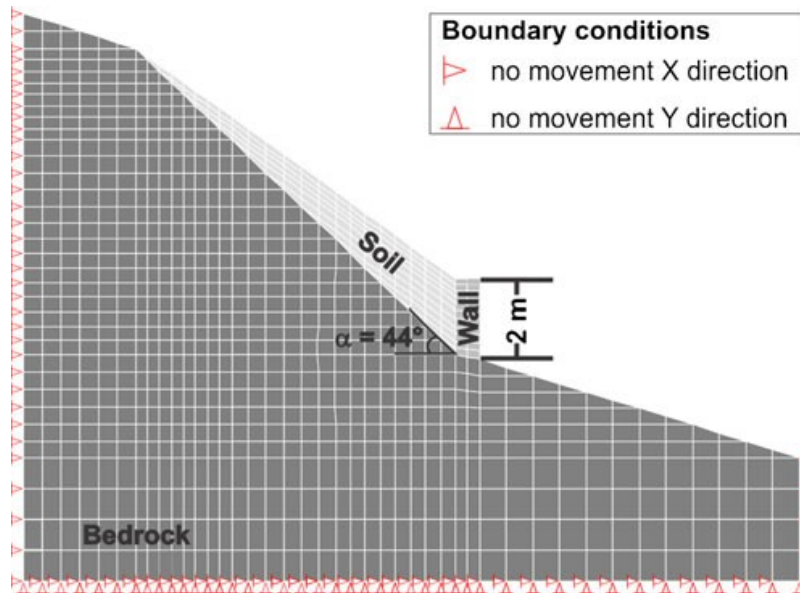
742 *Fig. 6 Model geometry and boundary conditions*

264 Figure 6: Model geometry and boundary conditions.

265 SEEP/W (GEOSLOPE International Ltd. 2002a), which is a finite elements code
266 that can account for both saturated and unsaturated soil conditions, was used for
267 numerical simulation of infiltration and groundwater movement processes. The
268 required input for characterizing the different materials involved are the saturated
269 hydraulic conductivity (k_s), the soil water retention curve (SWRC), and the
270 permeability function. Input data were derived from field and laboratory tests and
271 adjusted during the calibration phase of the model. The model was calibrated and
272 validated using two different rainfall events registered by the meteorological
273 station and by comparing the hydrographs – PGT levels vs. time – registered by
274 the piezometer data logger installed for this study with the hydrographs calculated
275 by the model.

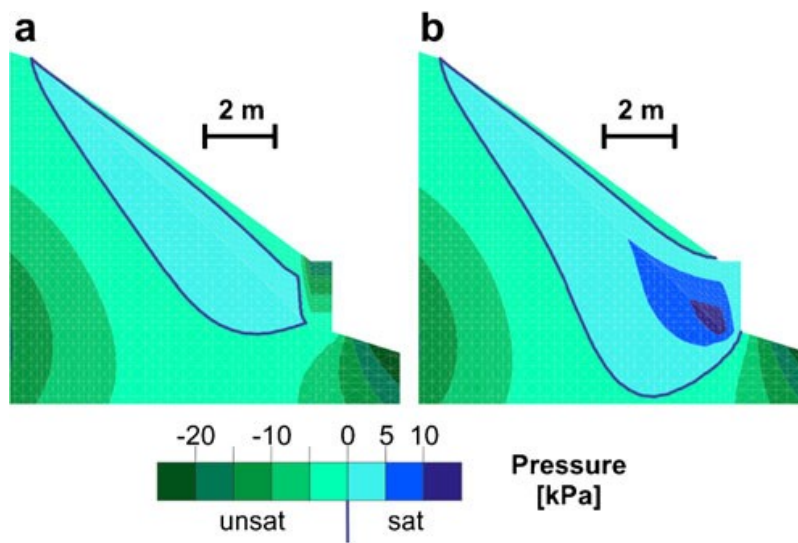
746 *Fig. 7 Overpressures developed at the wall base (kilopascal) for the project rainfall event of 72 h*
 747 *and 50-year return period, with a well-maintained wall (a) and an old, poorly maintained*
 748 *structure (b). Results obtained from SEEP/W*

295 Finally, the model was applied with a synthetic project rainfall lasting 72 hours
296 and characterized by constant intensity, obtained from statistical elaboration
297 (Quan Luna et al. 2010; Camera et al. 2012), similar to the one which caused the
298 triggering of the shallow landslide in May 1983. Two different limit conditions
299 were considered, on the base of wall status in the area: well maintained wall,
300 where the initial draining condition of the wall was still active and poorly
301 maintained wall, where clogging between stones had occurred. The first situation
302 was modeled considering the wall with a high hydraulic conductivity ($1E-4$ m/s)
303 while the second with a low hydraulic conductivity ($1E-6$ m/s) It is interesting to
304 see how the overpressure developed at base of the wall varies for different
305 conditions of maintenance of the walls (Fig. 7).

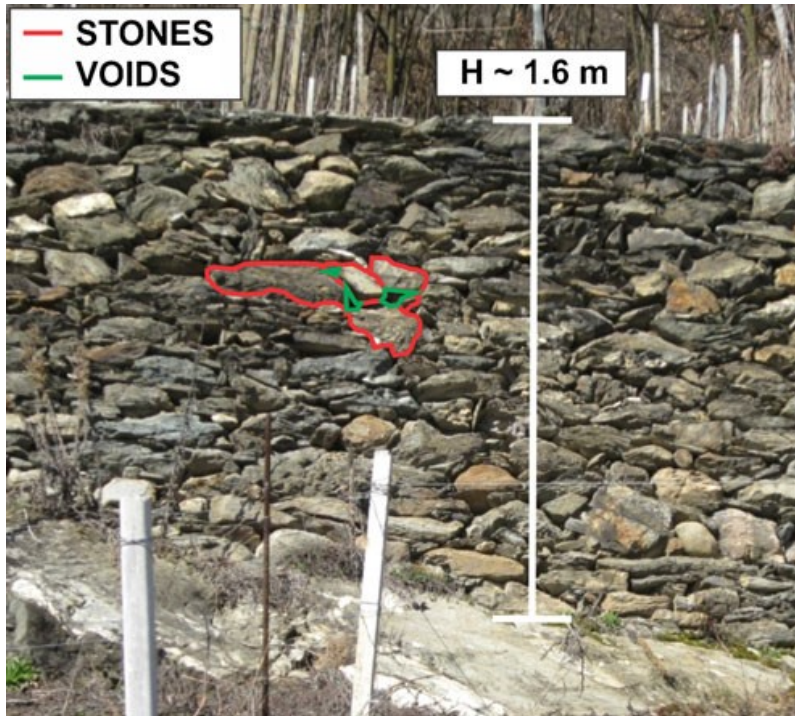
750 *Fig. 8 A dry stone wall with the stones and voids structure*

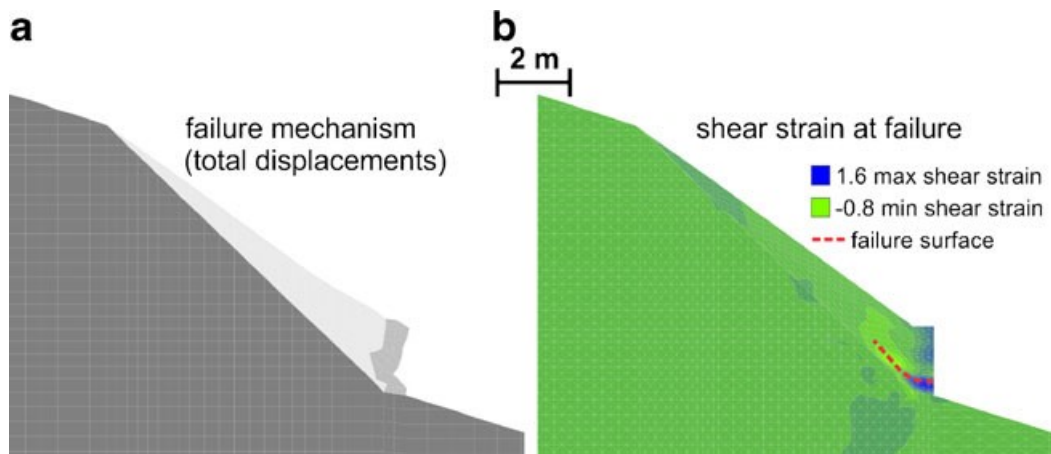
754 *Fig. 9 a Time of failure represented by the displacements experienced by the wall; b XY shear*
 755 *strain [-] developed in the model. Results obtained from SIGMA/W*

350 The pore water pressure distribution at collapse, obtained by simulating the May
351 1983 event (Fig. 9), is consistent with the description of Azzola and Tuia (1983),
352 who observed saturated backfill soils during the triggering of the second
353 superficial landslide. However, the main problem shown by the model is that it is
354 unable to correctly reproduce the mechanism of failure observed on site. Azzola
355 and Tuia (1983) described saturation of the backfill soil, followed by a bulging at
356 the toe of the dry-stone wall and then by subsequent collapse of both the wall and
357 soil. Figure 9 shows how this mechanism can be overlooked. As predicted, the

366 Figure 9: a) Time of failure represented by the displacements experienced by the wall; b) XY shear
367 strain [-] developed in the model. Results obtained from SIGMA/W.

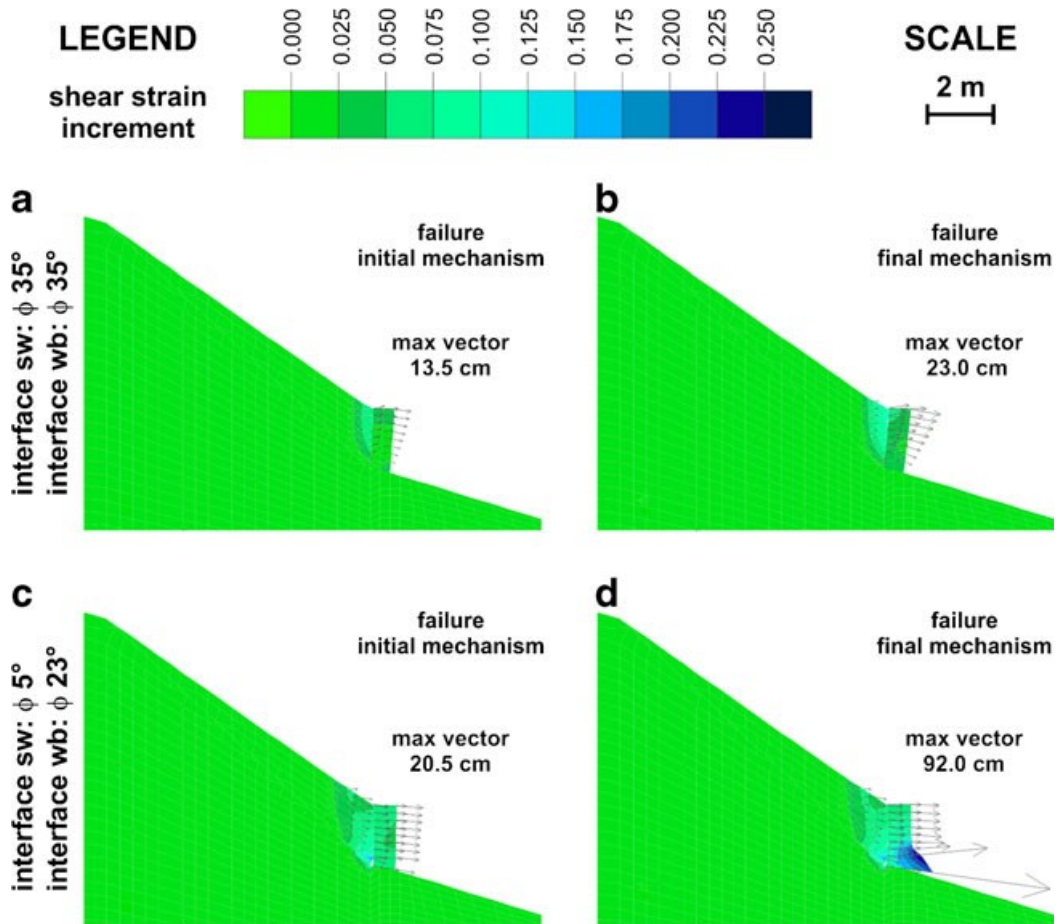
757 *Fig. 10 Results obtained from FLAC showing the shear strain increments and the displacement*
 758 *vectors. Initial (a, c) and final (b, d) failure mechanisms depending from soil–wall (sw) and*
 759 *wall–bedrock (wb) friction angle*

409 final stages of collapse. In this case, the friction angle between the wall and the
410 bedrock (and more generally, the bonded behavior of the wb-interface) does not
411 allow the wall to slide at the base; the deformation zone does not include the base
412 of the wall (Fig. 10a,b). By lowering the friction angle and threshold strength at
413 the contact between wall and bedrock, the simulation appears to better reproduce
414 the mechanism of failure as observed on site in 1983 (Fig. 10c,d). It is possible in
415 this simulation to observe an initial toppling (Fig. 10c) that later evolves into
416 bulging and sliding at the base of the wall (Fig. 10d) until collapse occurs.

425 Figure 10: Results obtained from FLAC showing the shear strain increments and the displacement
426 vectors. Initial (a,c) and final (b,d) failure mechanisms depending from soil-wall (sw) and wall-
427 bedrock (wb) friction angle.
