Catheter-based Closure of a Post-infective Aortic Paravalvular Pseudoaneurysm Fistula With Severe Regurgitation After Two Valve Replacement Surgeries: A Case Report

This article was submitted to
Structural Interventional Cardiology,
a section of the journal
Frontiers in Cardiovascular Medicine

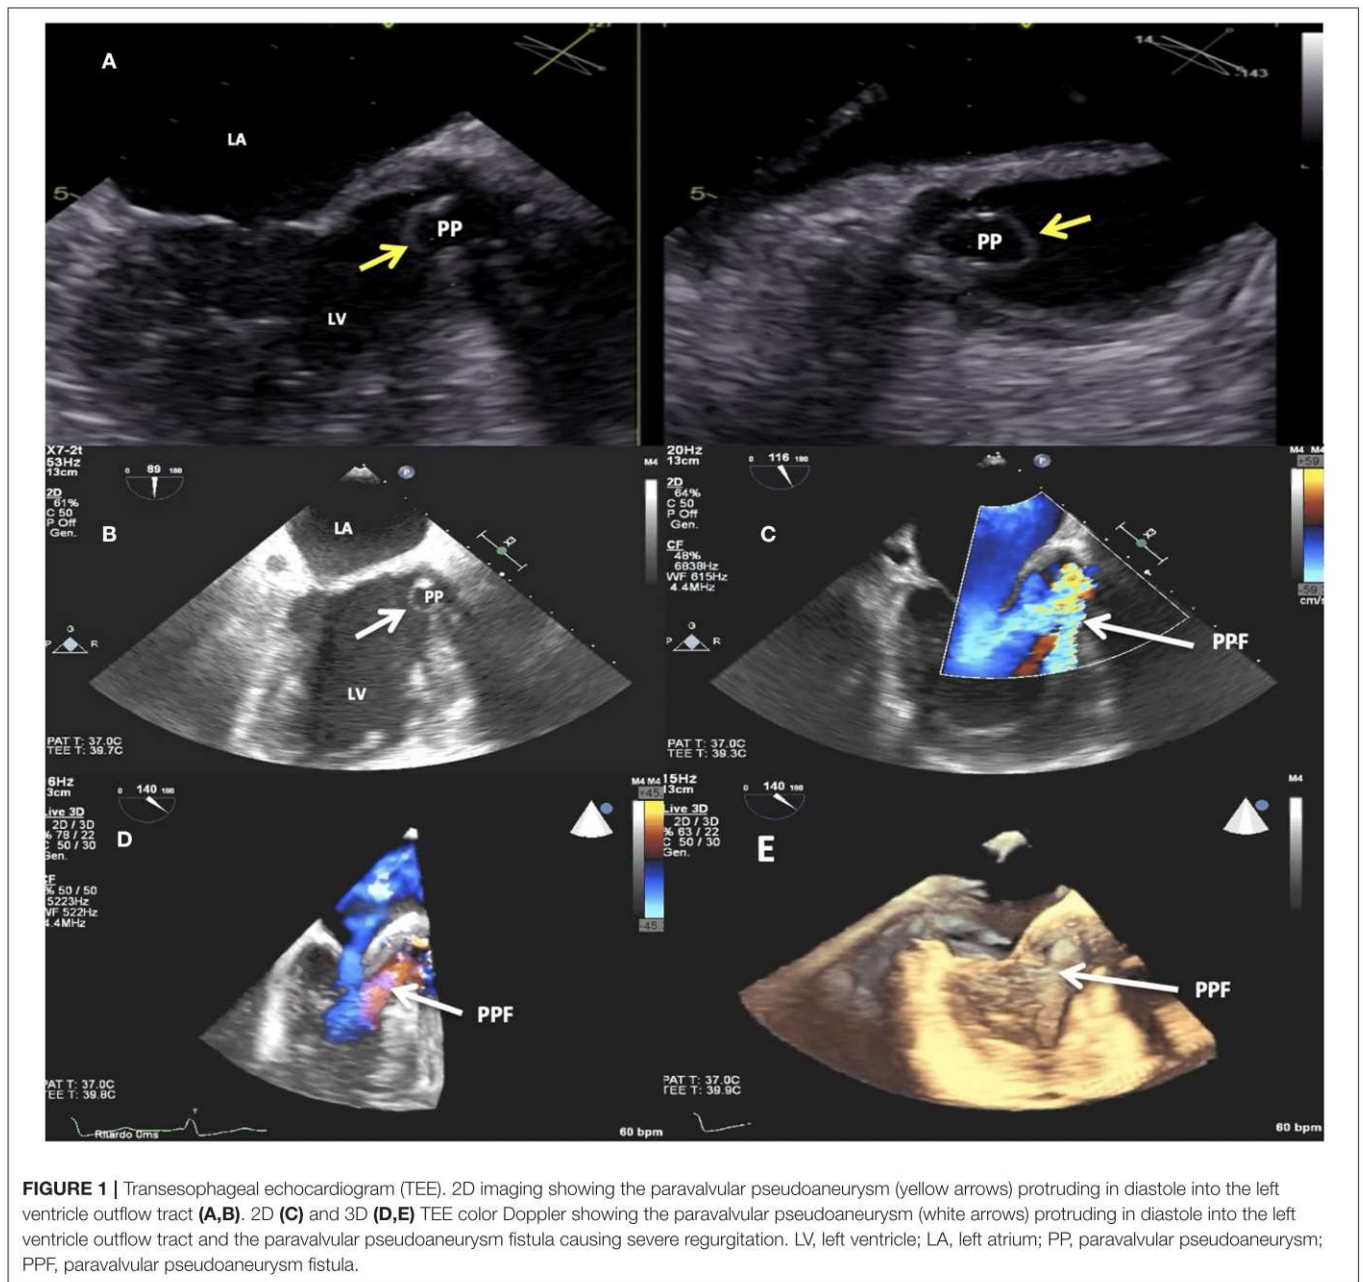
Three years later, she was hospitalized because of congestive heart failure. Two-dimensional and three-dimensional (2D/3D) transesophageal echocardiography (TEE) showed a well-functioning bioprosthetic valve and a PPF protruding in diastole into the left ventricle outflow tract with severe PVL (Figures 1A–E). Diastolic reversal flow with high velocity (>20 cm/s) in the descending aorta confirmed regurgitation severity. The PPF size was about 9 × 7 mm, with a neck size of 5 mm and an EROA of 0.5 cm². Multidetector computed tomography (MDCT) (Figure 2A) confirmed the PPF location under the left coronary cusp close to the left main coronary artery ostium. A silicone-printed 3D heart model was made based on MDCT reconstruction (Figure 2B, Supplementary Figure 1) to better understand PPF anatomy and its relationship with the surrounding structures and for planning “ex vivo” transcatheter implantation of the most appropriate occluding device (Figure 2C). This turned out

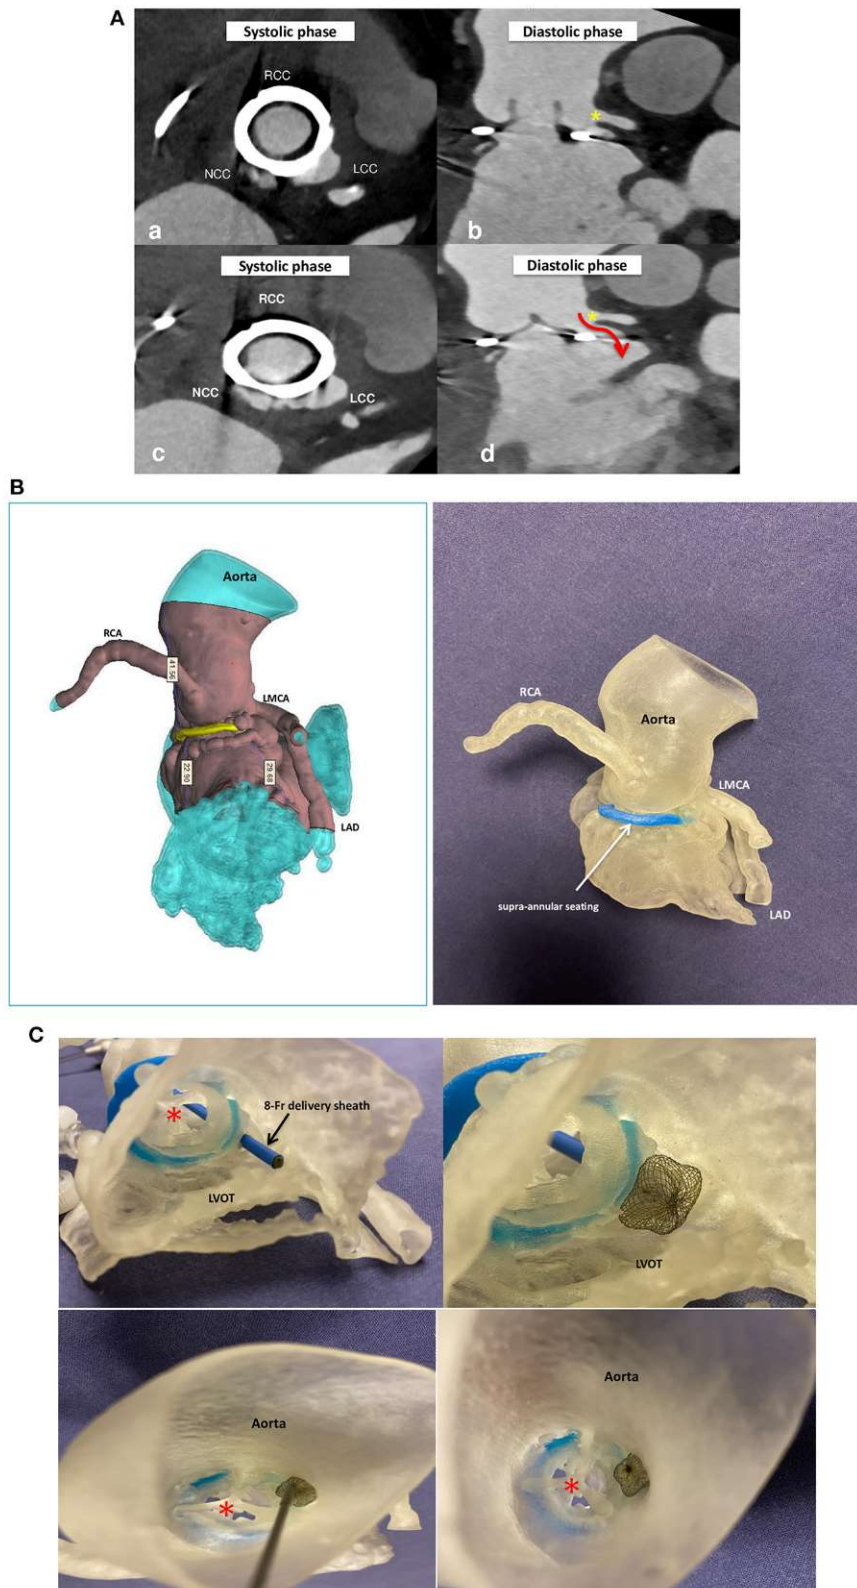
FIGURE 2 | Multidetector computed tomography angiography (MDCTA) scans **(A)** with acquired frames in systolic (a,c) and diastolic phase (b,d) confirming the presence of the paravalvular pseudoaneurysm fistula located at the left coronary cusp in close proximity of the left main coronary artery (yellow star) and protruding in diastole into the left ventricle outflow tract (red arrow). Silicone printed 3D heart model made on the basis of MDCTA scan reconstruction **(B)**. Silicone 3D model *(Continued)*

FIGURE 2 | (C) seen from the left ventricle outflow tract (upper panels) and from the ascending aorta (bottom panels) and used to mimic the implantation of a self-expanding double-disc 5-mm square twist Occlutech PLD, with a distal left ventricle disc of 10 mm and a proximal aortic disc of 8.5 mm. Note that the device does not impinge on the bioprosthetic aortic valve (red star). RCC, right coronary cusp; LCC, left coronary cusp; NCC, non-coronary cusp; RCA, right coronary artery; LMCA, left main coronary artery; LAD, left anterior descending; LVOT, left ventricle outflow tract.

to be a self-expanding double-disc 5-mm square twist PLD (PLD, Occlutech, Helsingborg, Sweden) with a 10-mm left ventricular disc and an 8.5-mm aortic disc. The patient was discharged to be referred to our tertiary cardiovascular center for transcatheter PPF closure. However, due to the impact of the COVID-19 pandemic on the national health system, elective interventional procedures were restrained in all Italian centers and the patient hospitalization was put on hold (4). During the waiting time, she was hospitalized again for congestive heart failure complicated by ventricular fibrillation, properly treated by ICD. The hemodynamic condition was unstable and required intravenous diuretics, inotropes and non-invasive ventilation. Ecocardiography documented a left ventricle ejection fraction of 40% with a moderate to severe mitral regurgitation. Two months later, the patient was finally transferred to our tertiary hub cardiovascular center. She was symptomatic for dyspnea at rest and was treated with high-dose of i.v. furosemide. Three days after admission, hyperpyrexia (up to 38.4°C) developed and blood culture showed the presence of staphylococcus aureus. She was treated with piperacillin/tazobactam and vancomycin with clinical benefit. At the same time, severe anemia occurred likely due to hemolysis through the PVL requiring blood transfusion. After 15 days of diuretic and antibiotic therapy, the patient was relatively stable with clinical improvement and furosemide dosage was reduced. However, a new episode of acute heart failure occurred requiring high-dose diuretics, dobutamine and non-invasive ventilation that rapidly restored an acceptable hemodynamic state. The decision was made by our multidisciplinary heart team to offer the only possible therapeutic option, a percutaneous PVL closure, due to the prohibitive surgical risk of the patient. Written informed consent, after detailed explanation, was obtained from the patient. The procedure was carried out in a hybrid operating room under general anesthesia, continuous real time 2D/3D TEE and fluoroscopic guidance. Ascending aorta angiogram showed the PPF adjacent to the bioprosthetic aortic valve with severe PVL (Supplementary Video 1). The PPF was measured with TEE and angiography that showed a diameter of 11 × 13.8 mm (Figure 3A) and 12.5 × 13.3 mm (Figure 3B), respectively. A pre-shaped extra small exchange guidewire (Safari²) was positioned through the PPF into the left ventricle apex and an 8-Fr delivery sheath was advanced over the wire. The left main coronary artery was protected with a 0.014” guidewire advanced through a 3.5 extra back up guiding catheter (Figures 4A–C). Based on the measurements made with TEE and angiography, a bigger PDL (10 × 4 mm), different both in shape (rectangular) and in type of connection (waist), with a 19-mm distal LV disc and 17-mm proximal aortic disc was advanced into the LV (Figure 4D; Supplementary Figure 2) and deployed under continuous fluoroscopic, angiographic and 2D/3D TEE guidance. Correct device alignment was achieved thanks to the rotational feature of the Occlutech PLD with significant decrease of the regurgitant jet and without impingement of the device on the prosthetic aortic leaflets. A pull-and-push maneuver was performed to check PLD stability and the device was successfully deployed (Figure 4E). Final TEE and angiographic assessment confirmed the PLD stable position with moderate

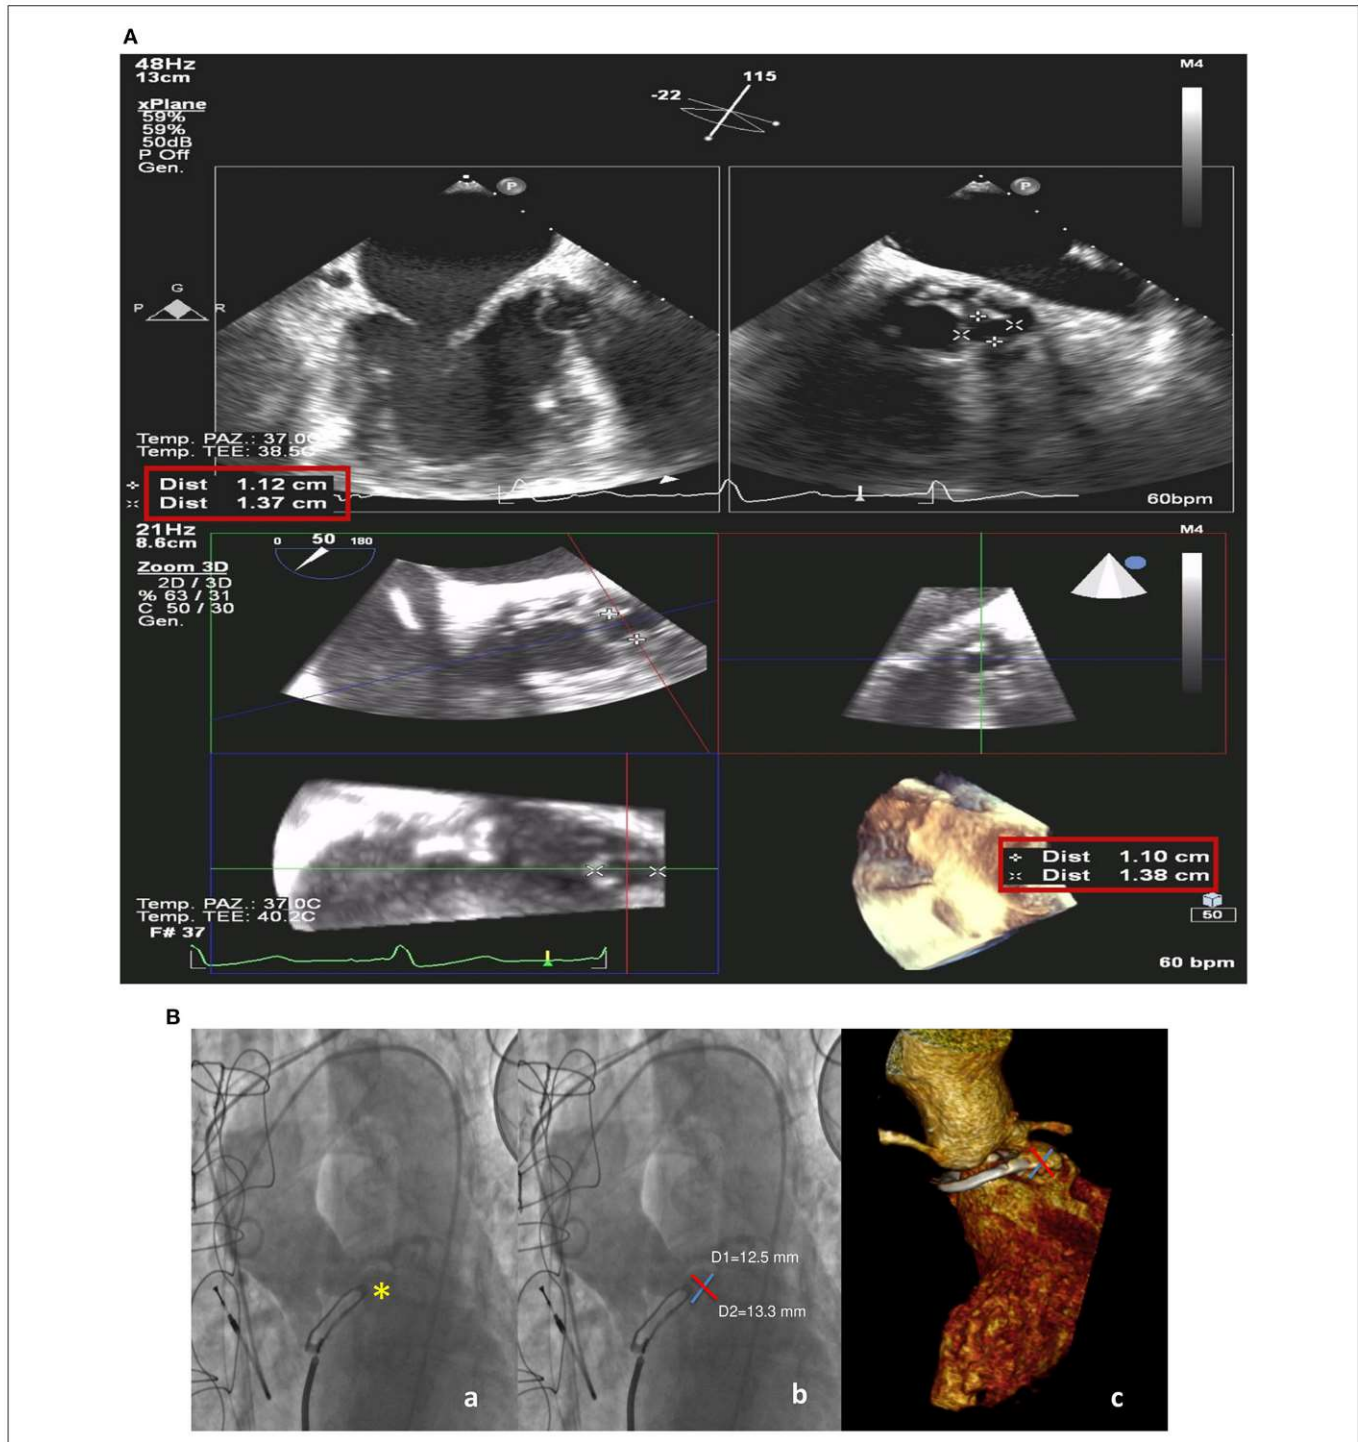
FIGURE 3 | Intraoperative transesophageal echocardiogram **(A)**, 2D X-plane imaging (upper panels) and 3D (bottom line) with measurements of the paravalvular pseudoaneurysm fistula. Preprocedural ascending aorta angiogram and volume-rendering three-dimensional (3D) multidetector computed tomography angiography (MDCT) **(B)** showing the paravalvular pseudoaneurysm (yellow star) (a) and its measurements on the two orthogonal axes from angiographic (b) and MDCT images (c).

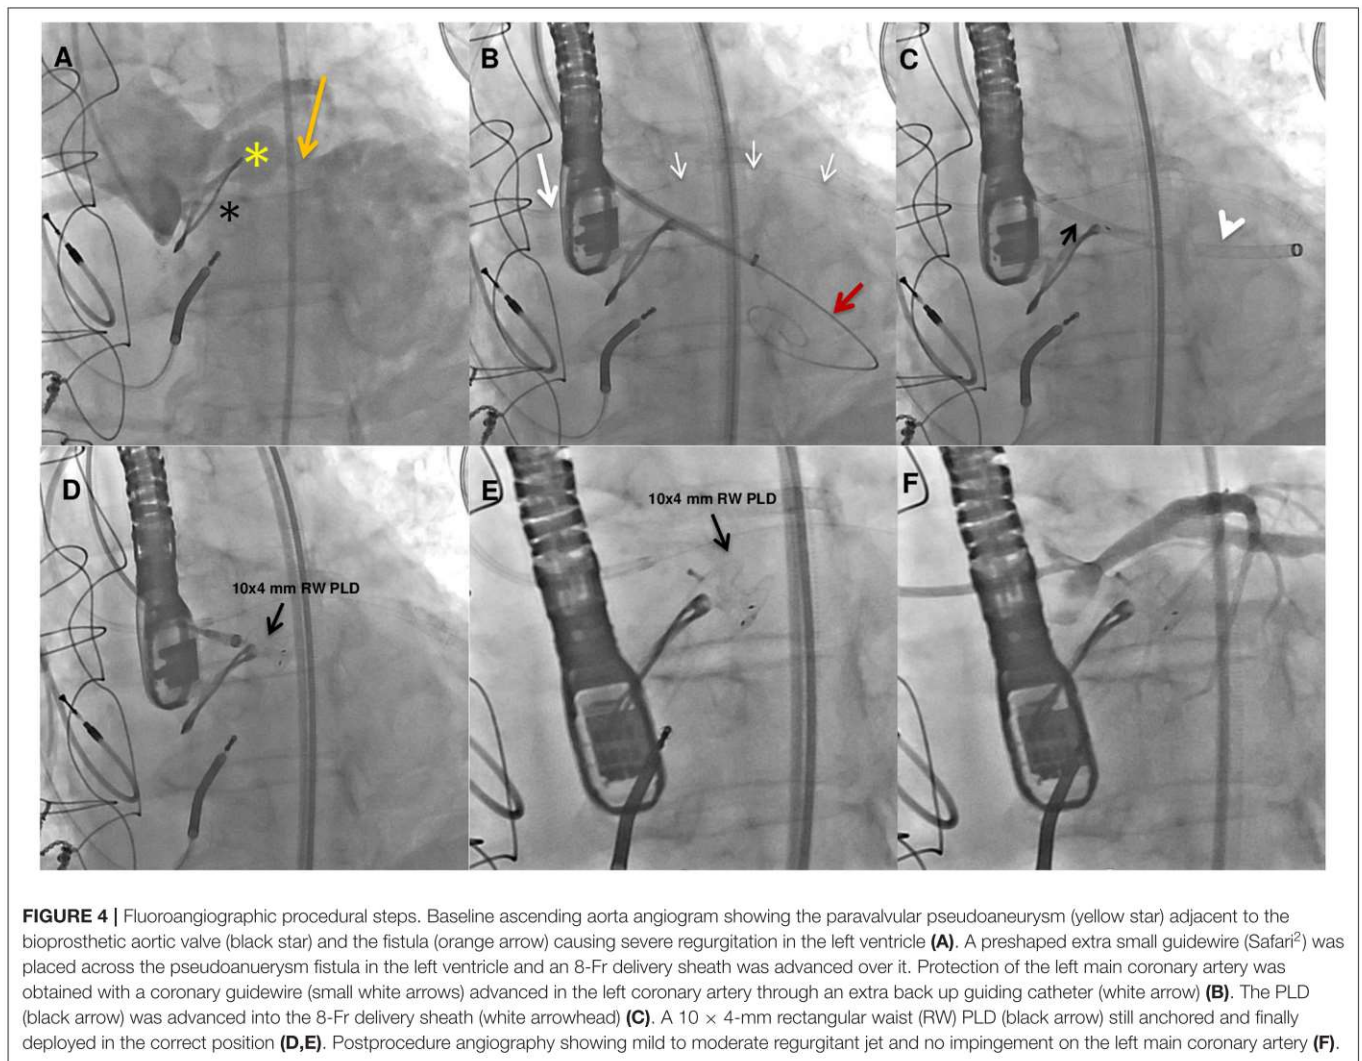
FIGURE 4 | Fluoroangiographic procedural steps. Baseline ascending aorta angiogram showing the paravalvular pseudoaneurysm (yellow star) adjacent to the bioprosthetic aortic valve (black star) and the fistula (orange arrow) causing severe regurgitation in the left ventricle (A). A preshaped extra small guidewire (Safari²) was placed across the pseudoaneurysm fistula in the left ventricle and an 8-Fr delivery sheath was advanced over it. Protection of the left main coronary artery was obtained with a coronary guidewire (small white arrows) advanced in the left coronary artery through an extra back up guiding catheter (white arrow) (B). The PLD (black arrow) was advanced into the 8-Fr delivery sheath (white arrowhead) (C). A 10 × 4-mm rectangular waist (RW) PLD (black arrow) still anchored and finally deployed in the correct position (D,E). Postprocedure angiography showing mild to moderate regurgitant jet and no impingement on the left main coronary artery (F).

residual leak (Figure 4F; Supplementary Videos 2–4). After the procedure, the patient remained hemodynamically stable, antibiotic therapy was continued for 15 days and she was then transferred to a rehabilitation center with the indication to maintain long-term oral antibiotics. However, 1 month later the clinical condition worsened again with congestive heart failure and deterioration of renal function requiring hospitalization. On admission, 2D TEE confirmed a satisfactory result of the PPF percutaneous closure with mild-to-moderate residual leak and mitral regurgitation graded as moderate to severe. Irreversible clinical worsening occurred and the patient died of multiorgan failure 2 days later.
